# Building Observations Survey ©2016

## Deer Park Community Center Deer Park, Texas

**Building Survey for Deer Park Community Center,  
610 East San Augustine Street, Deer Park, Texas**

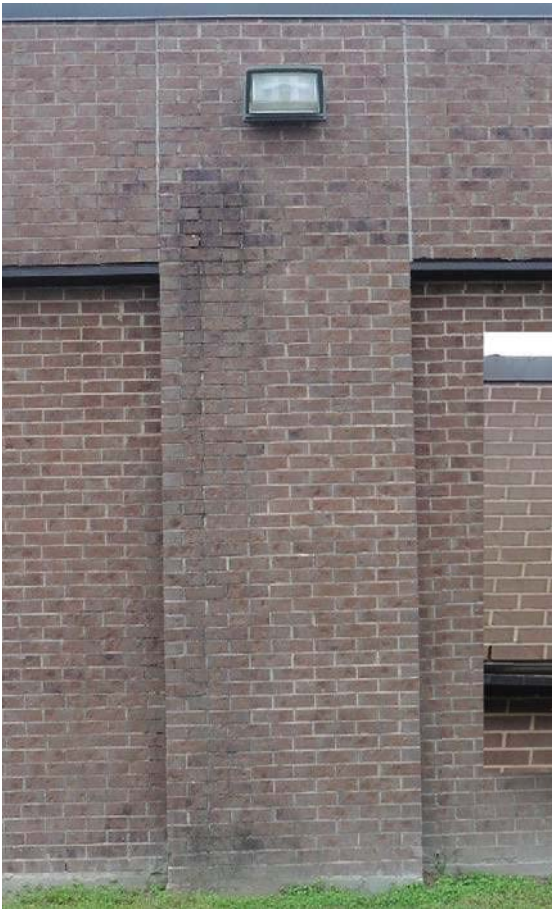
Examples of water damage

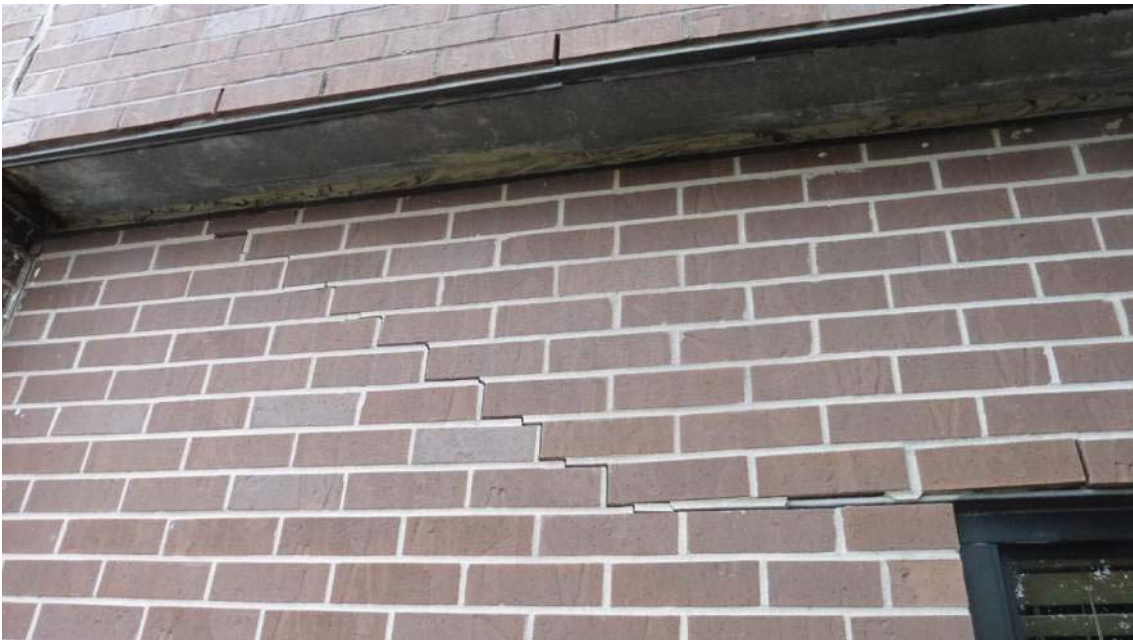
Examples of structural movement damage

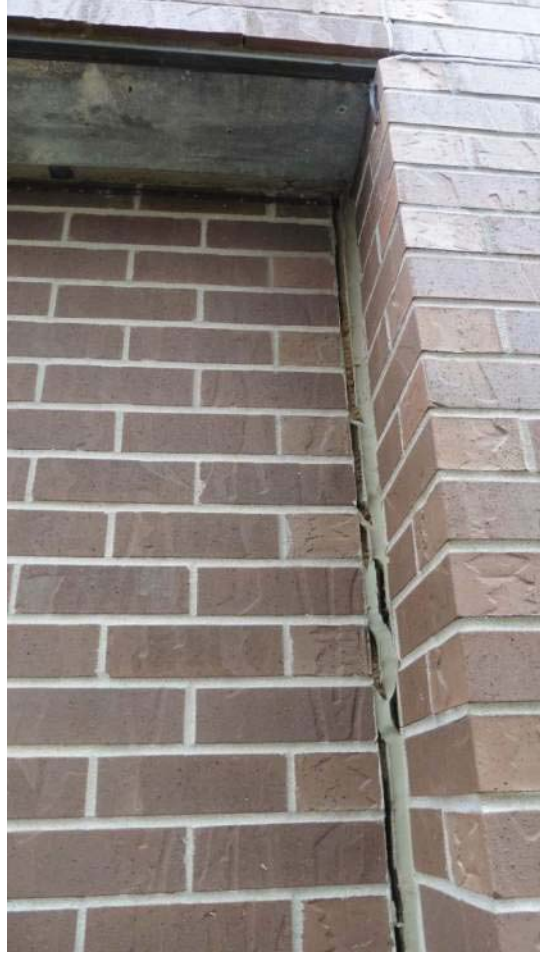
Examples of movement damage

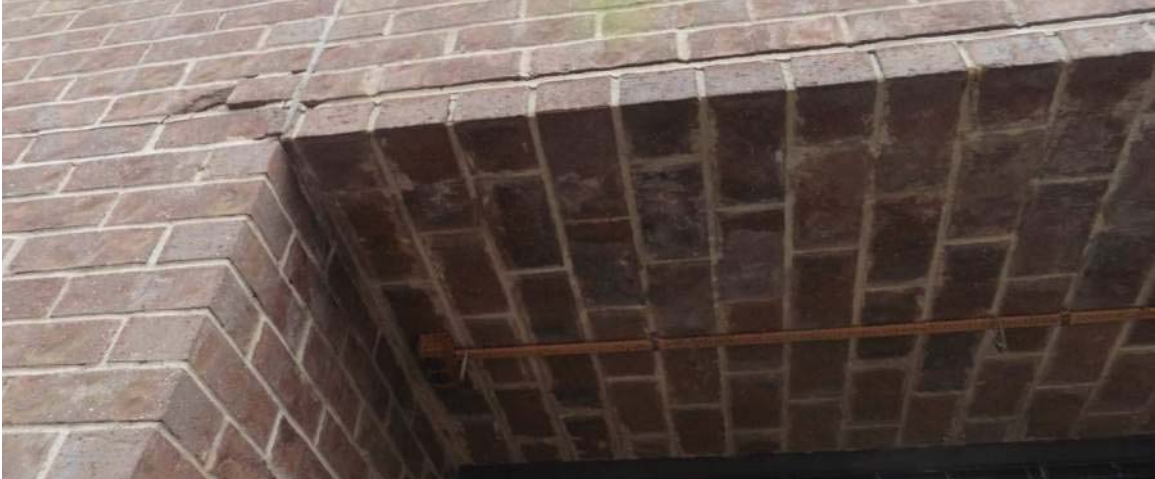
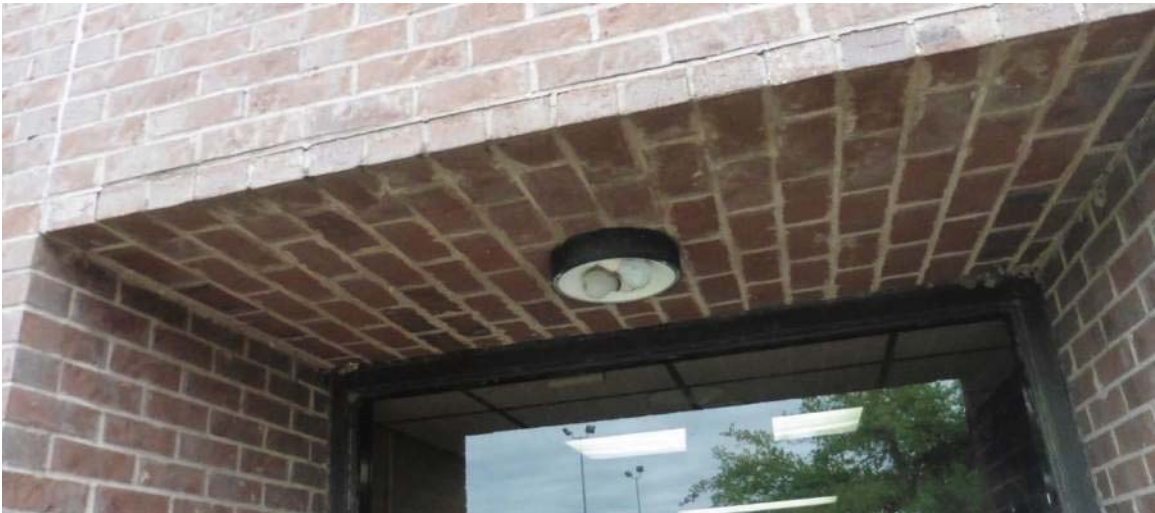
Examples of brick soffit water damage, abandoned or broken electrical

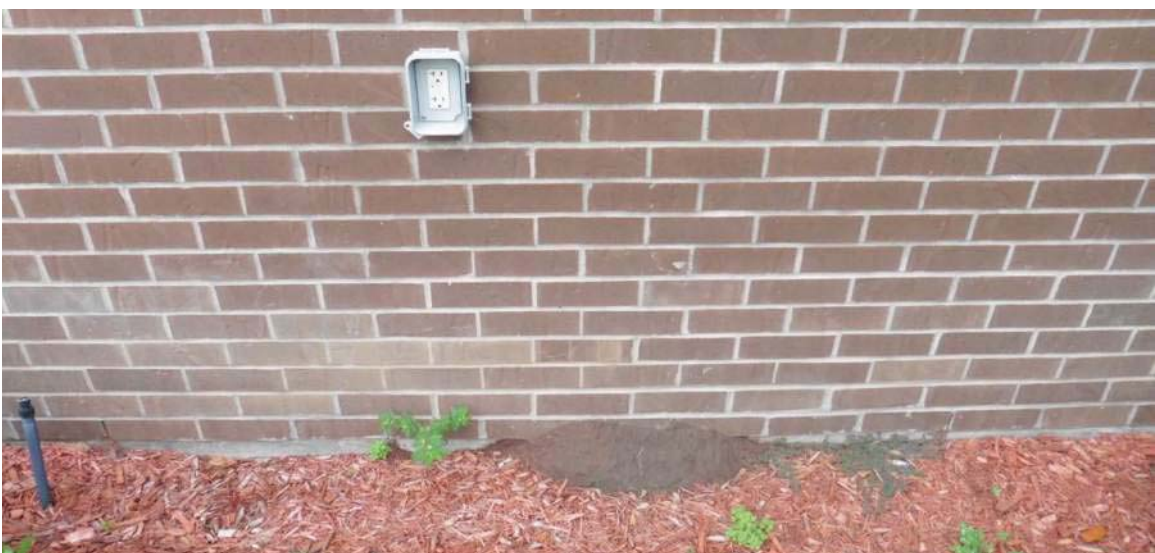
Insect infestation, and example of unprotected electrical

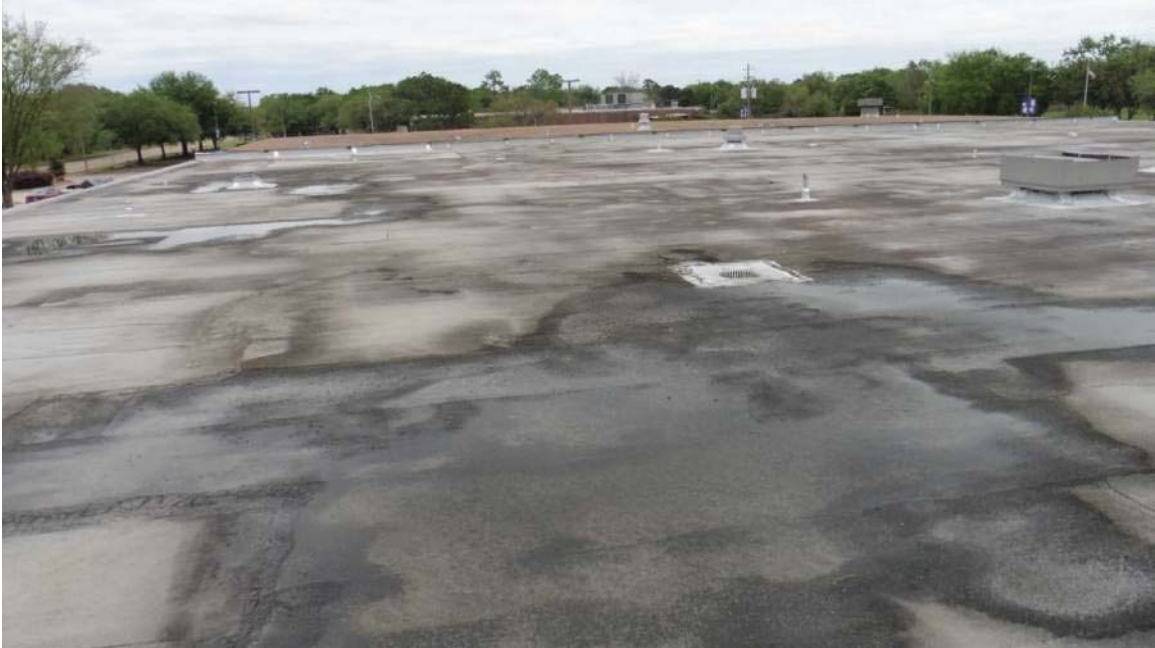
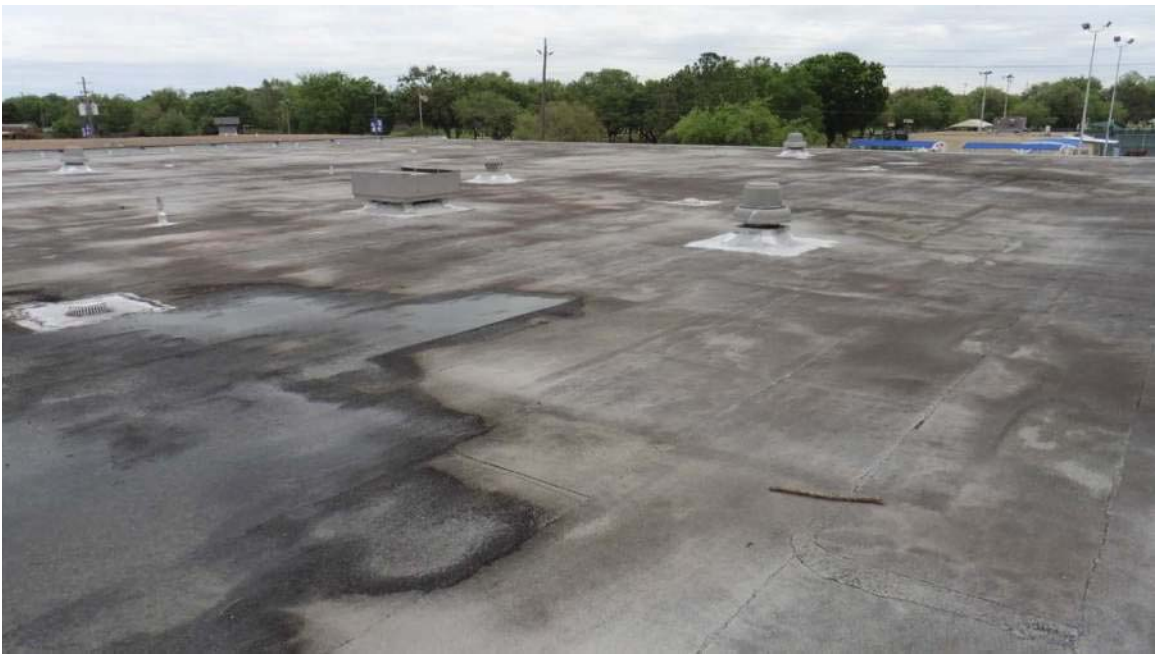
Condition of roof at original building

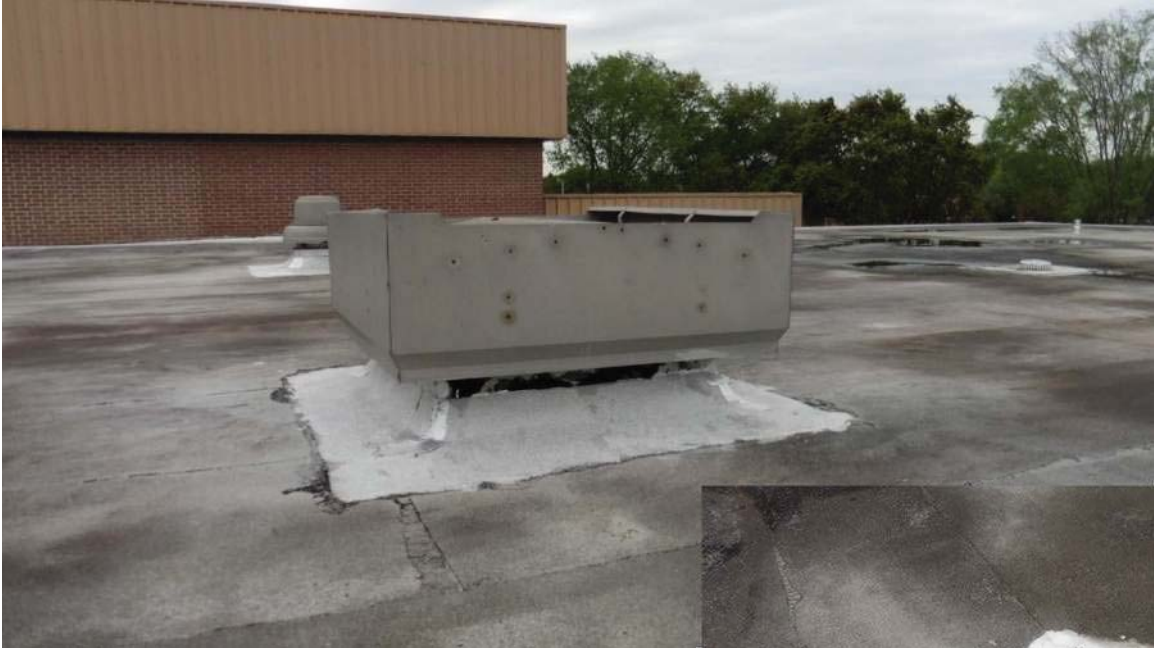
Condition of roof at original building

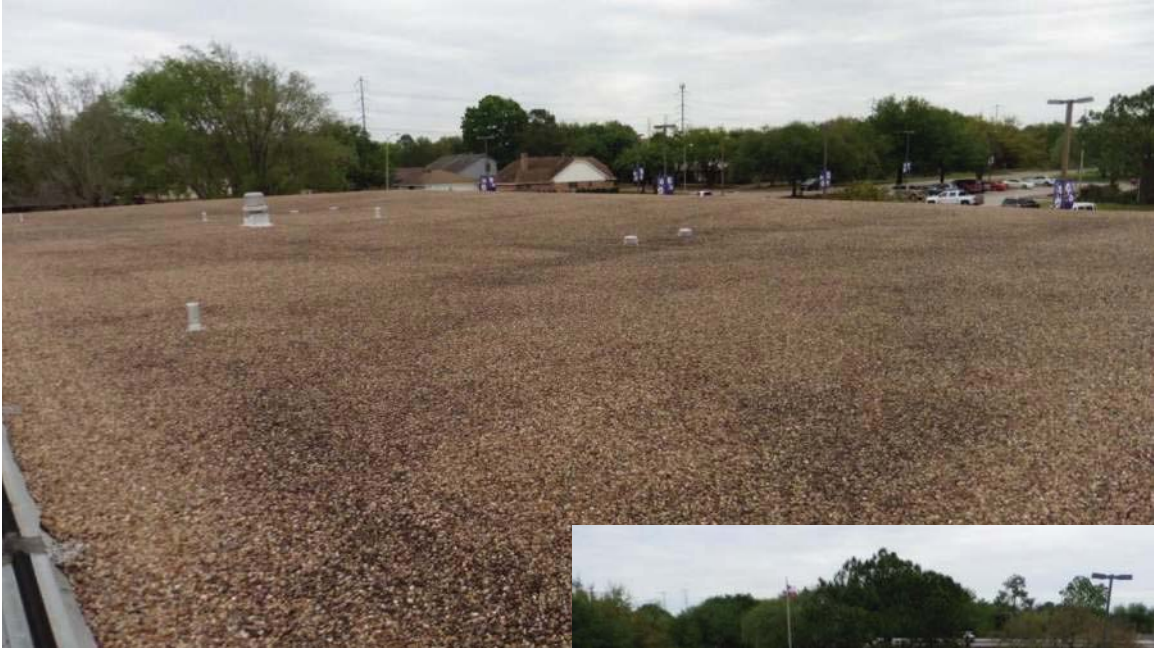
Condition of roof at addition

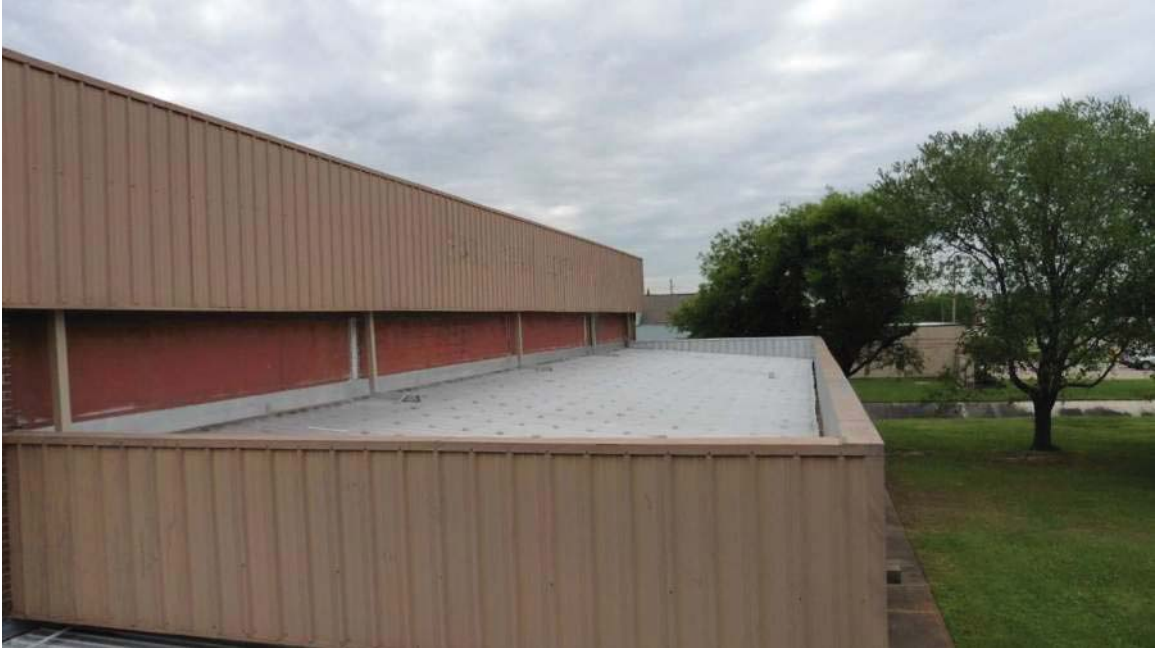
Condition of lower gym roof

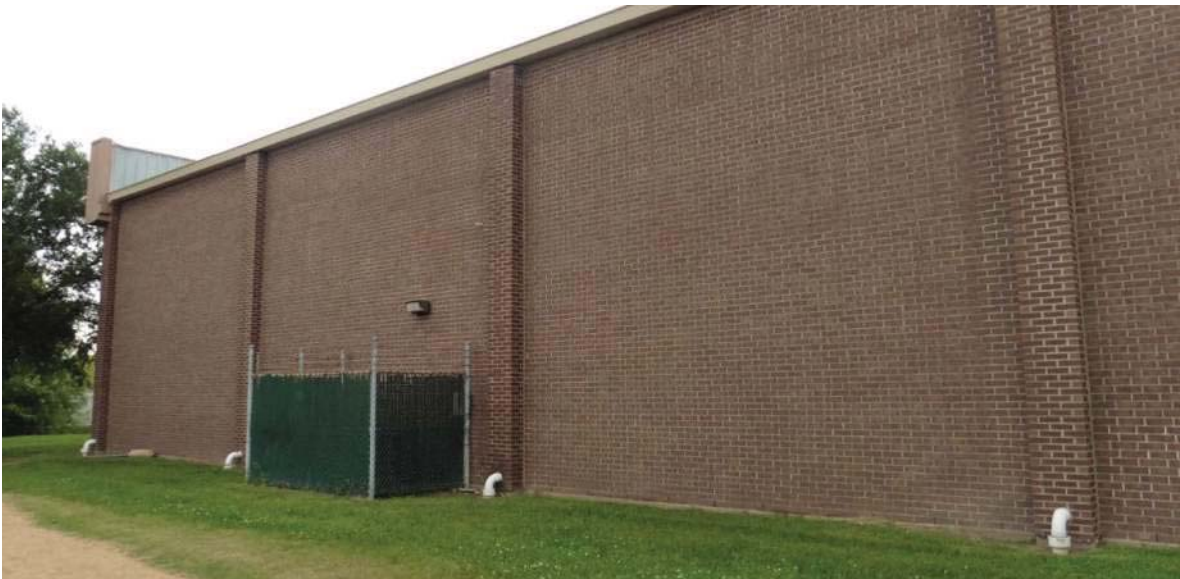
Gym – Example of mechanical screening, different brick

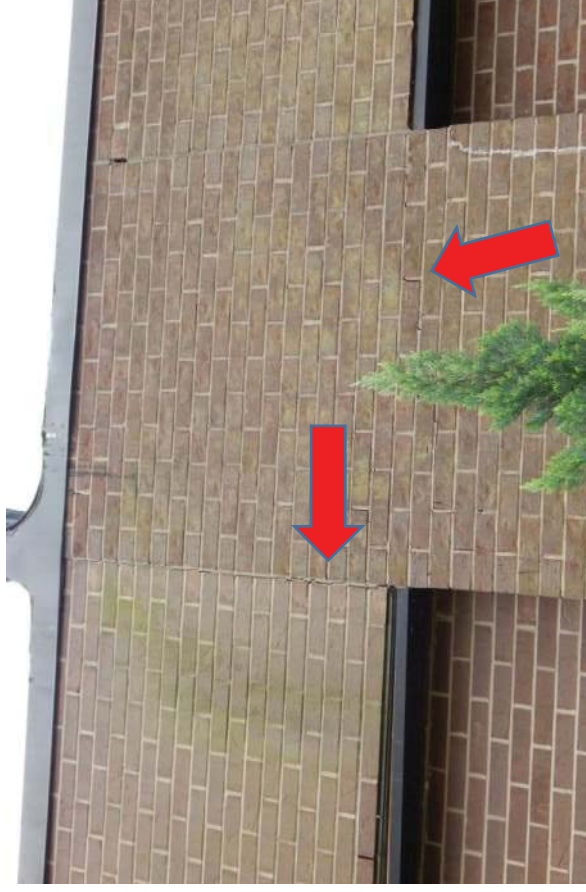
#8 Control joint between phase one (on right) and phase two (on left) showing separation in joint. Also, there is a step crack in the brick.

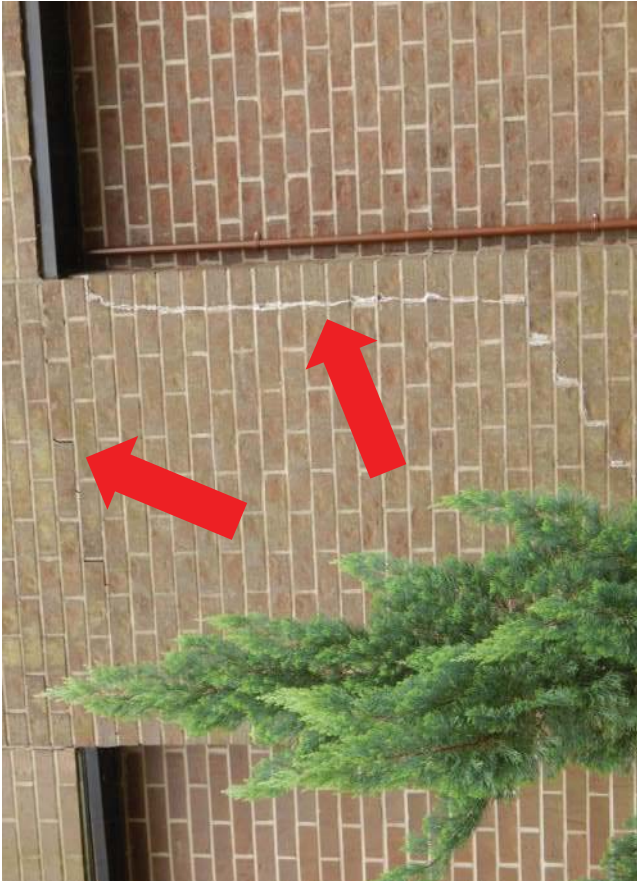
**#9** Same as photo #8 showing step crack in brick and vertical crack in phase one that has been repaired.

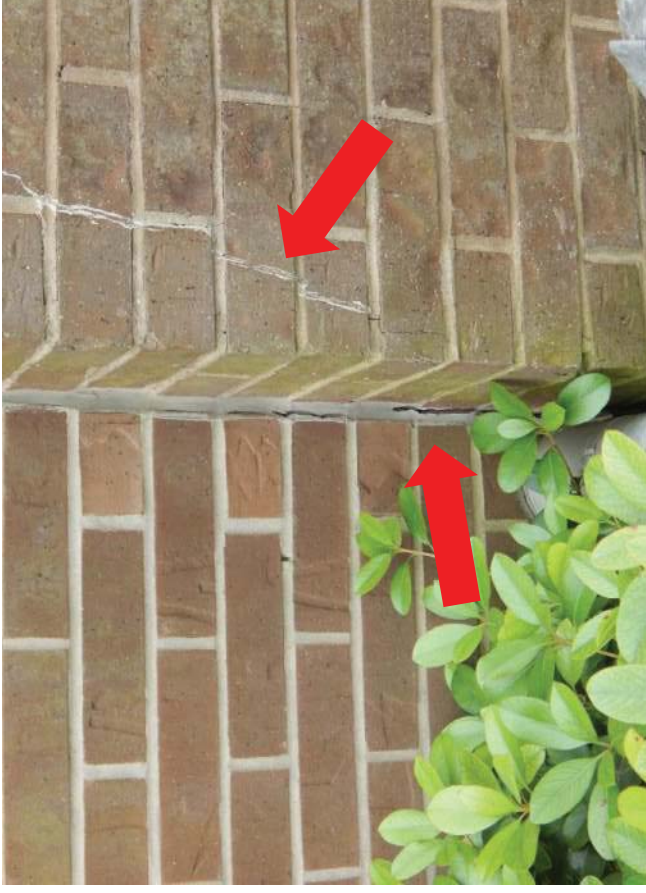
**#10** Same as photo #9 at bottom of crack repair and separation in caulk joint.

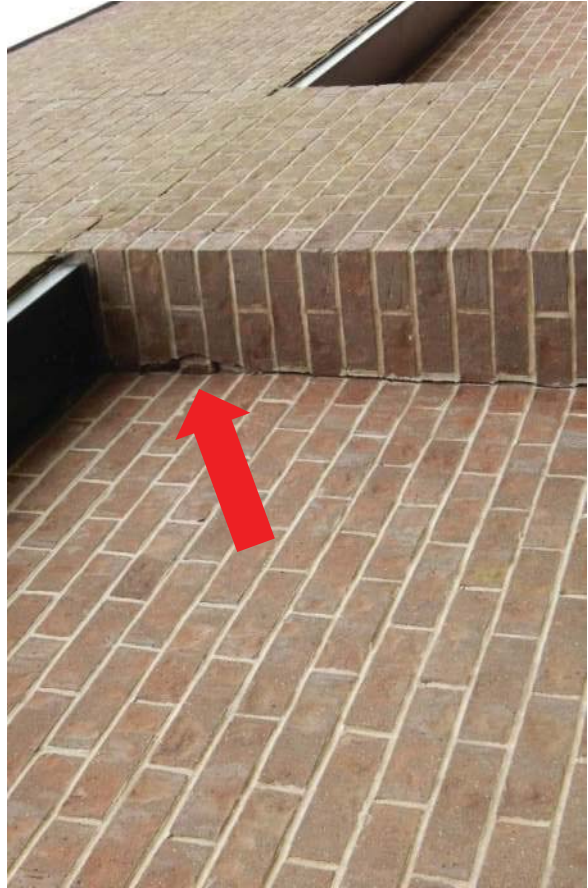
**#11** Cracked brick at end of inset panel.

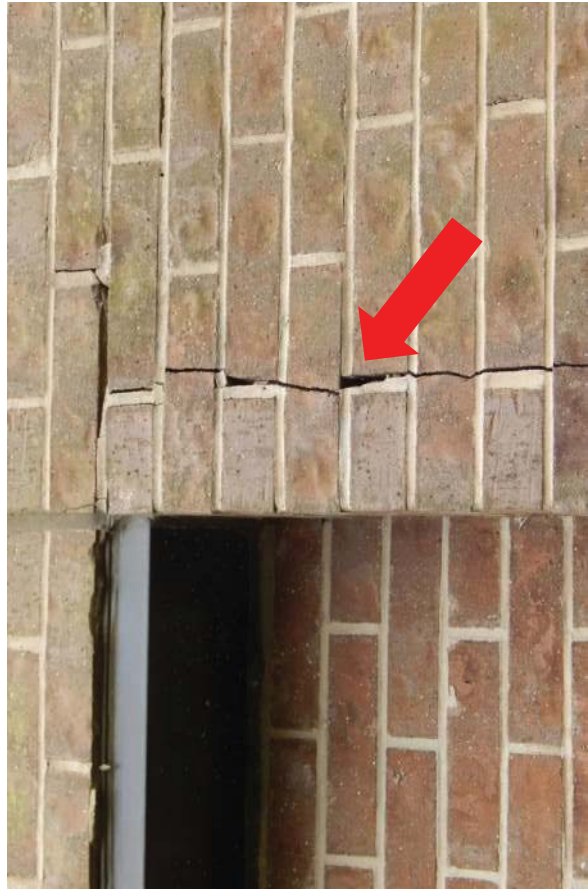
**#12** Same location as photo #11 showing cracked brick in column. Lintel movement is causing this cracking.

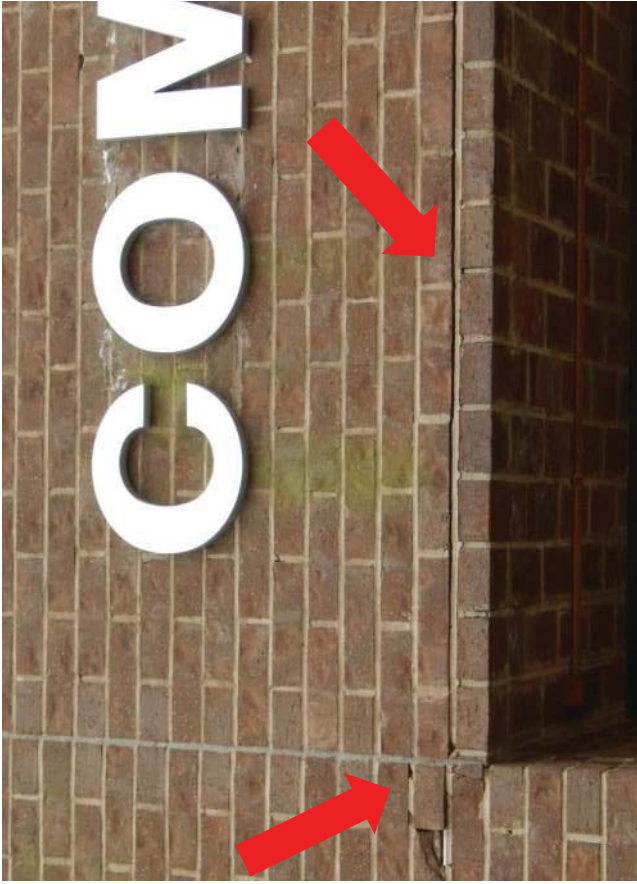
**#13** Horizontal crack between brick soffit and brick on face of building.  
Cracking brick where lintel angle is bearing on brick column.

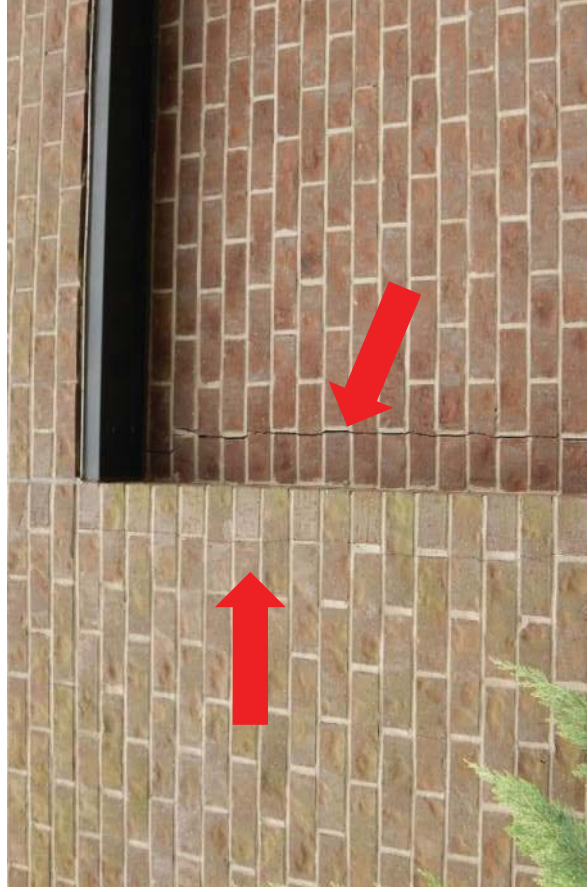
**#15** Vertical crack in brick column and in brick inset panel.

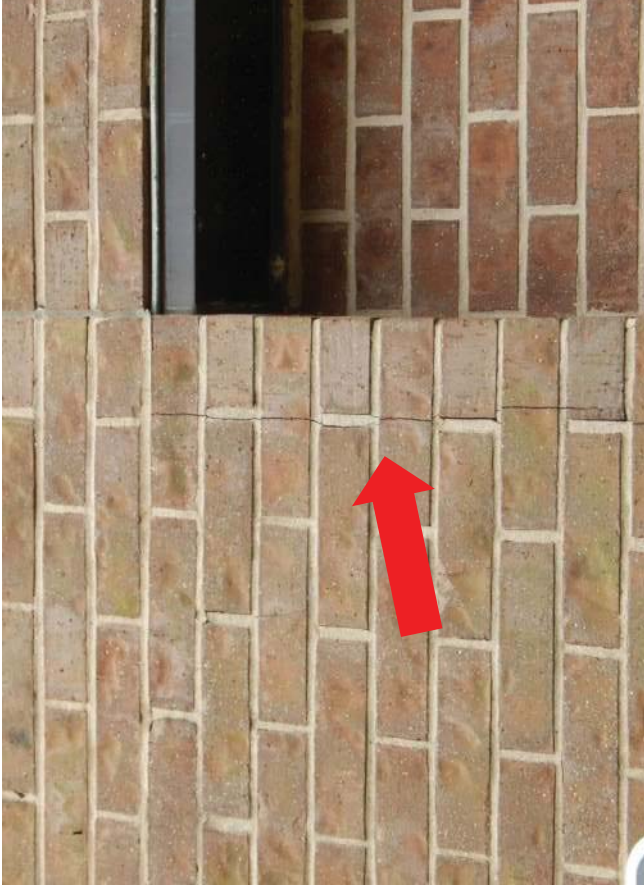
**#14** Vertical crack where steel lintel over inset brick is  
Moving and dragging the brick on the column

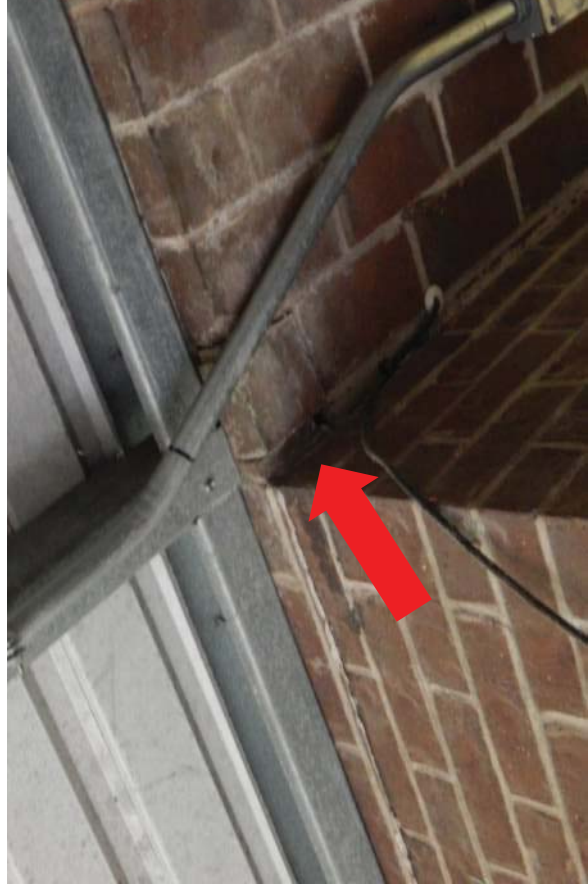
**#16** Crack in brick of soffit brick same as photo #13

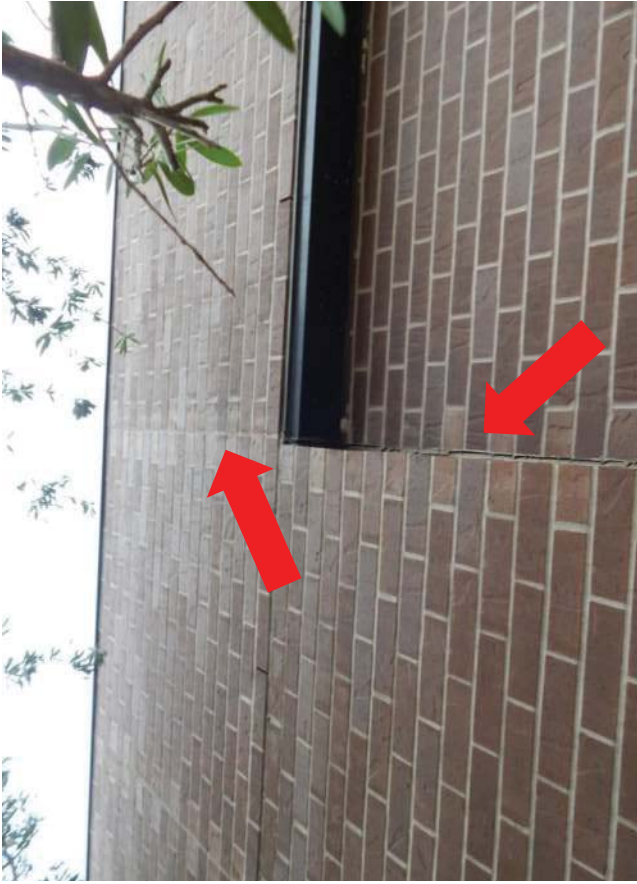
**#17** Separation in caulk joint at end of inset panel. Crack does not go up in control joint above inset panel

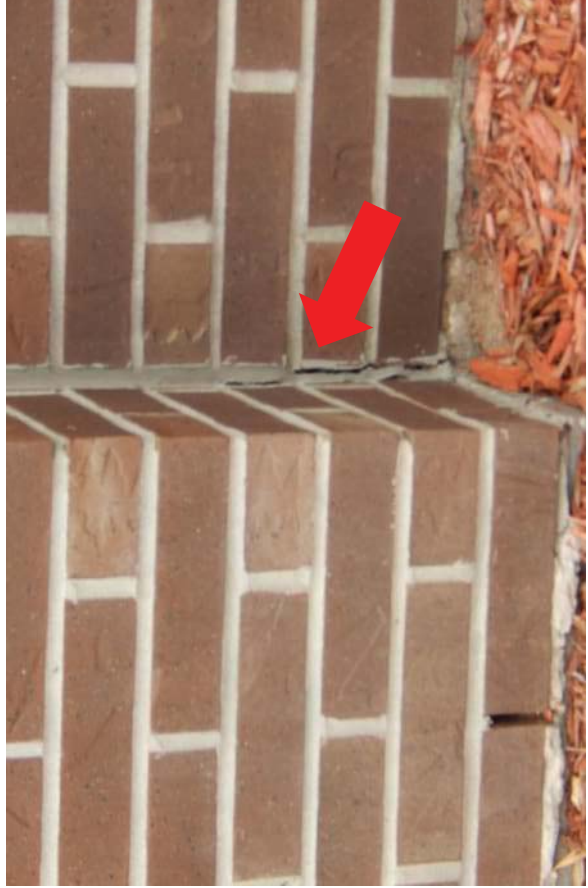
**#19** Separation in caulk joint at end of inset panel at bottom of joint

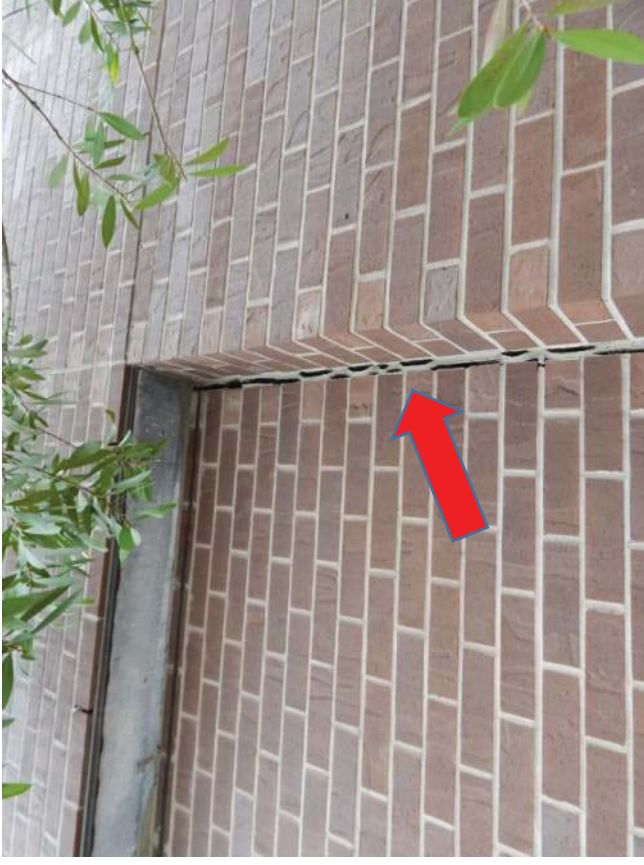
**#18** Separation in caulk joint at end of inset panel. Crack does not go up in control joint above inset panel. Separation at top was measured at approximately  $\frac{1}{2}$ "

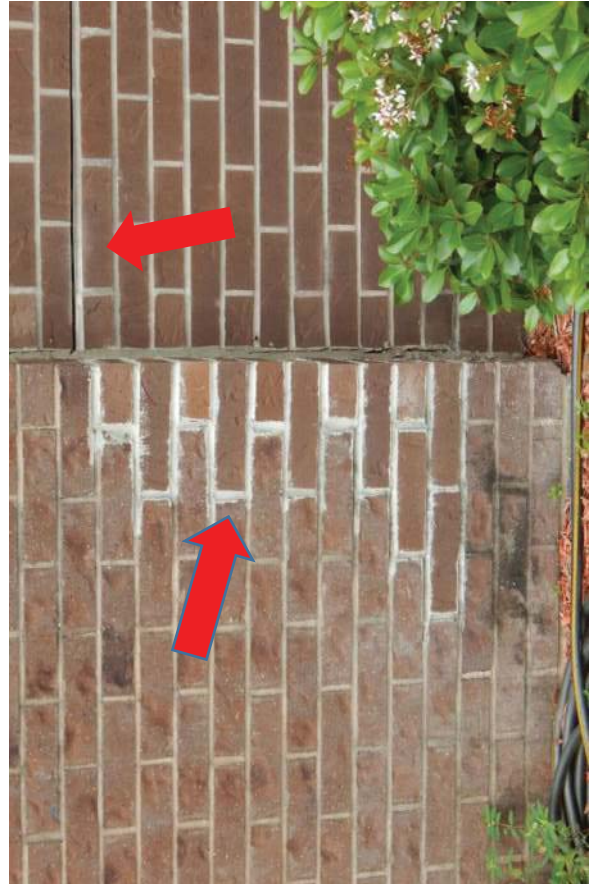
**#27** Photo at connection of phase one and phase two buildings. Horizontal crack in brick in phase two. Repaired brick cracking in phase one.

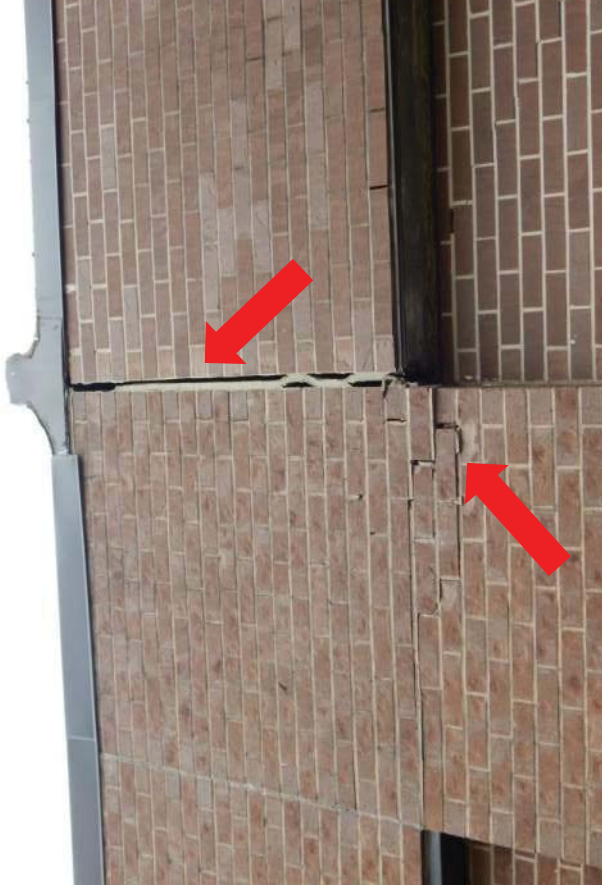
**#26** Photo at connection of phase one and phase two buildings. Separation of caulk joint between phase one and phase two. Brick cracking and being pushed out on phase one building.

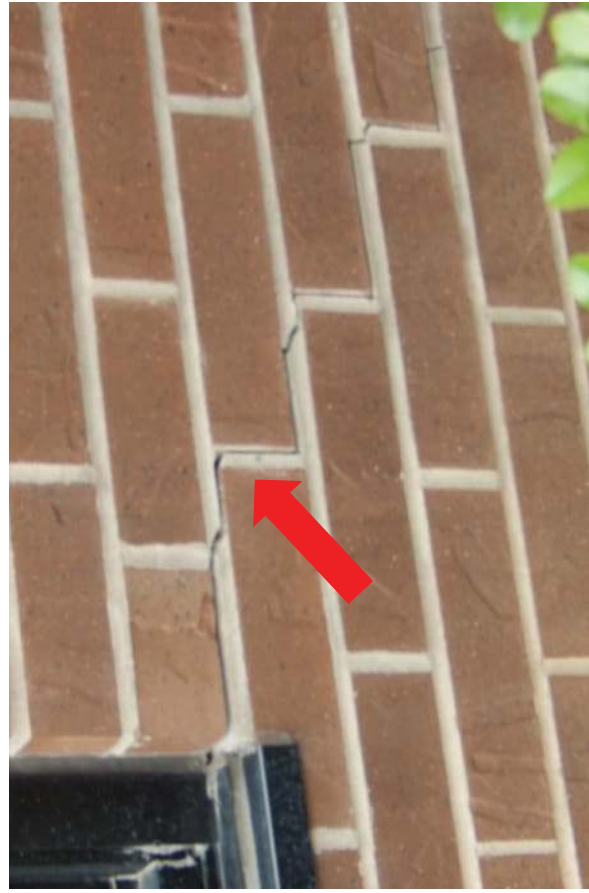
**#28** Step crack in brick going from window down to foundation. See photo #59 Which shows how the window is out of square.

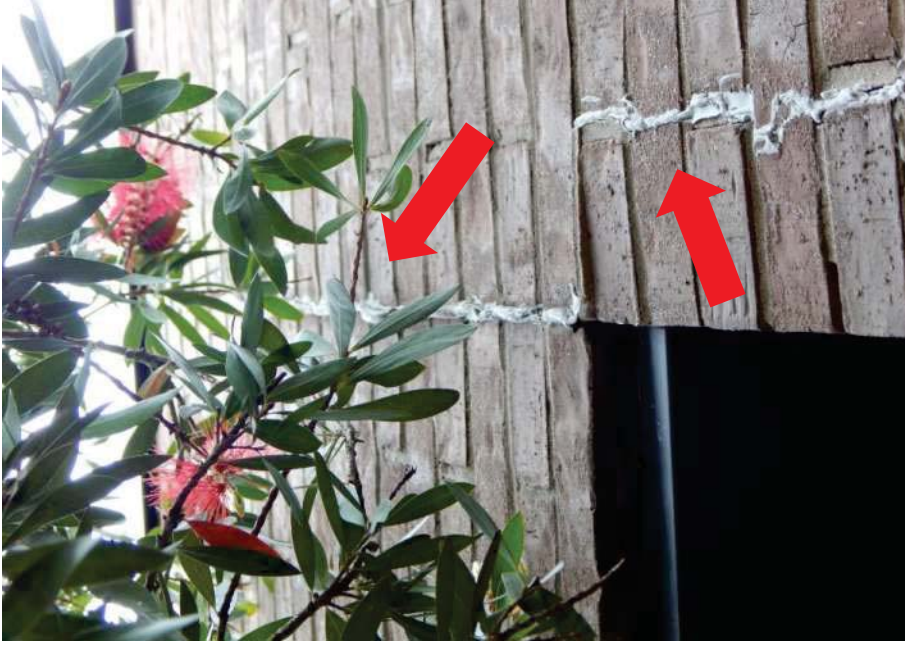
**#30** Photo at same location as photo #29 at the corner of the inset brick Panel. Repaired crack goes up through control joint above inset panel

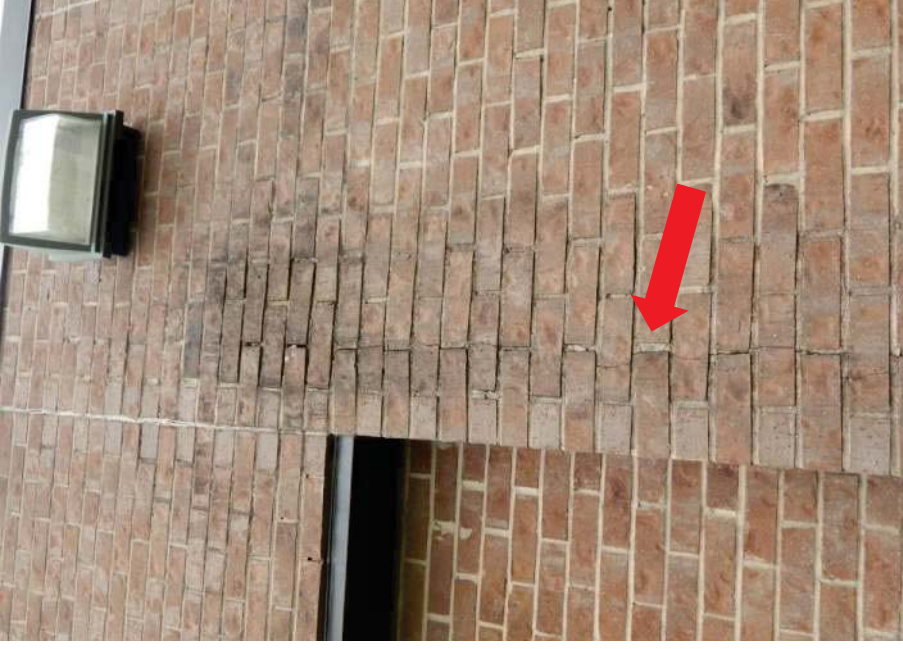
#32 Vertical crack in column brick the same as described in photo #30

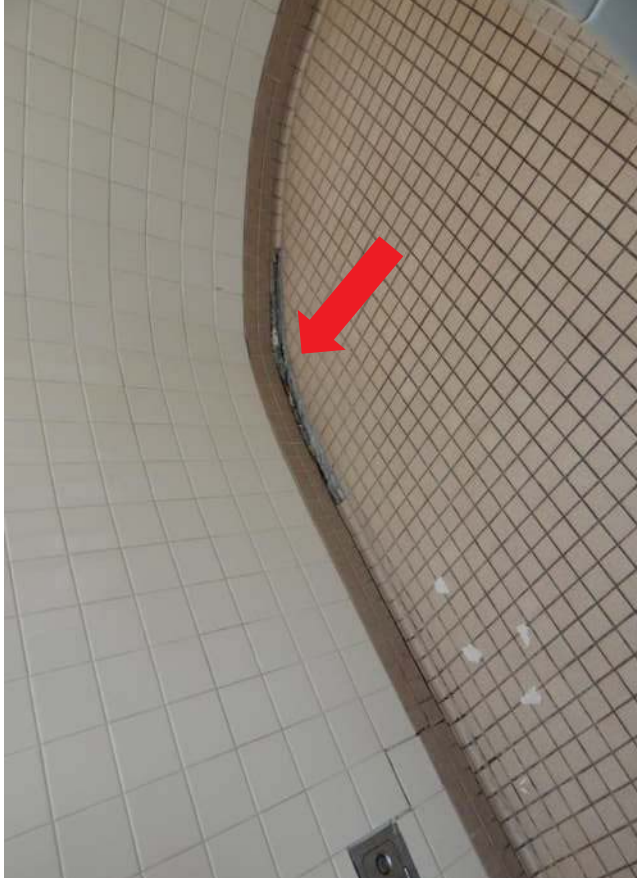
#34 Cracking in the tile floor at base of wall

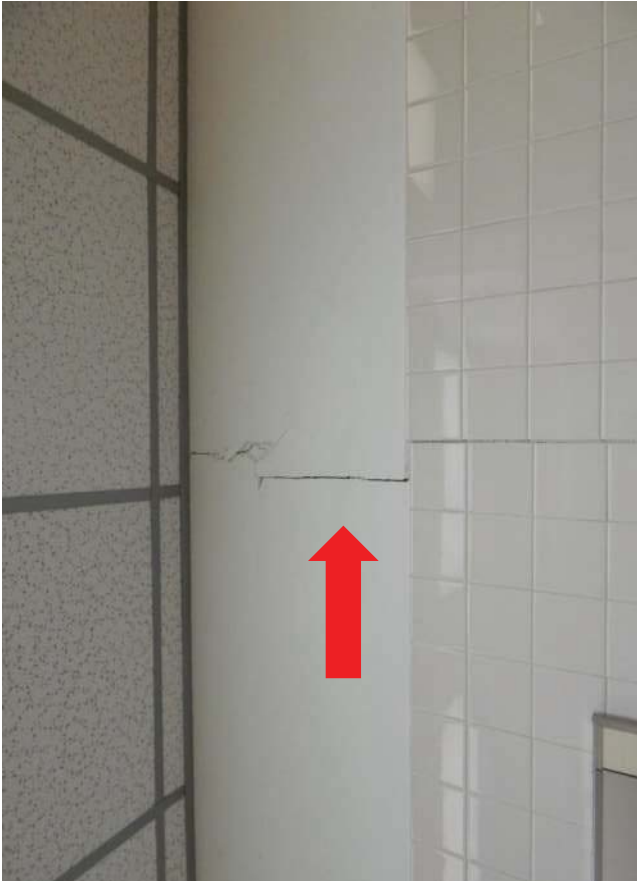
#35 Cracking in sheetrock wall and tile in bathroom

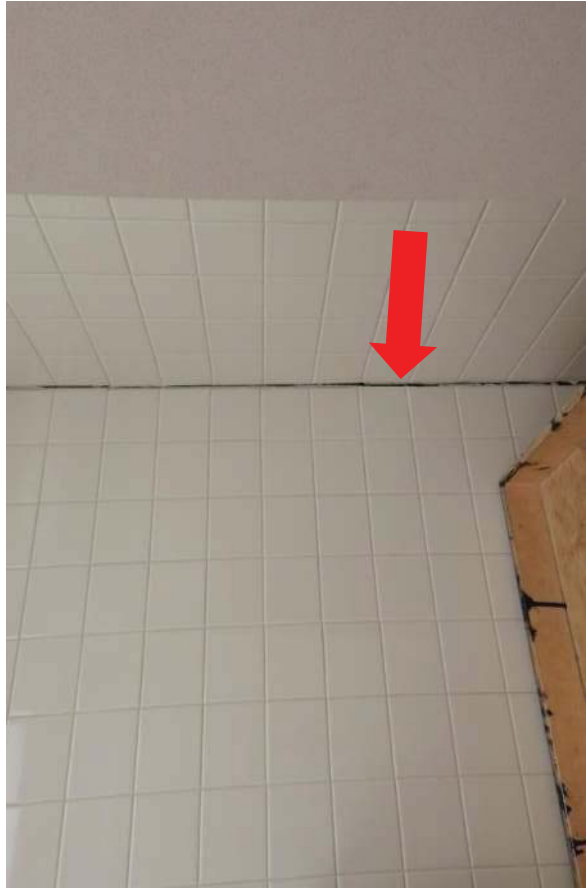
#37 Cracking and separation in tile

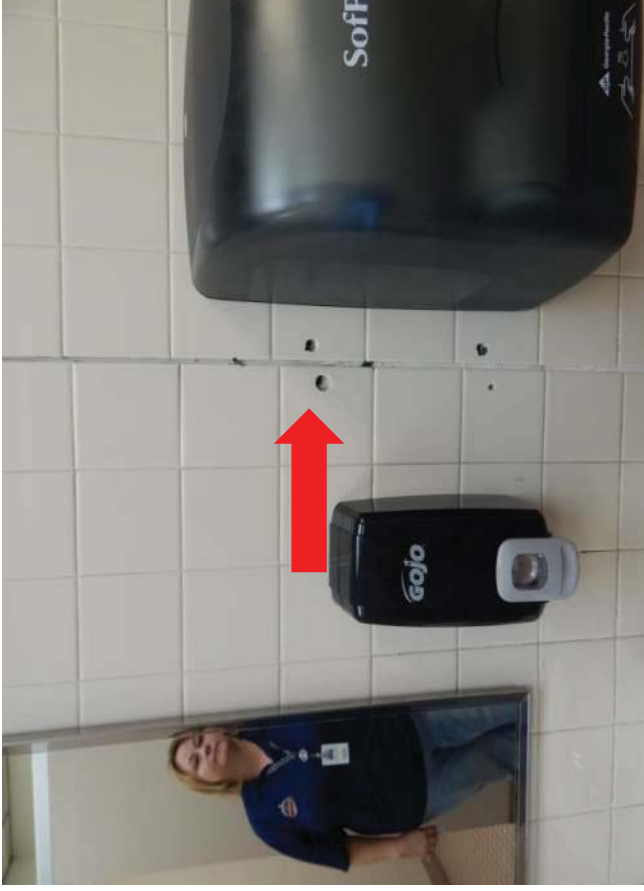
#36 Cracking and movement in tile joint. Mrs. Crenshaw said towel dispenser had to be moved.

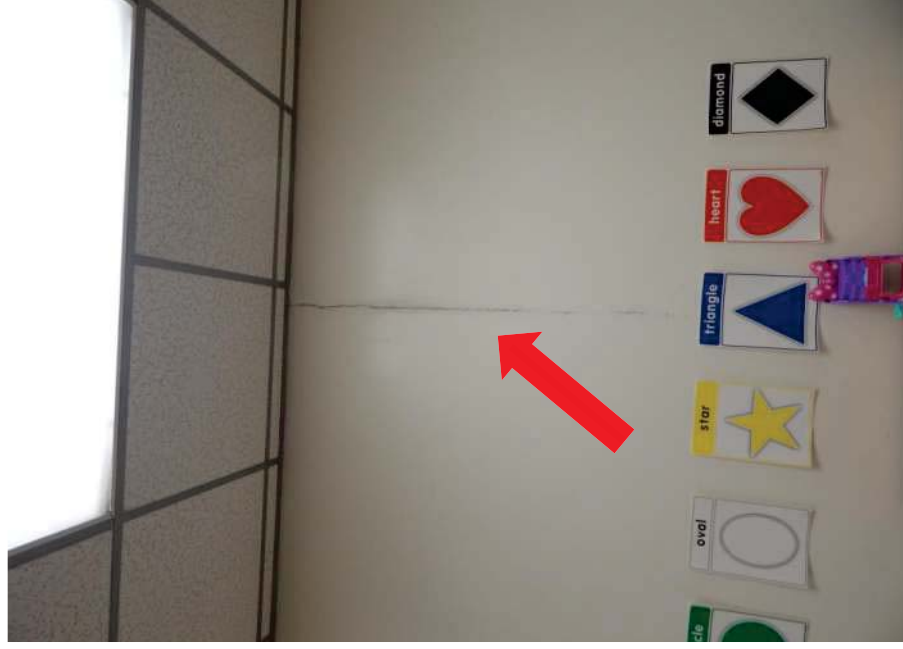
#38 Cracking in sheetrock

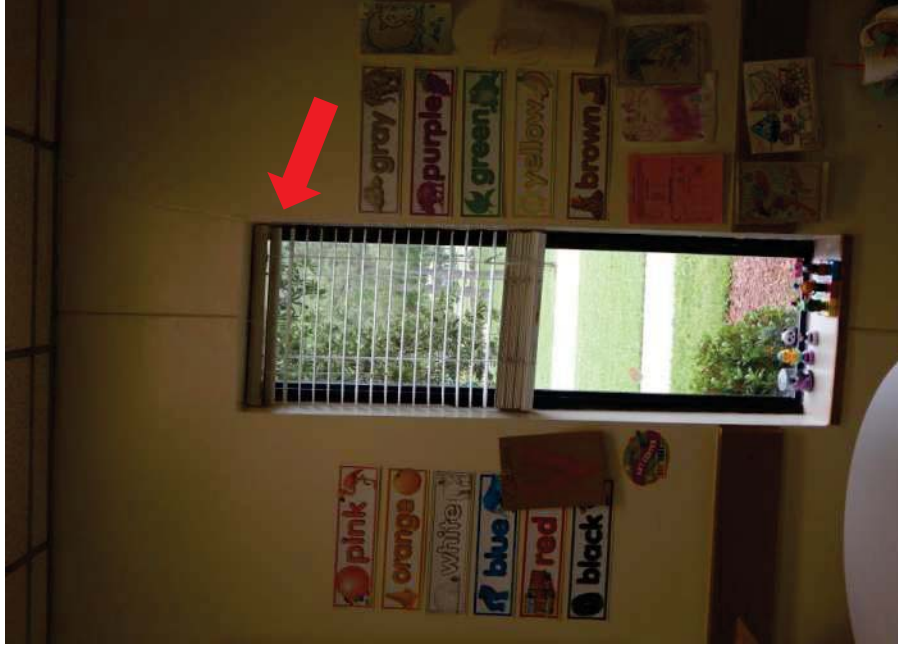
#41 Window has been tilted out of square. Photo #28 shows cracking of outside brick in this area

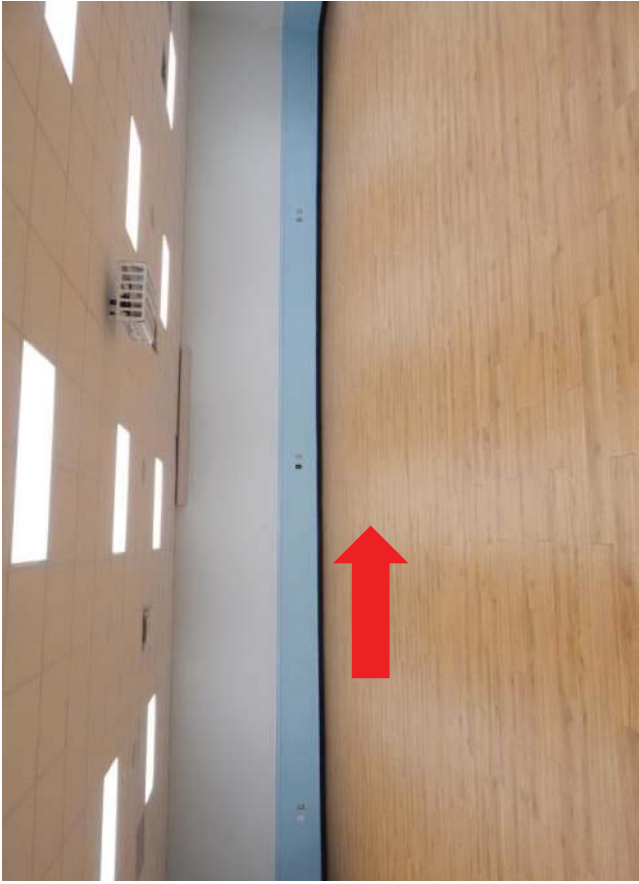
#42 A visible hump up of the floor can be seen in this area

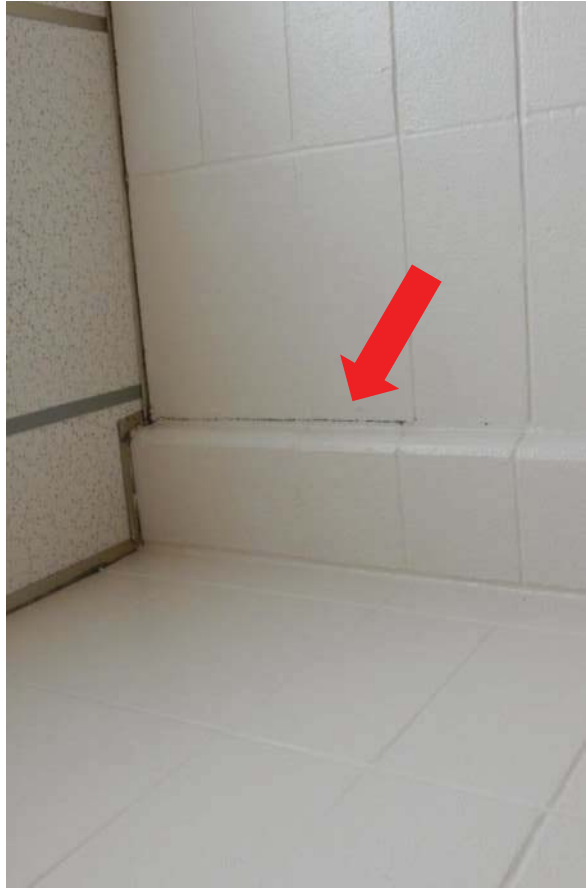
#44 Crack in corner of CMU wall

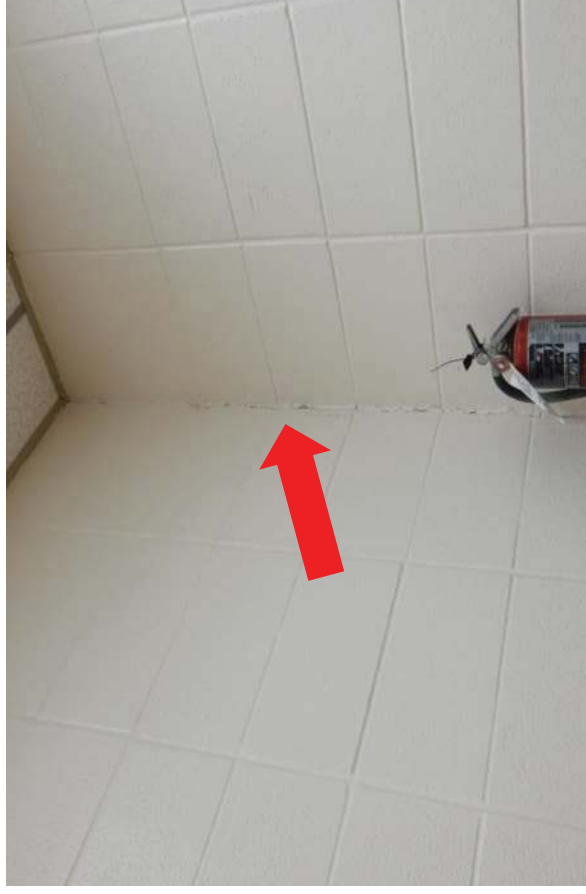
#45 Crack in corner of CMU wall
