# Building Observations Survey ©2016

## Deer Park Community Center Deer Park, Texas

**Building Survey for Deer Park Community Center,  
610 East San Augustine Street, Deer Park, Texas**

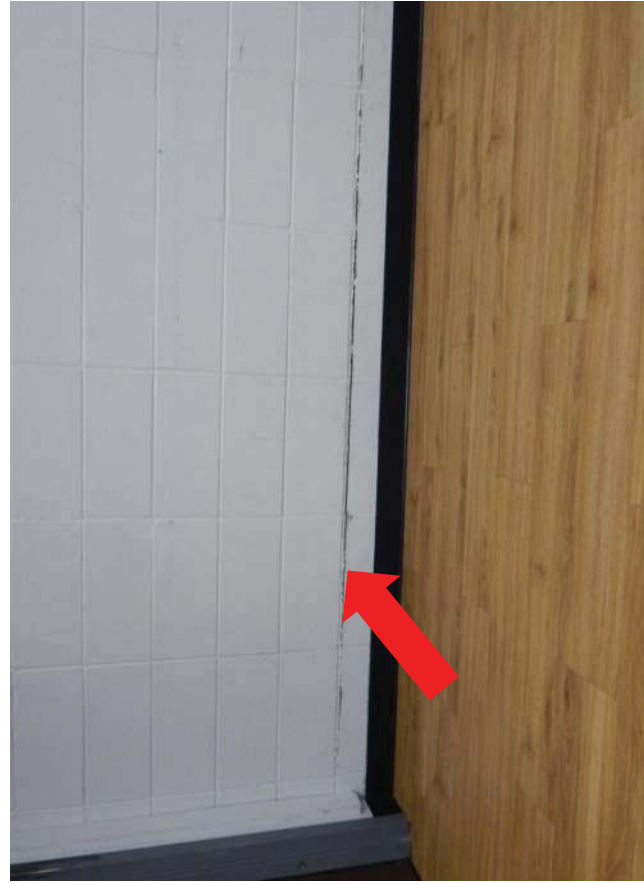
#46 Horizontal crack at base of CMU wall

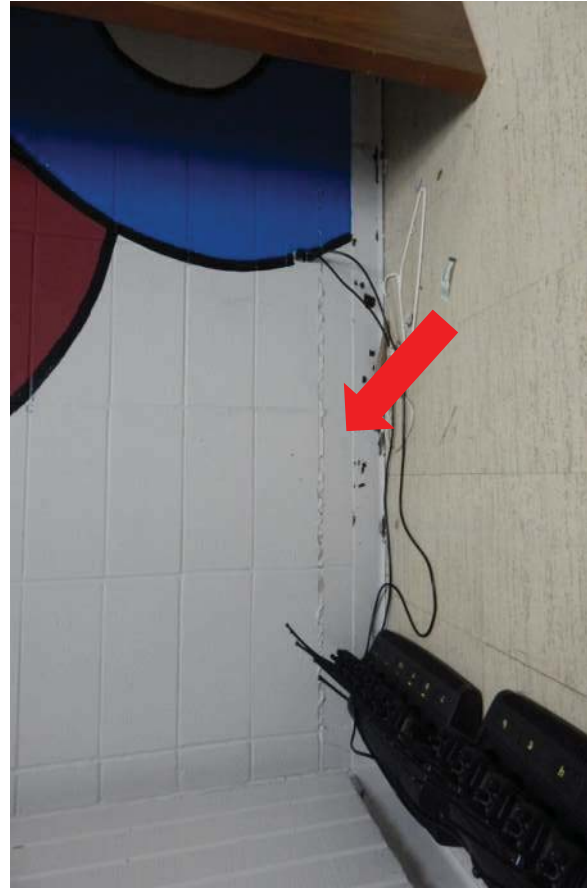
#48 Horizontal crack at base of CMU wall

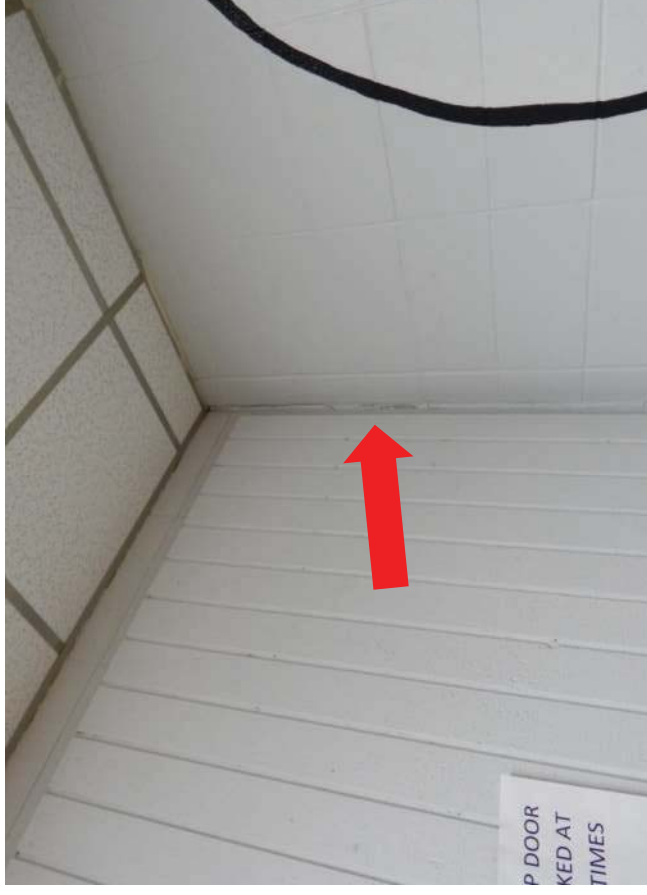
#47 Crack in corner of CMU wall

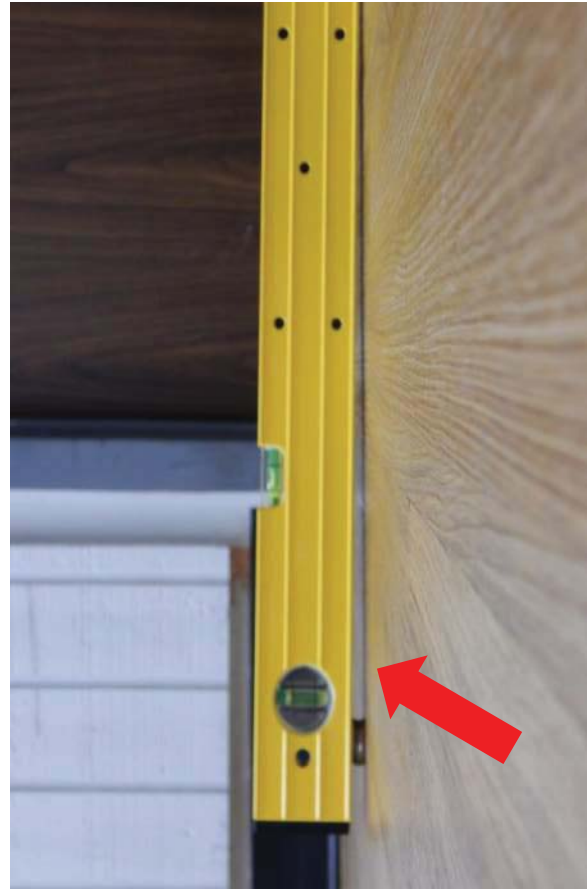
#49 Level on floor showing a slope of approximately  $3/16$ " per foot

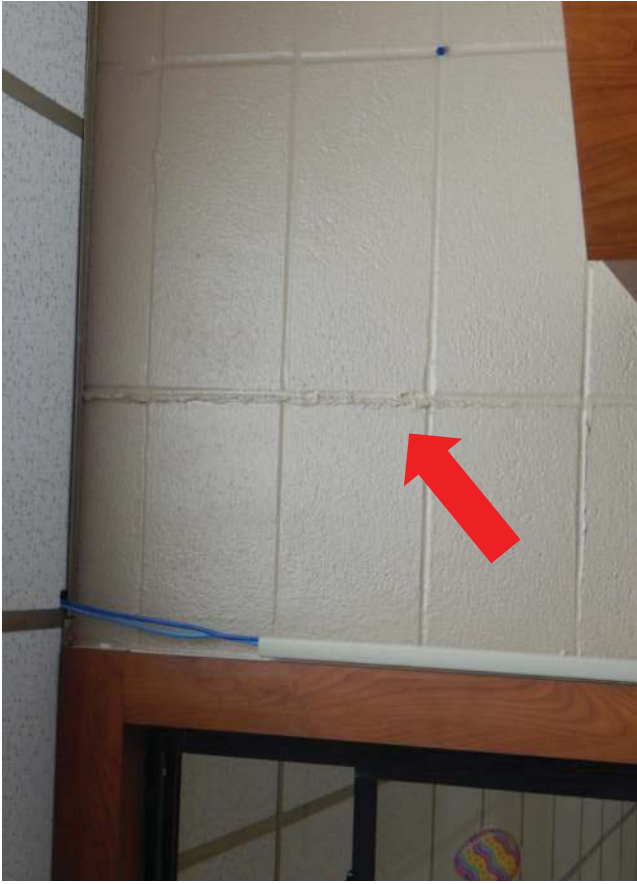
#50 Vertical crack in CMU wall

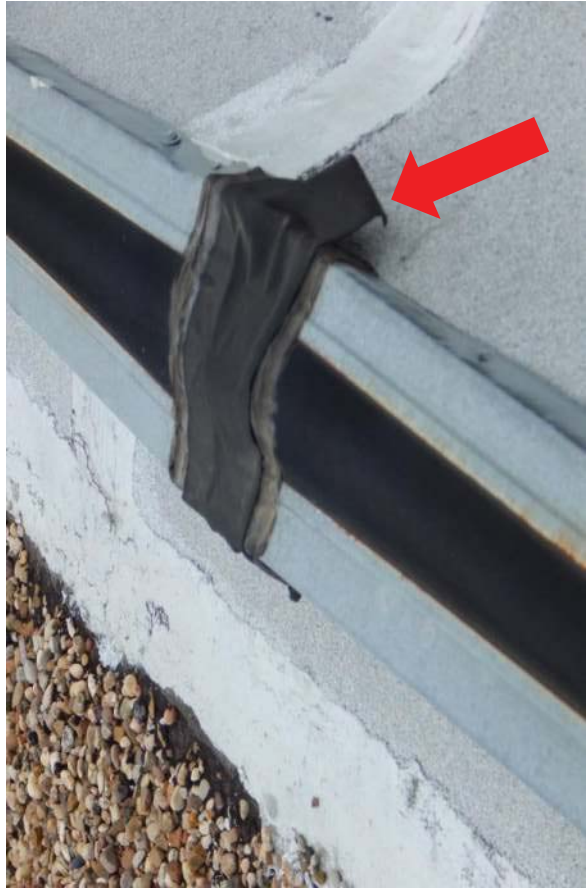
#56 Roof Expansion joint at splice where splice has come loose

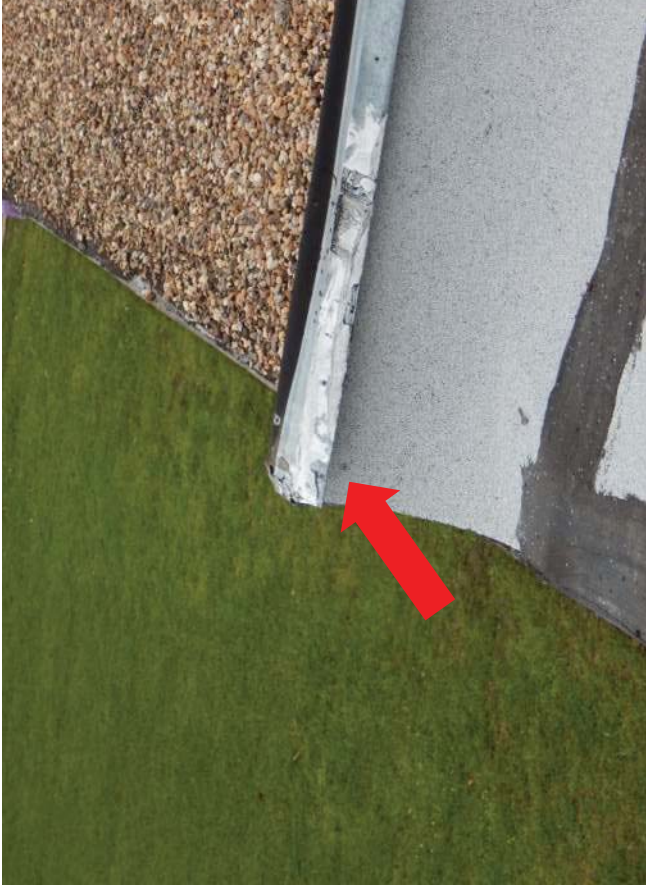
#55 End of roof expansion joint where join is coming loose

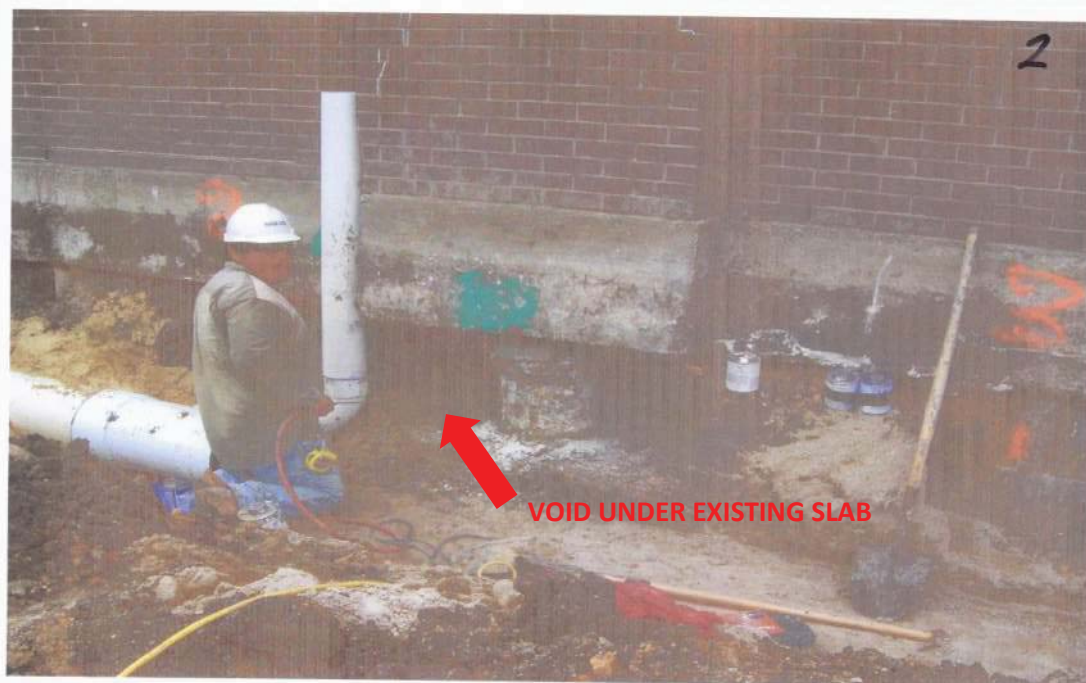
#1 Photo taken by contractor of Phase Two revealing void under foundation of Phase One

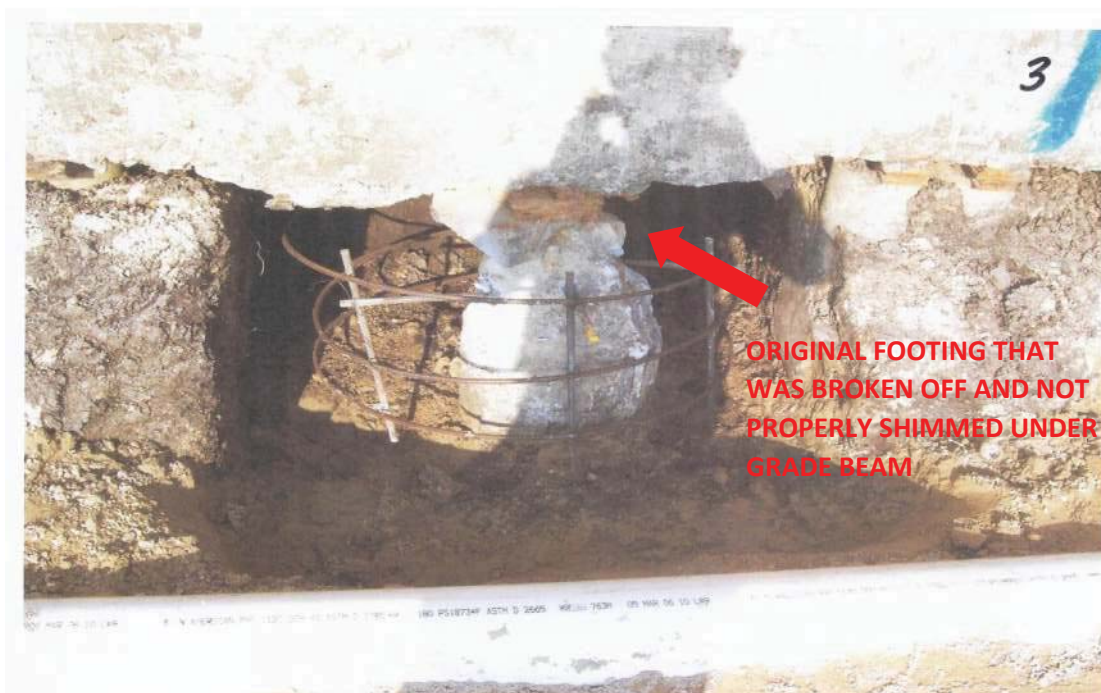
#2 Photo taken by contractor of Phase Two showing no reinforcing extending out of Footing into grade beam

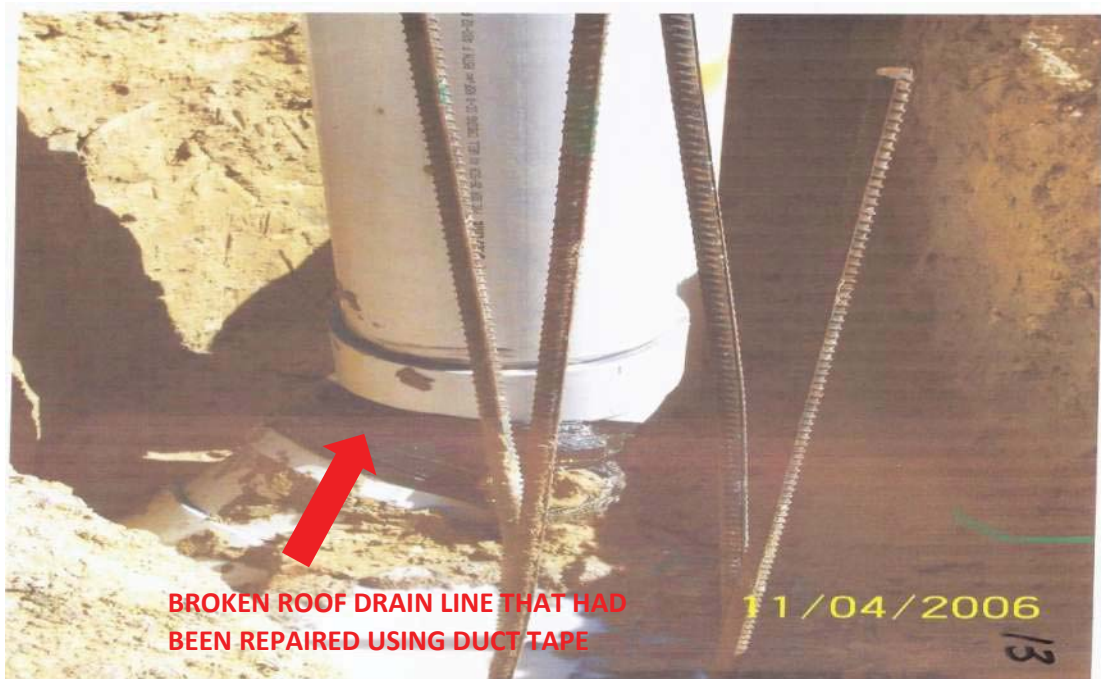
#6 Photo taken by contractor of Phase Two showing broken drain line that was repaired using duct tape

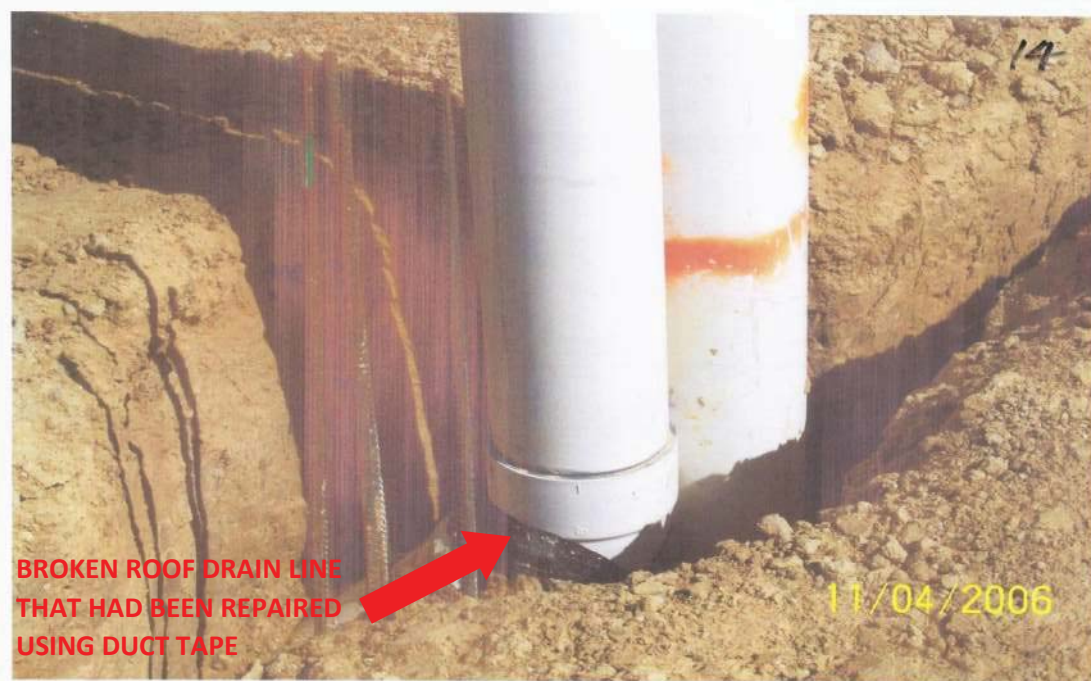
#7 Photo taken by contractor of Phase Two showing broken drain line that was repaired using duct tape and being covered with fill.

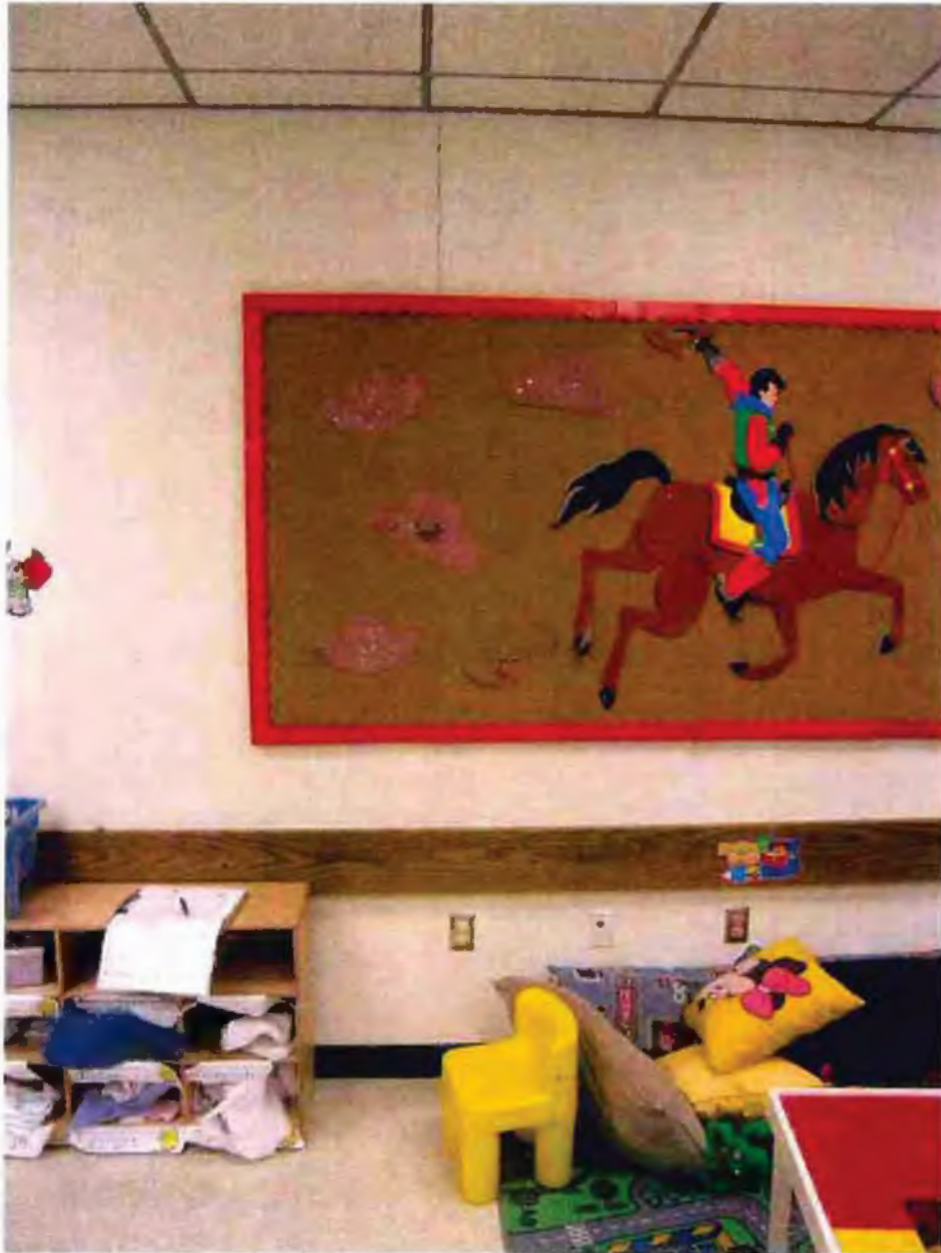
Photo 1. Plaster board crack 1/8 inch wide at ceiling tapering out near floor of addition.

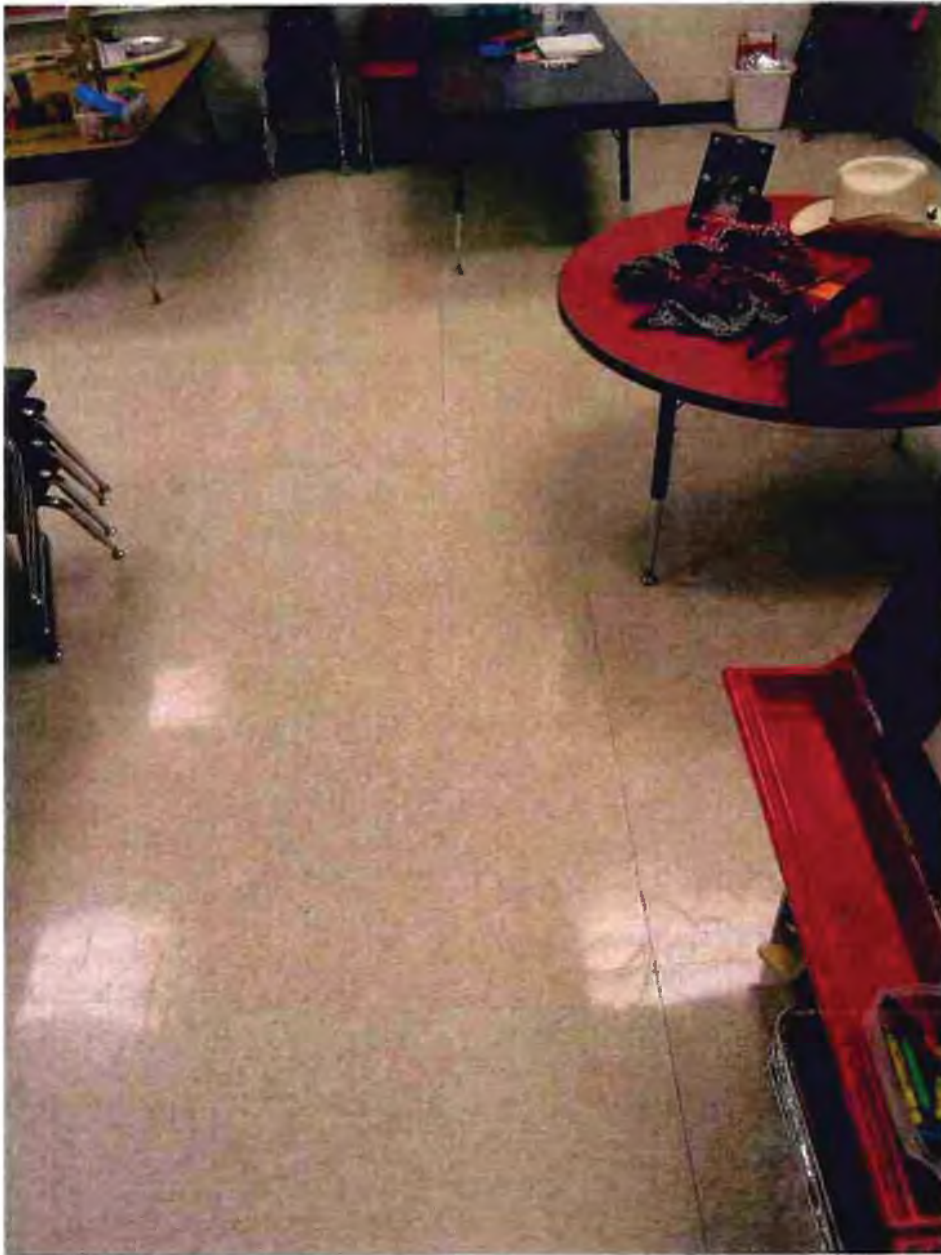
Photo 2. Separation of floor tiles in addition.

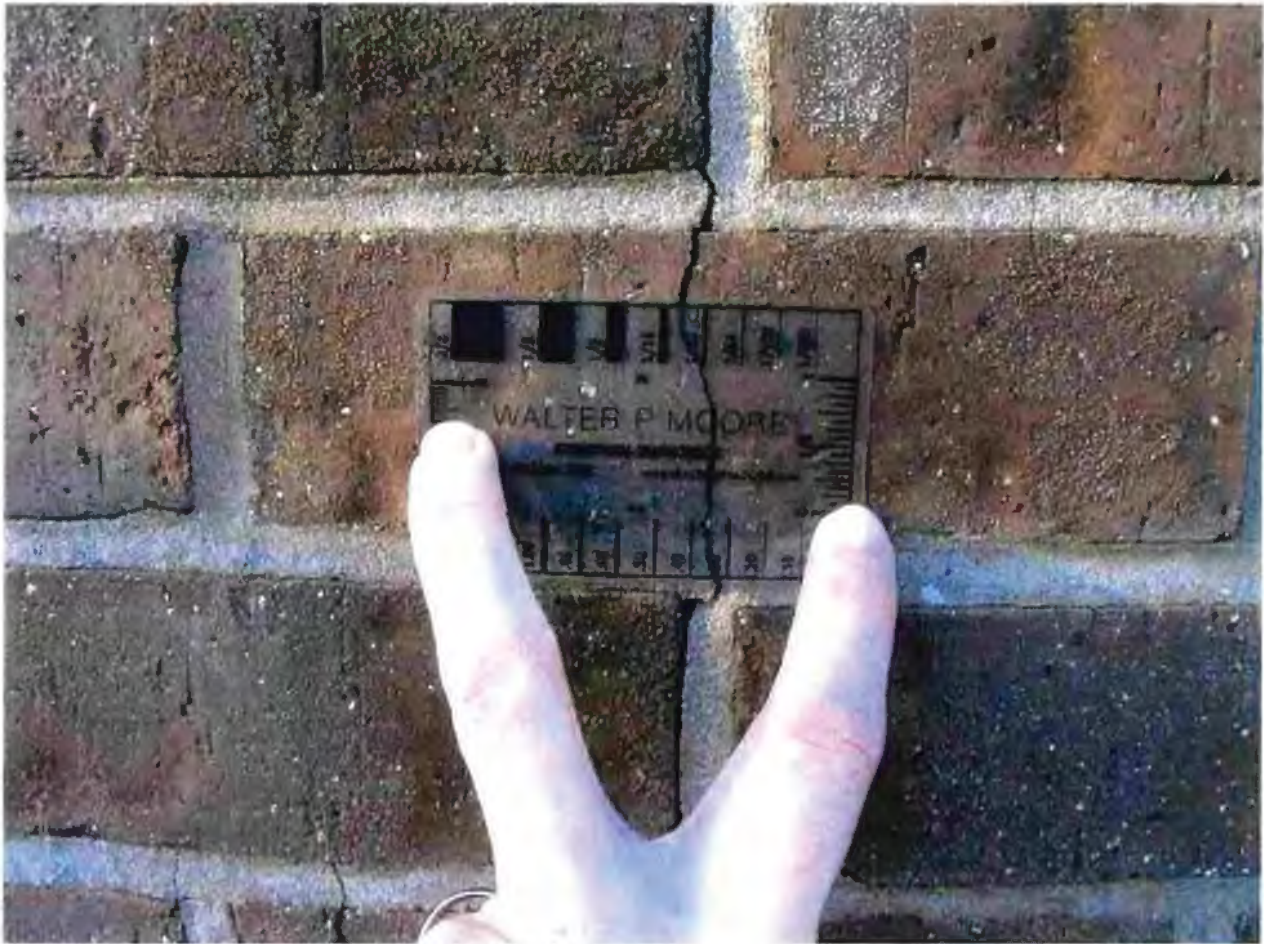
Photo 3. Exterior façade crack (in original building) near grade.

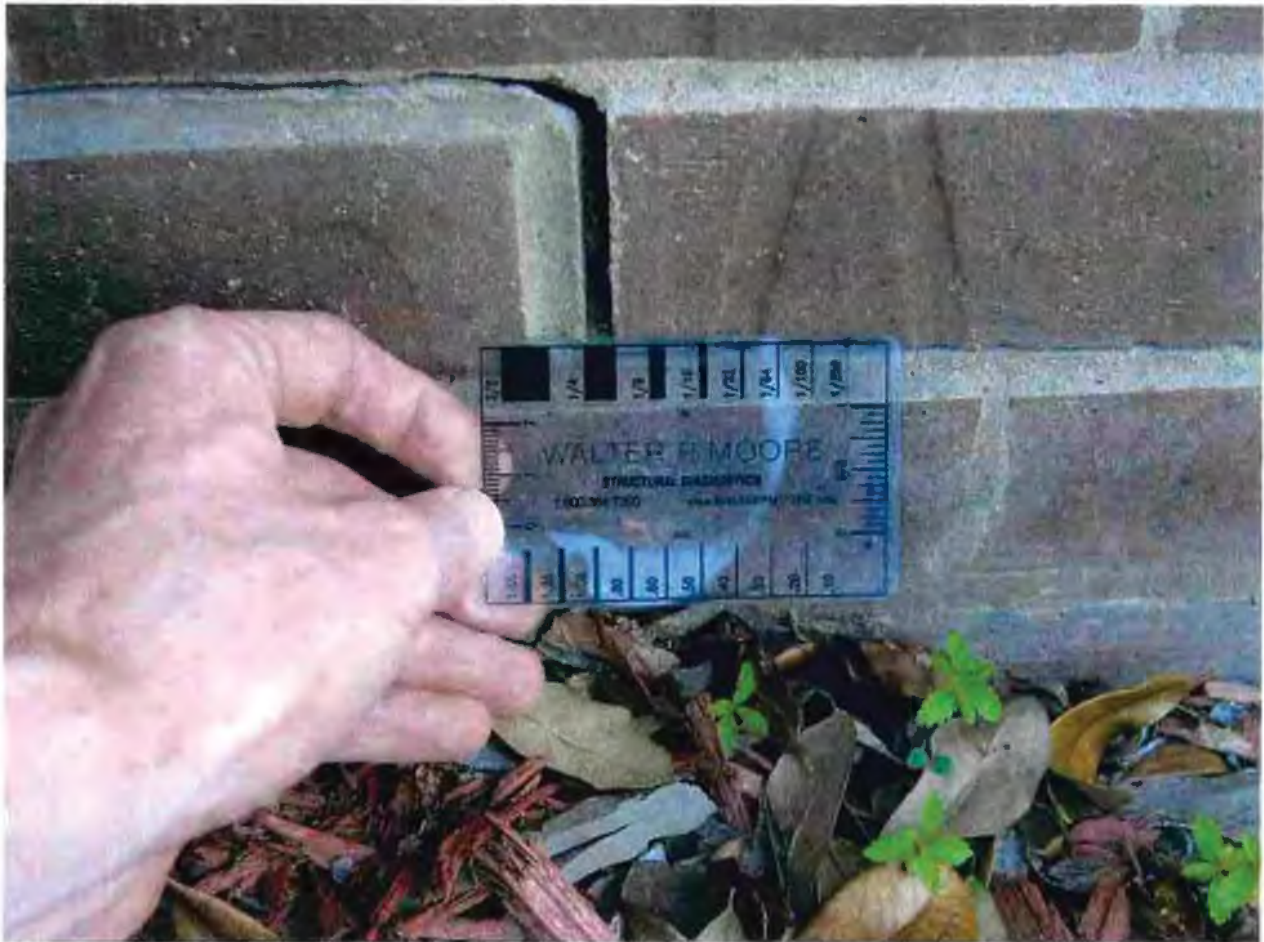
Photo 4. Exterior façade crack (in addition) near original building.

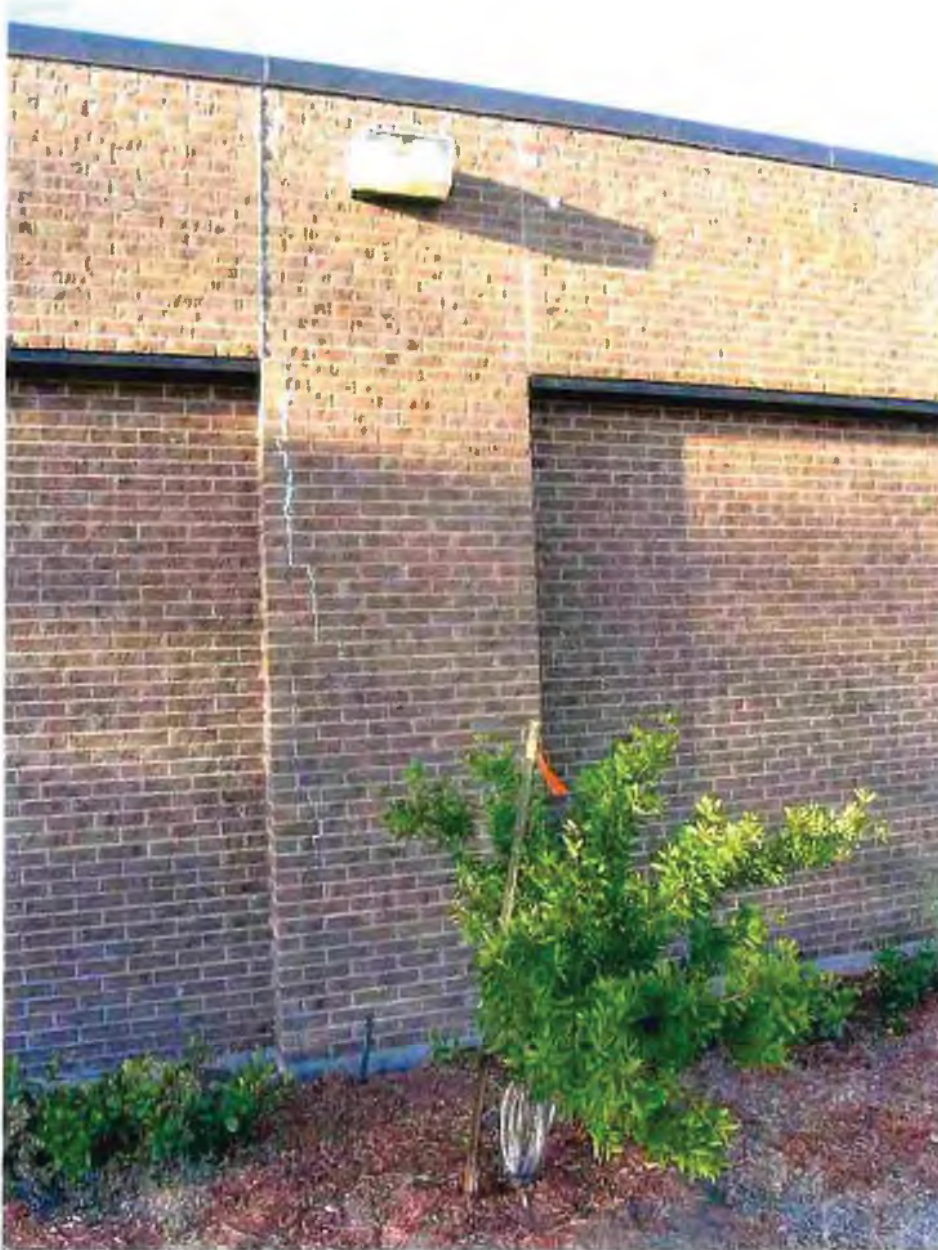
Photo 5. Exterior façade cracks (in original building) closing at top.

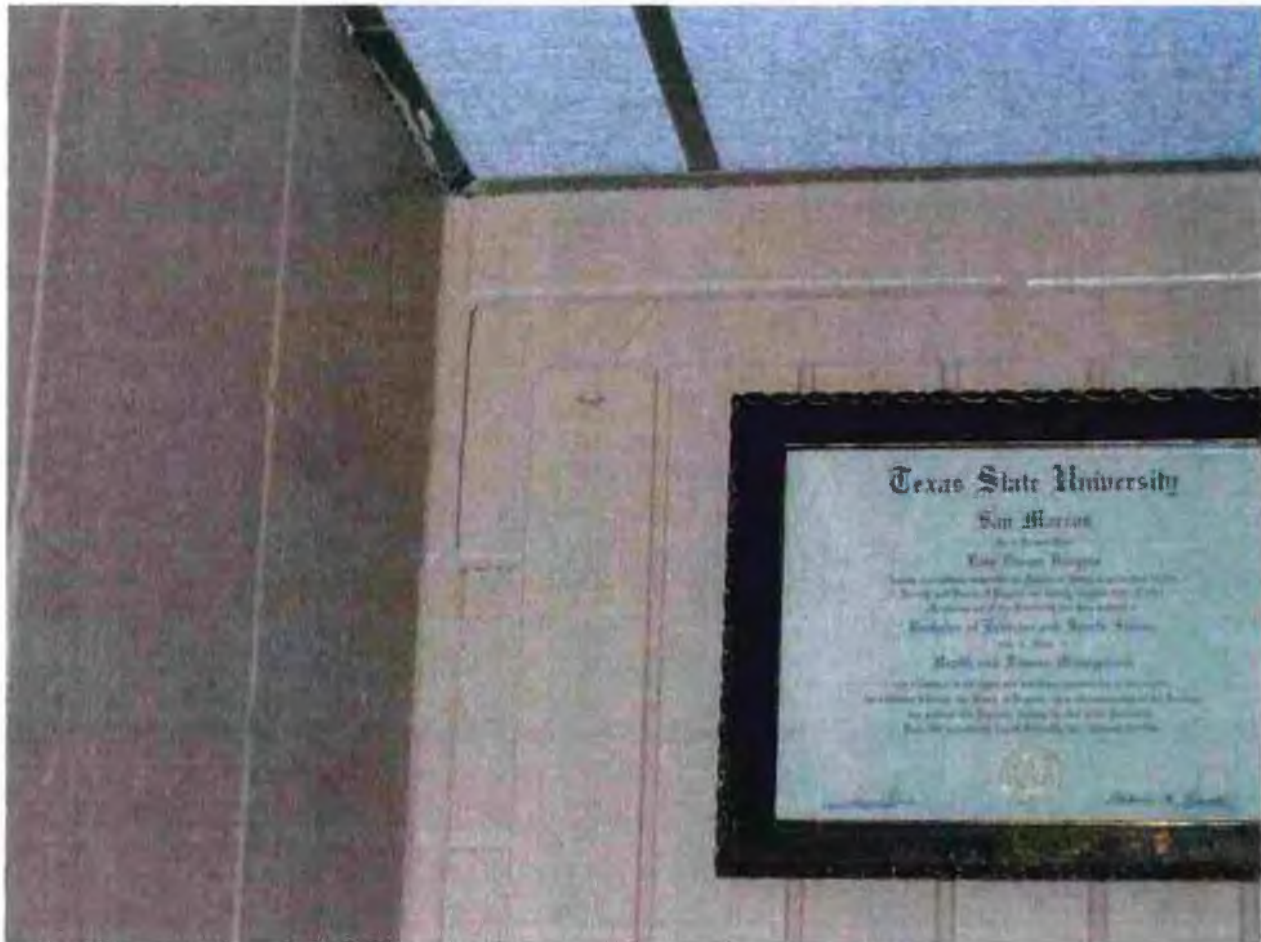
Photo 6. Concrete masonry unit cracks in original building wall.

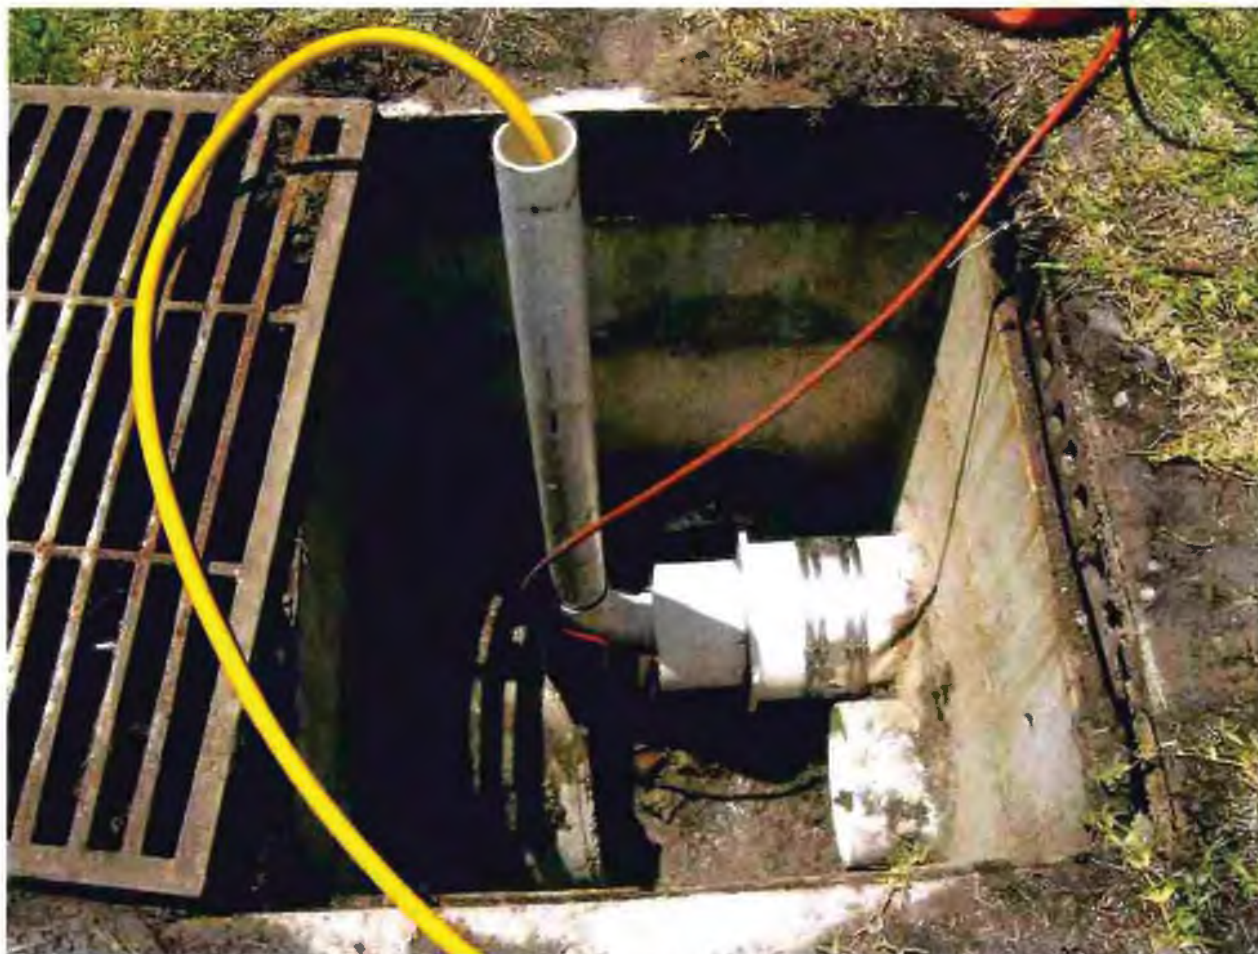
Photo 7. Leak testing of underground 10-inch diameter main roof drain for addition.

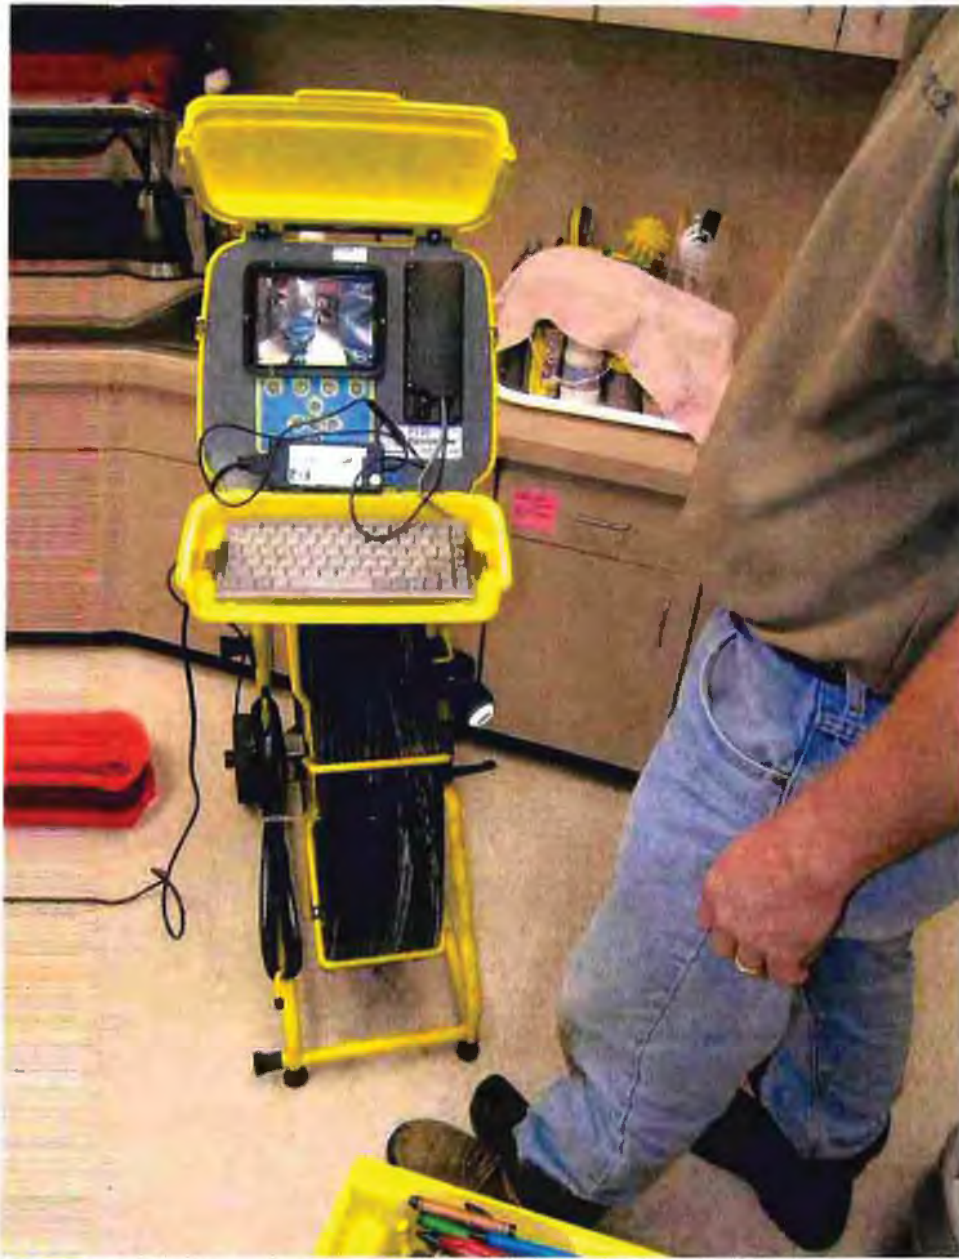
Video inspection of underground sanitary plumbing in addition.
