# Building Observations Survey ©2016

## Deer Park Community Center Deer Park, Texas

**Building Survey for Deer Park Community Center,  
610 East San Augustine Street, Deer Park, Texas**

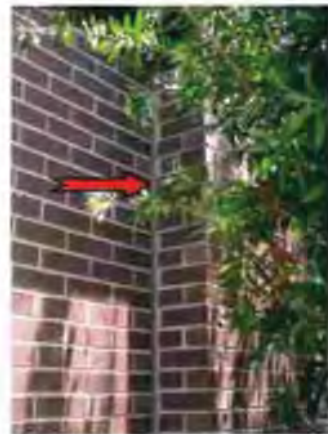
**Photo #18** Separation at expansion joint

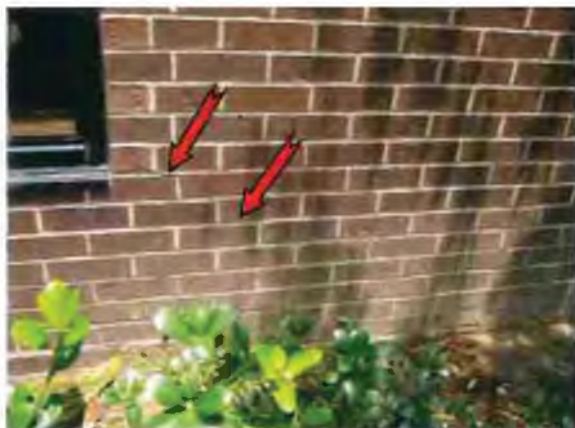
**Photo #19** Masonry-mortar-joint crack

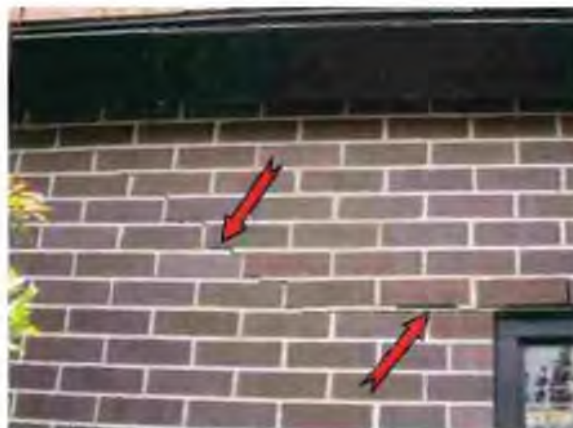
**Photo #20** Masonry-mortar-joint crack

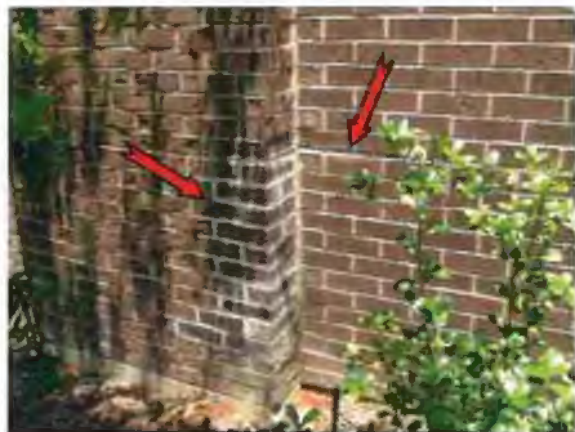
**Photo #21** Masonry-mortar-joint crack

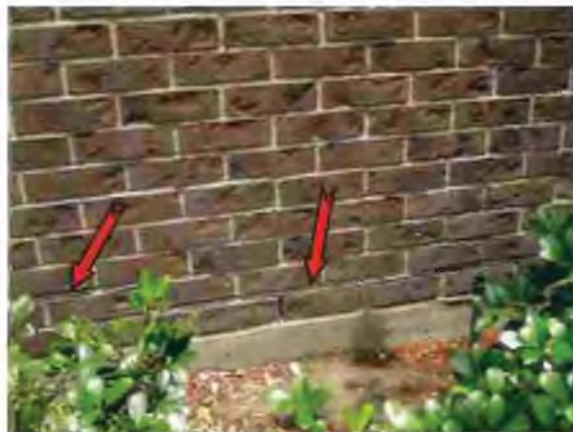
**Photo #22** Masonry-mortar-joint crack

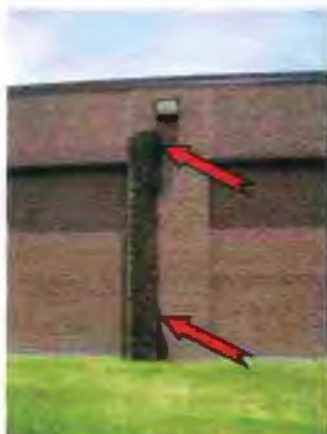
**Photo #23** Staining on exterior brick veneer

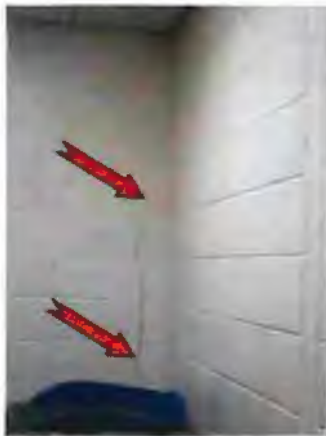
**Photo #25** Crack through concrete masonry unit wall

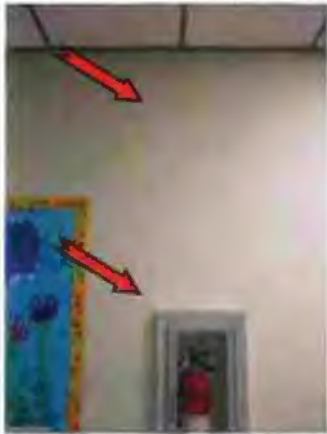
**Photo #43** Crack in gypsum wallboard wall

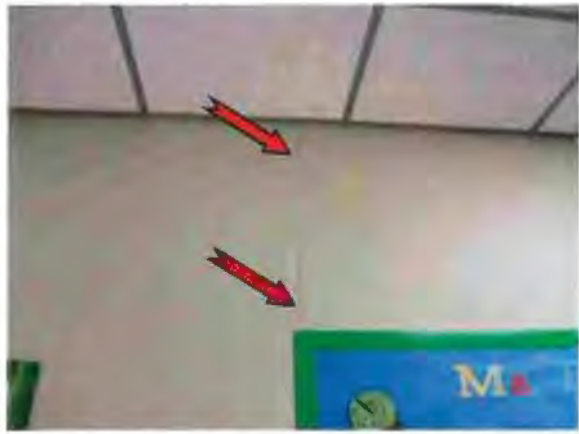
**Photo #46** Crack in gypsum wallboard wall

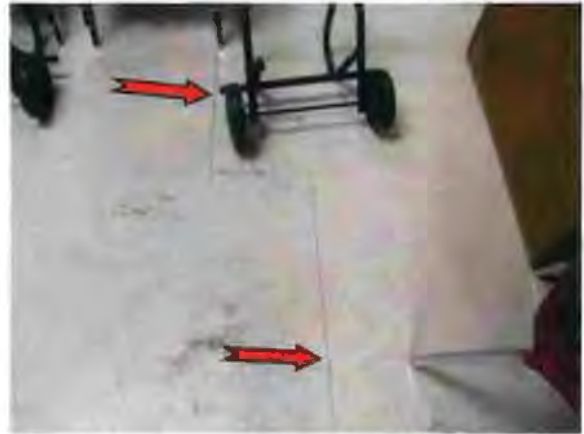
**Photo #50** Separations in vinyl tile floor

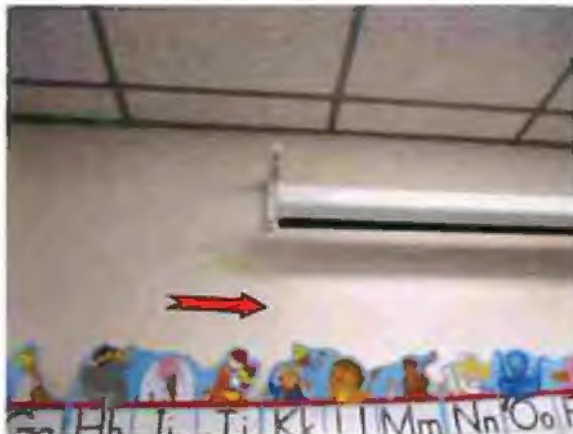
**Photo #55** Crack in gypsum wallboard wall

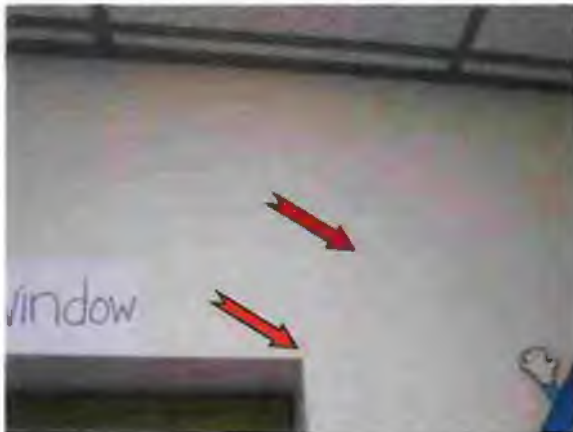
**Photo #57** Crack in gypsum wallboard wall

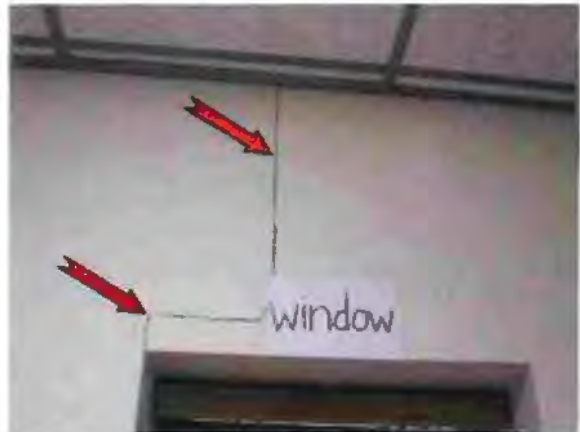
**Photo #58** Crack in gypsum wallboard wall

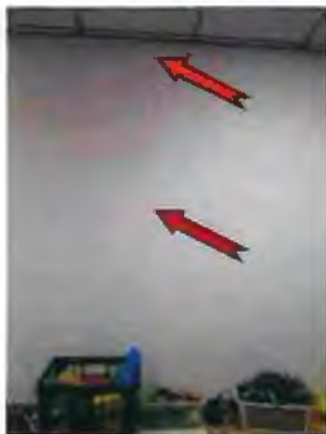
**Photo #59** Crack in gypsum wallboard wall

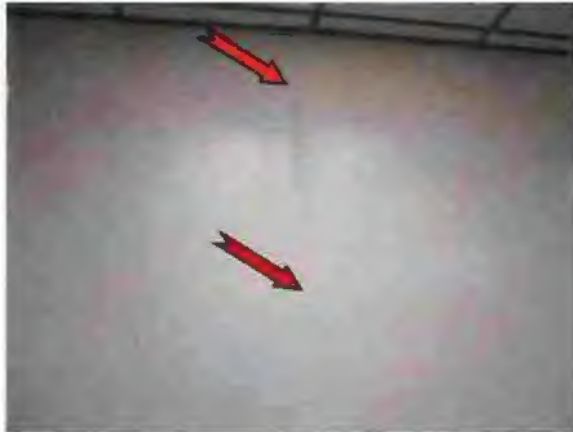
**Photo #67** Crack in gypsum wallboard wall

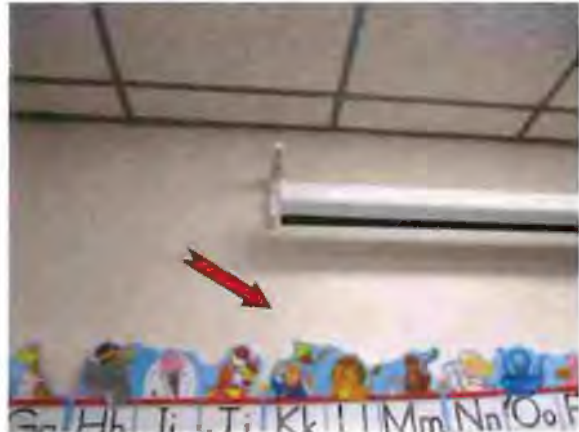
**Photo #68** Crack in gypsum wallboard wall
