# Building Observations Survey ©2016

## Deer Park Community Center Deer Park, Texas

**Building Survey for Deer Park Community Center,  
610 East San Augustine Street, Deer Park, Texas**

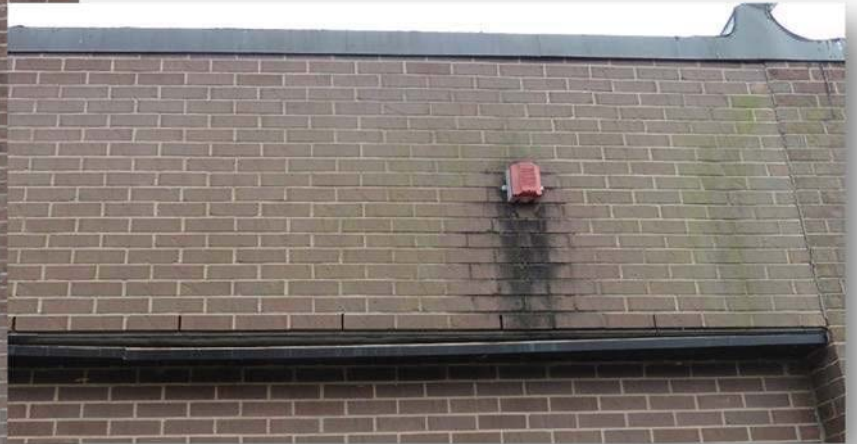
Examples of water damage

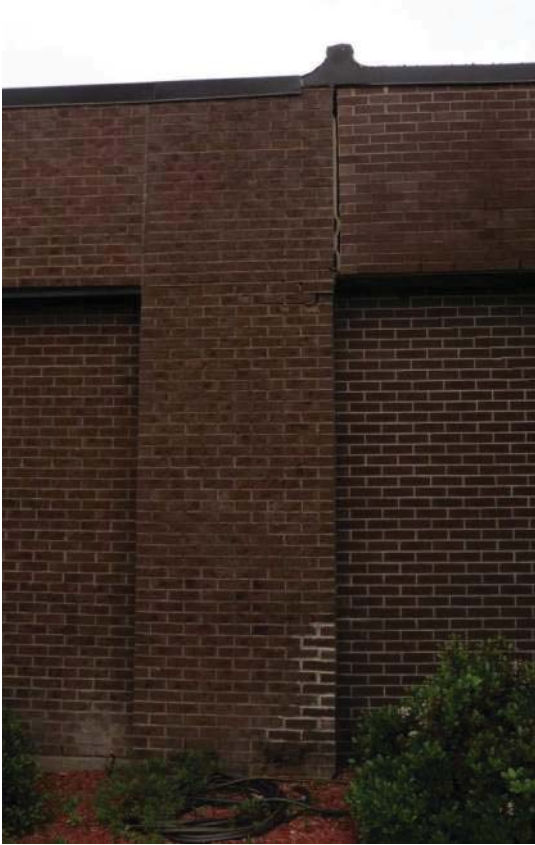
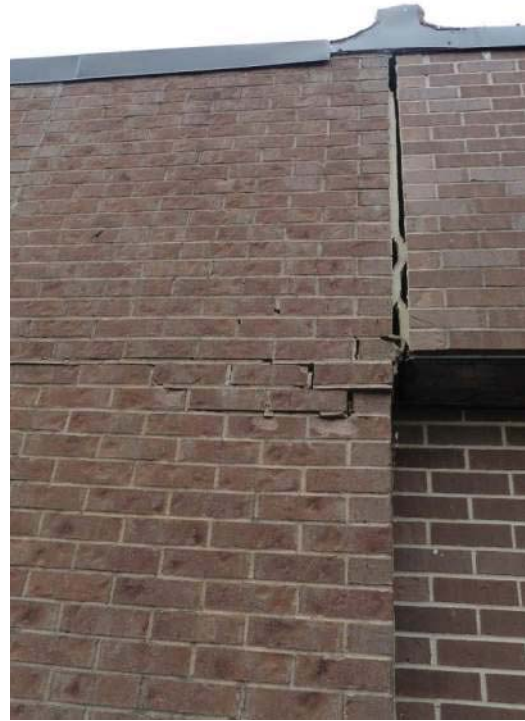
As noted elsewhere in this survey, the community center (especially the addition) has been experiencing significant structural movement for some time. This movement manifests in cracking and separation of cladding materials, which is creating unacceptable water intrusion and water damage. These are significant problems which must be continually maintained and patched. However they are symptomatic of larger challenges and cannot

Examples of structural movement damage

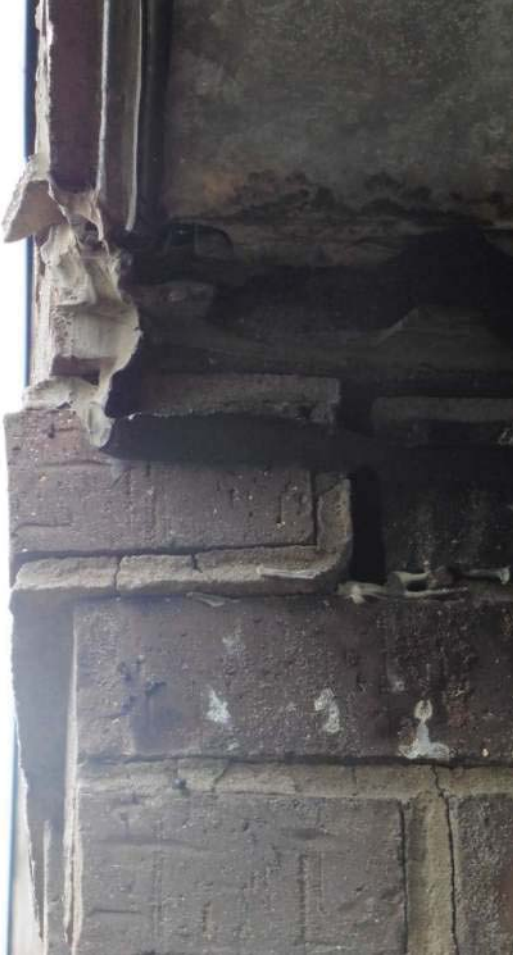
Examples of movement damage

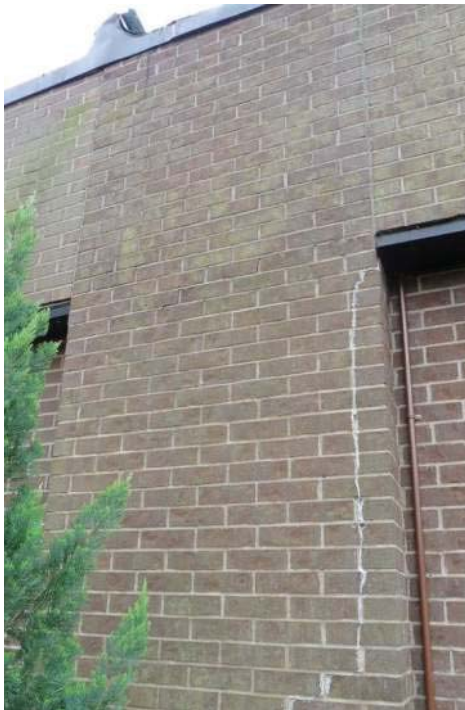
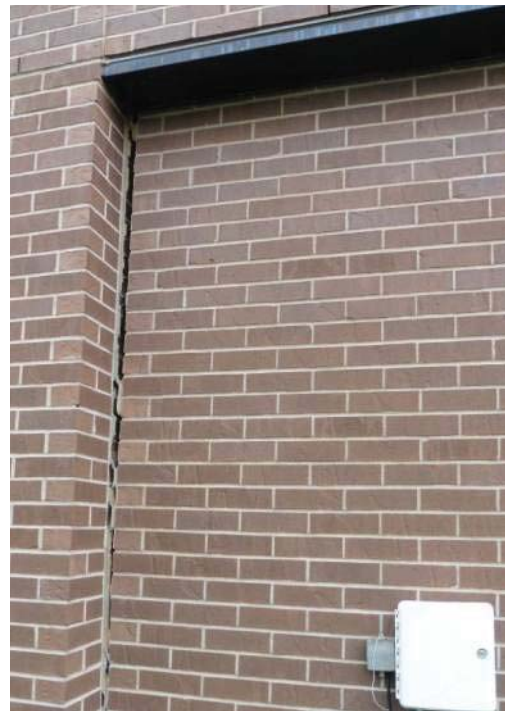
Examples of brick soffit water damage, abandoned or broken electrical

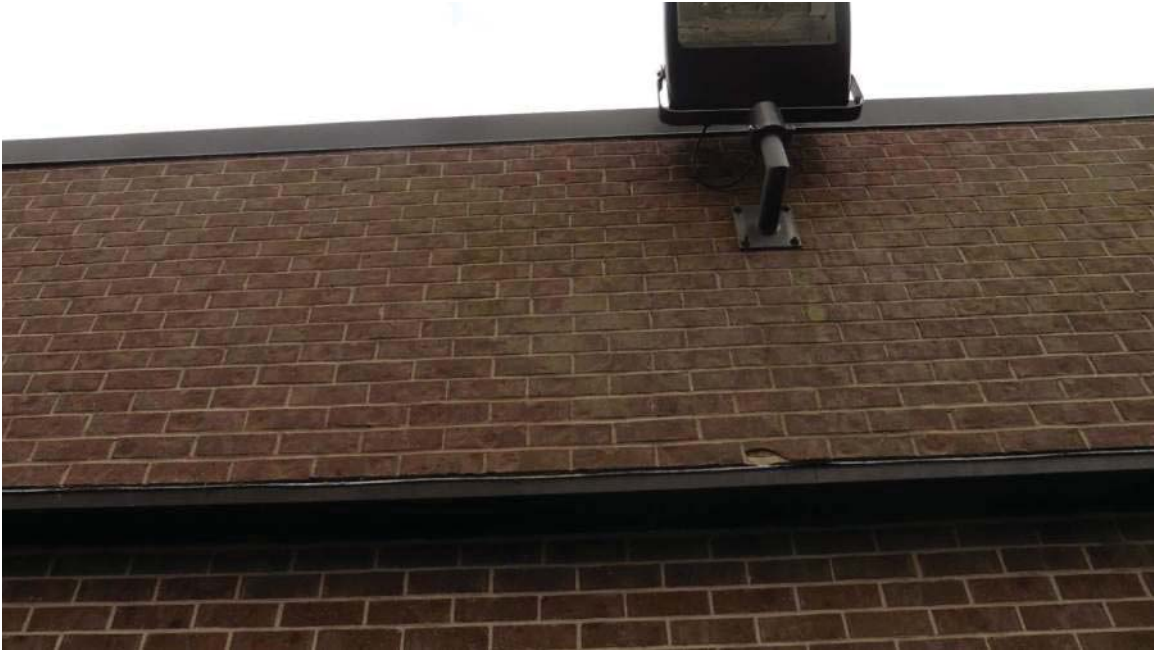
Spalled brick at an inset panel, example of existing security lighting

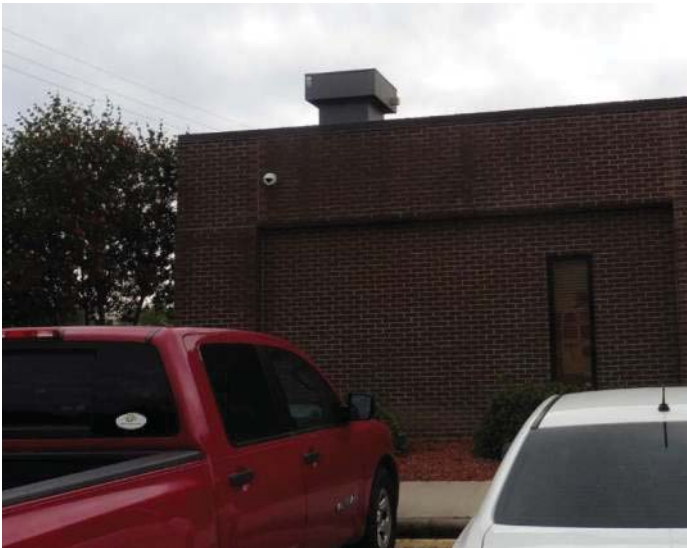
Unscreened rooftop equipment

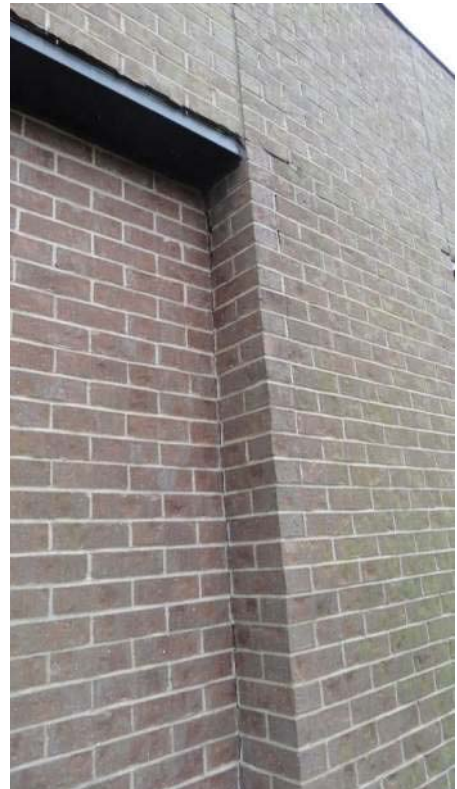
Example of missing control joints at panel inset

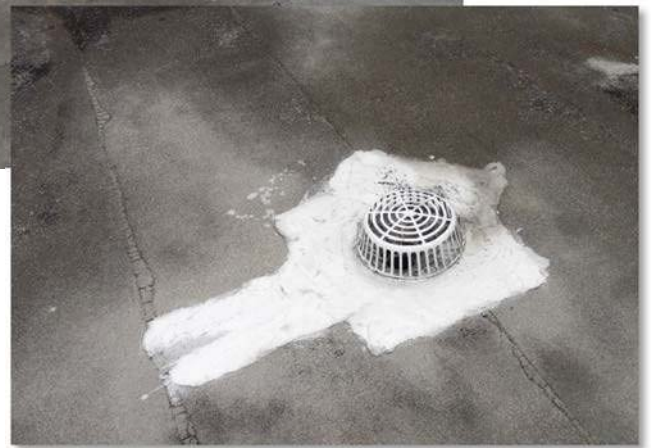
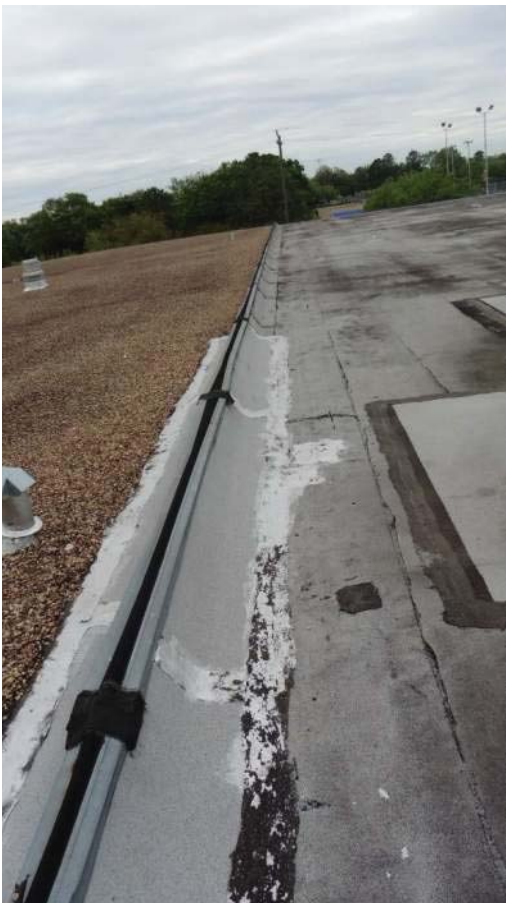
Condition of expansion joint

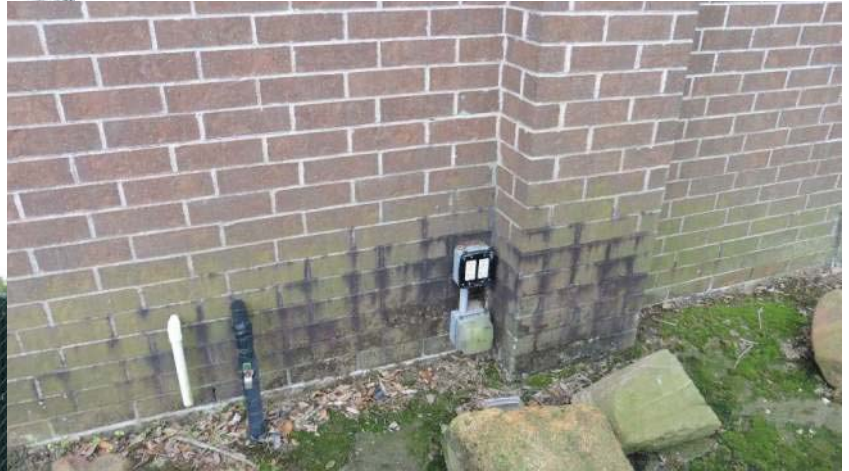
Mildew growth and damaged electrical

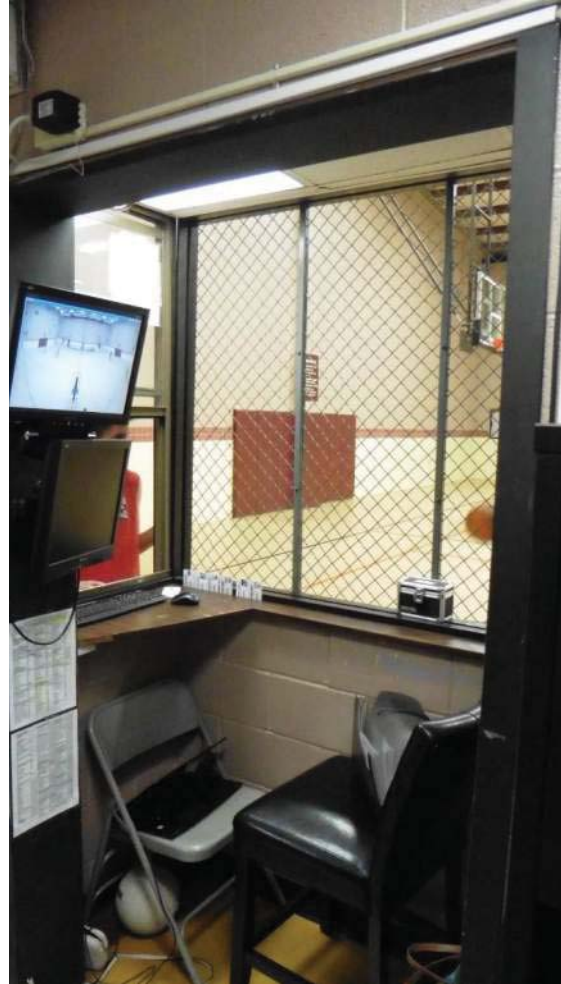
Gym Control

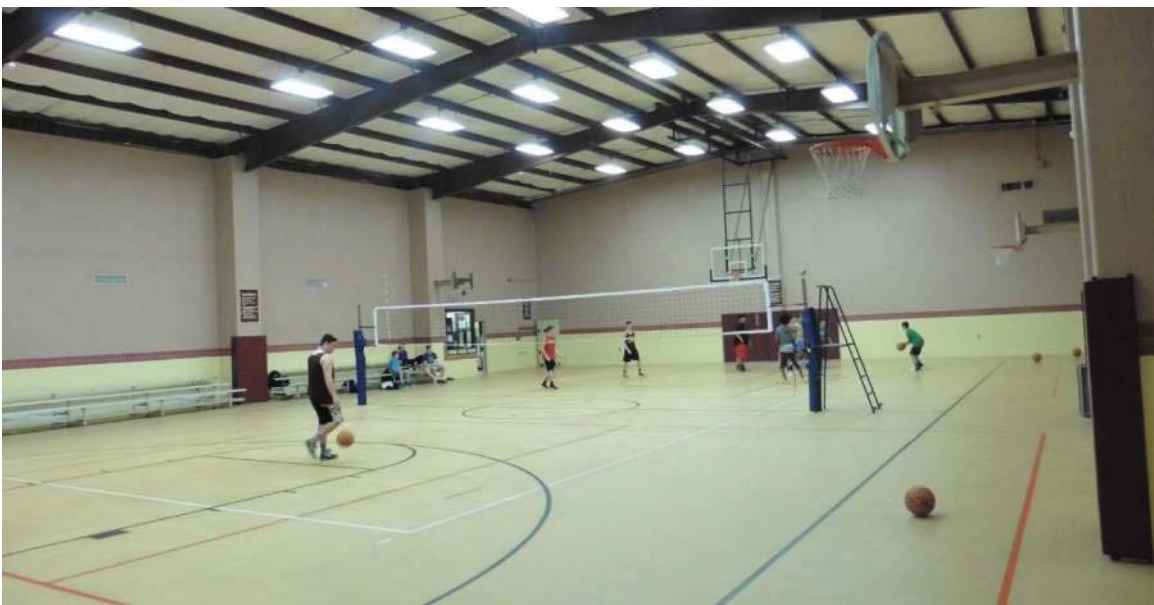
Gym Court

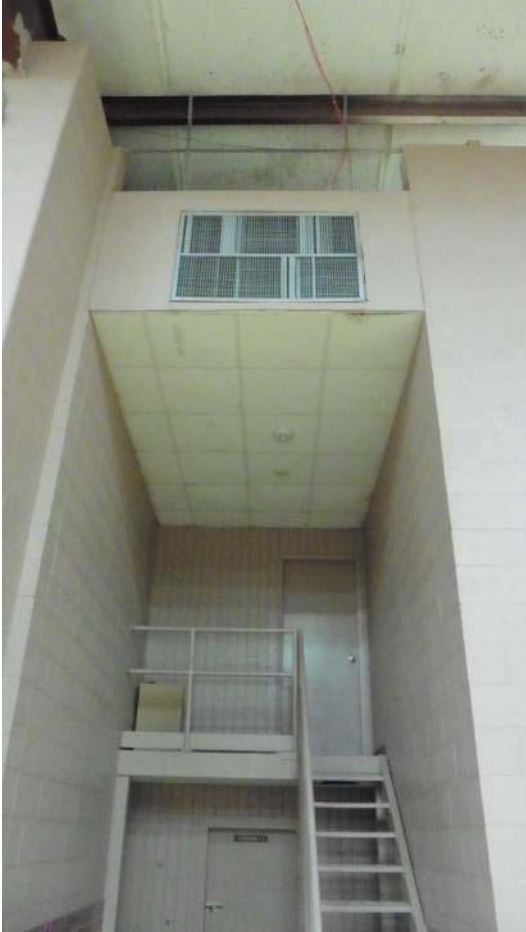
Mezzanine storage

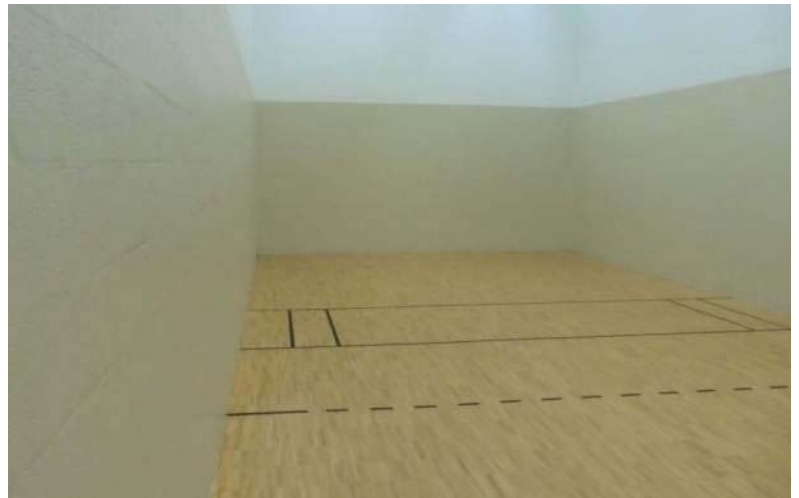
Racquetball court used for sport

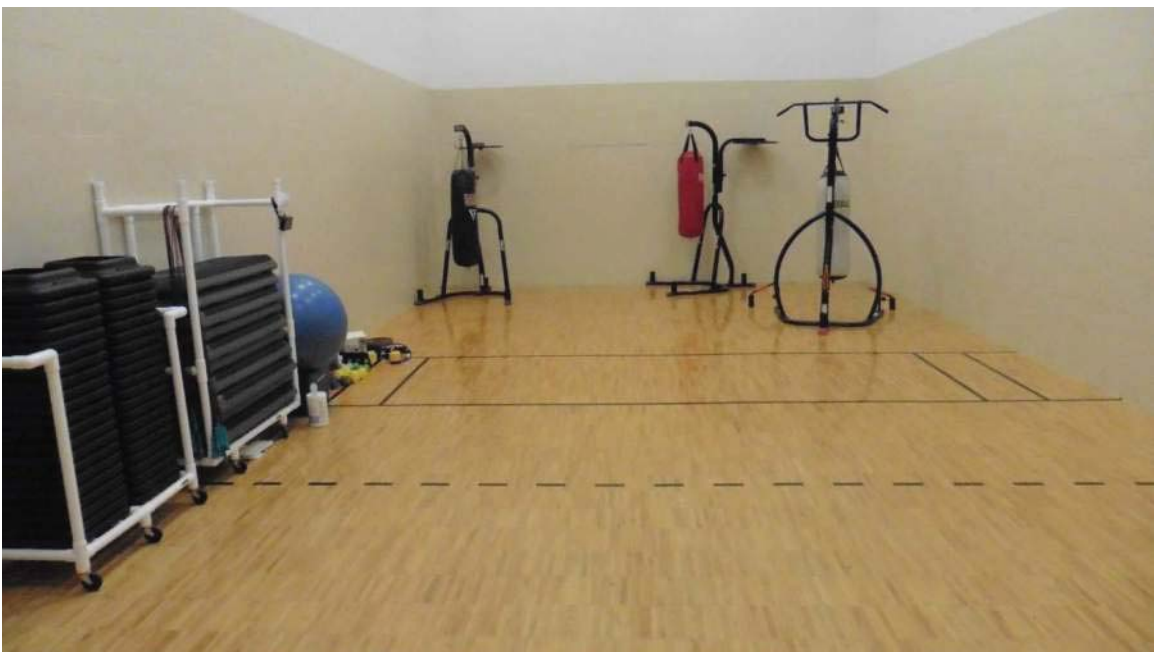
Racquetball court being used for exercise

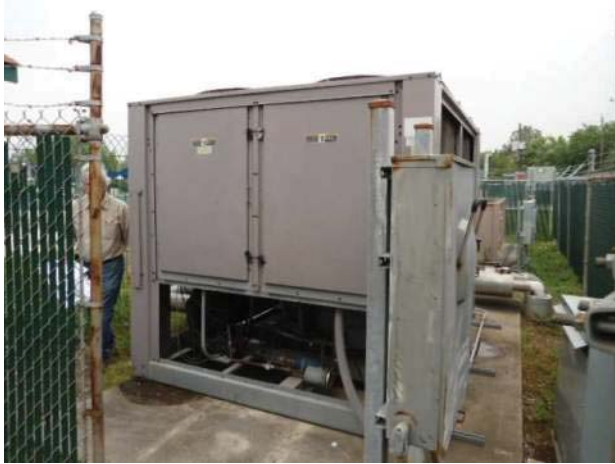
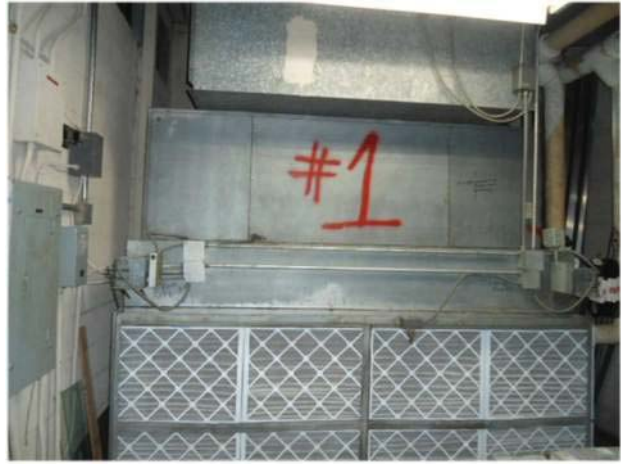
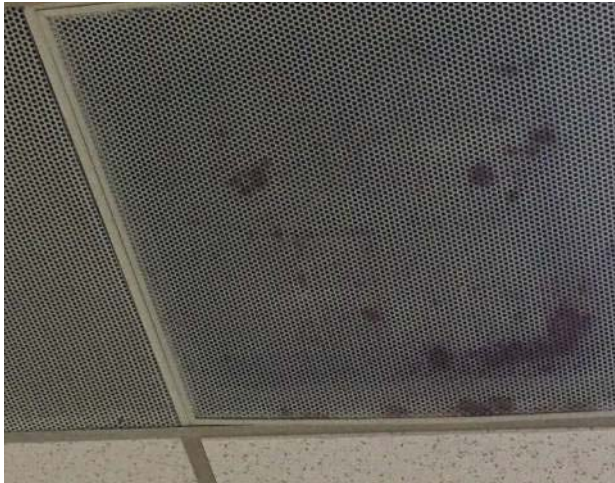
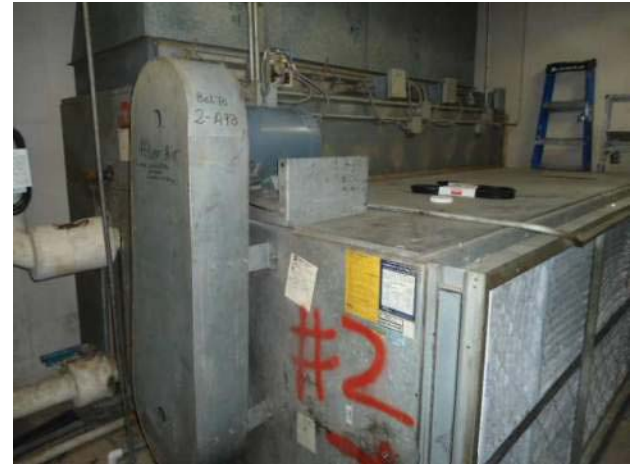
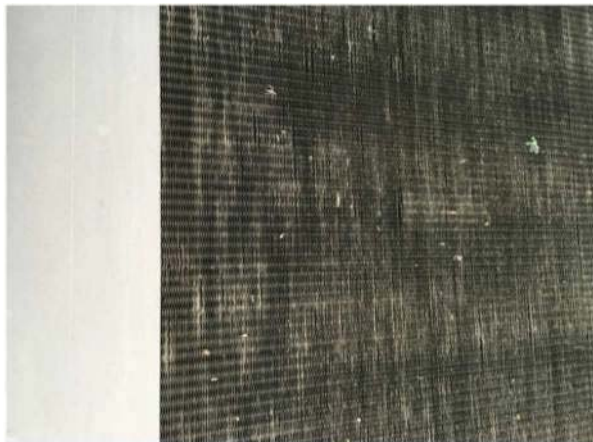
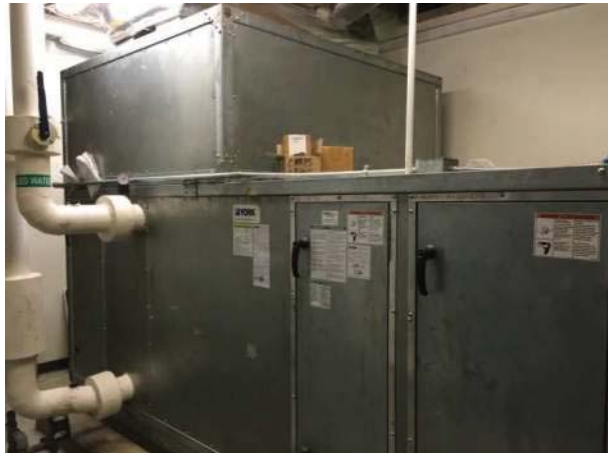
1. The 70-ton Carrier 30GTN070 chiller was built in 2004. It was operating but showed signs of corrosion on the condenser coil. Compressors appeared to be in good condition and were fully charged with oil and refrigerant. Carrier has advised that the life expectancy of a well maintained chiller of this type is approximately 15 years. They can perform an oil and vibration analysis to determine the condition of the chiller and make service recommendations, in addition to, predicting remaining useful life of the chiller. This chiller uses R-22 refrigerant which is no longer in production but is still readily available.

2. The 41 ton York YCAL005TN070 chiller was built in 2007. It was operating and appeared to be in acceptable condition. Fan guards and compressor area guards were rusty but still functional. York has advised that the life expectancy of a well maintained chiller to this type is approximately 15 years. The manufacturer can perform oil and vibration analysis to determine condition and make service recommendations, in addition to, predicting remaining useful life. This chiller uses R-22 refrigerant which is no longer in production but is still readily available.

3. Both chiller pumps were running and appeared to be in serviceable condition. The 3 hp chiller pump serving the York chiller had a noticeable whine while in operation and show signs of excessive wear.

4. The chilled water pipe insulation was rigid type (foamglass or phenolic) and was in good condition. This type insulation is the proper type for chilled water. Metal covering was in good condition. Most isolating valve handles were severely rusted.

5. The two McQuay air handling units serving the original Community Center had some minor corrosion did not show signs of excessive wear. In addition, they were operating without excessive noise due to belts or bearings. There was no indication of leaks. The zone ducts had access plates installed to clean, repair or inspect the internal liner. The outside air damper appeared to be inoperable.

9. Ceiling diffusers in the original Community Center show signs of rust or corrosion.

1. The mechanical systems appear to be well maintained with items repaired or replaced as needed. Funds should be set aside to replace one or both chillers in the near future as they are reaching the end of their expected life. Replacement chillers will have better efficiency which should be a consideration for replacement timing. Balancing and shutoff valves at the chillers should be replaced when the chillers are replaced. Air devices are functional but could be replaced if the rooms are refreshed.
2. DX systems at the gymnasium will need to be replaced in the near future.

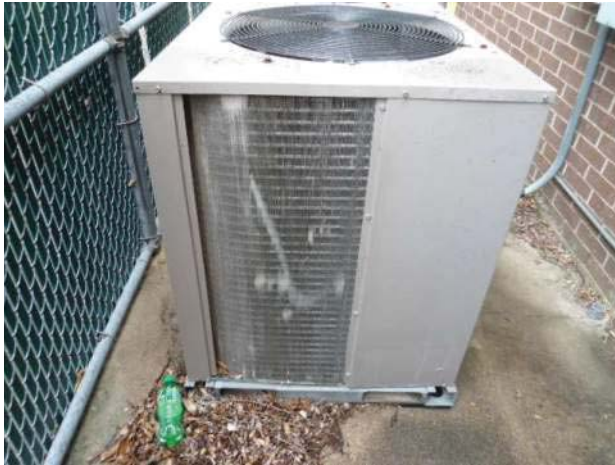
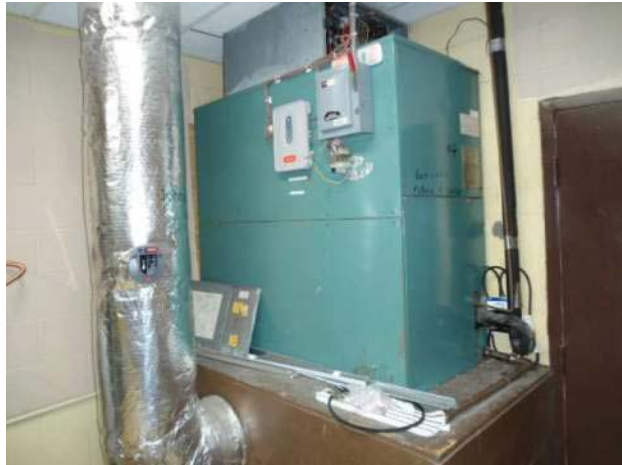
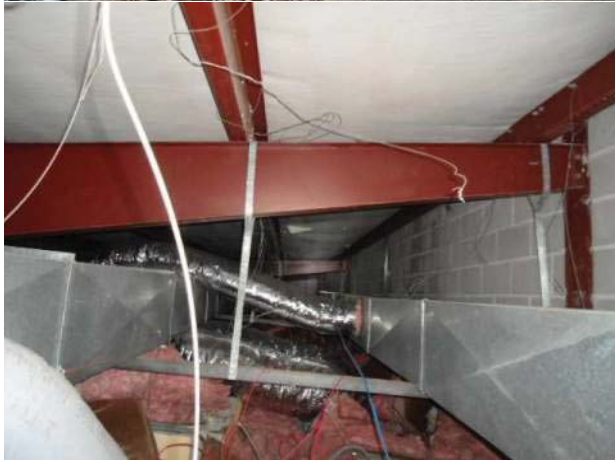
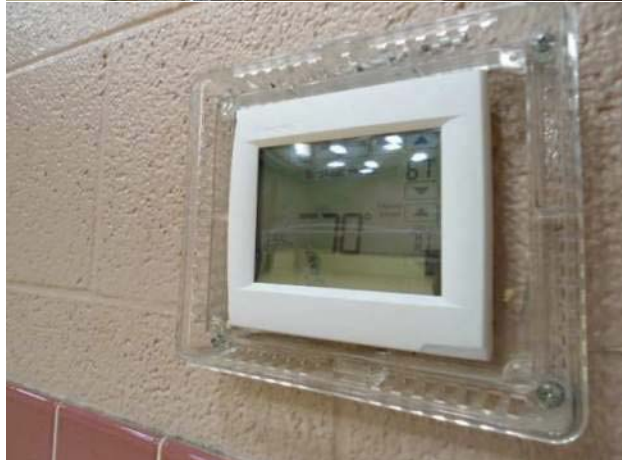
1. Rheem package units were manufactured in 2011 and appear to be in acceptable and serviceable condition. Rheem has advised that this type of units have a life expectancy of approximately 15 years. With proper maintenance these units should have approximately 10 years of remaining serviceability.
2. DX split system condensers have moderate to excessive wear and moderate to excessive damage to condenser coils. The Carrier unit was manufactured in 2004 and the York in 2006, both of these units are nearing the end of their expected serviceable life.

3. Ceiling diffusers show signs of rust or corrosion.

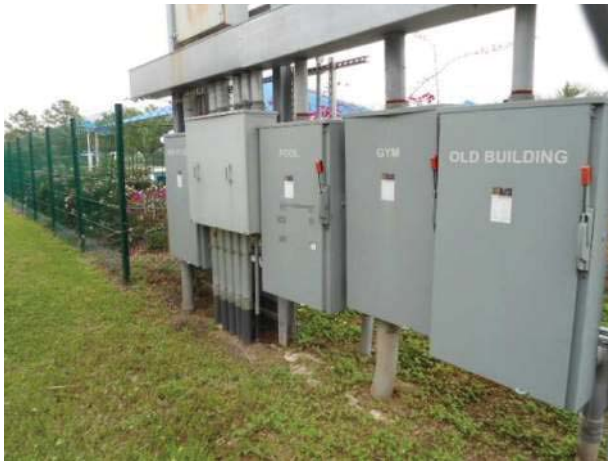
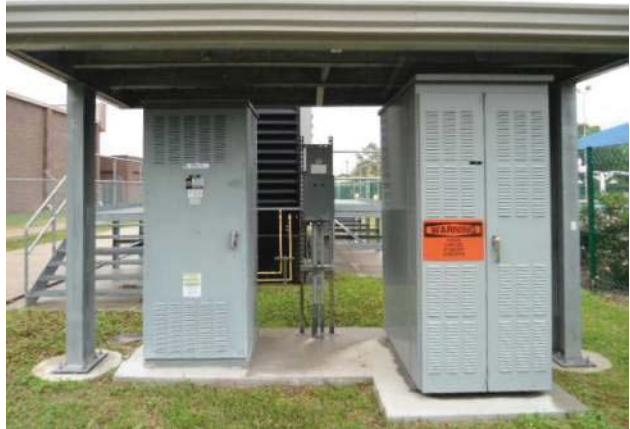
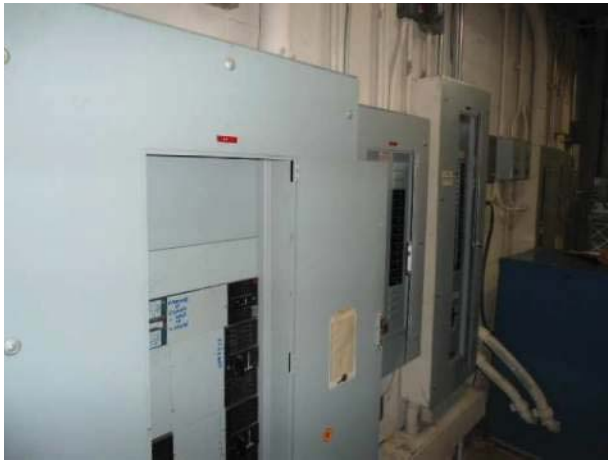
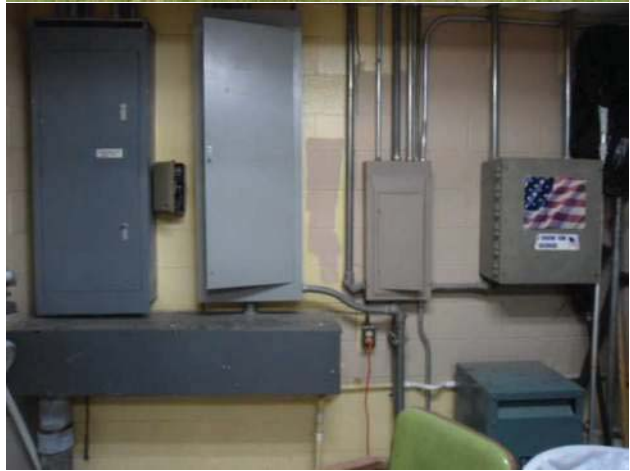
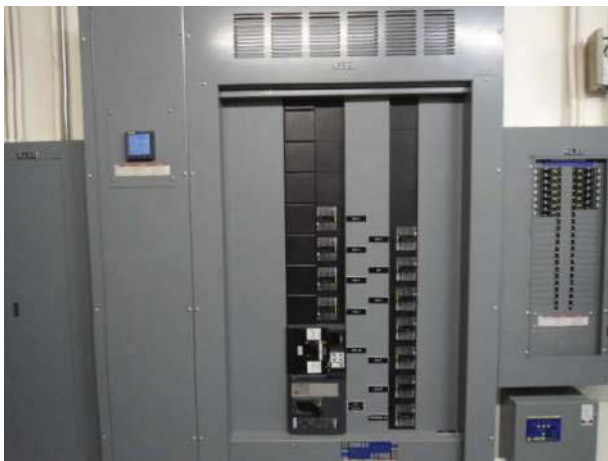
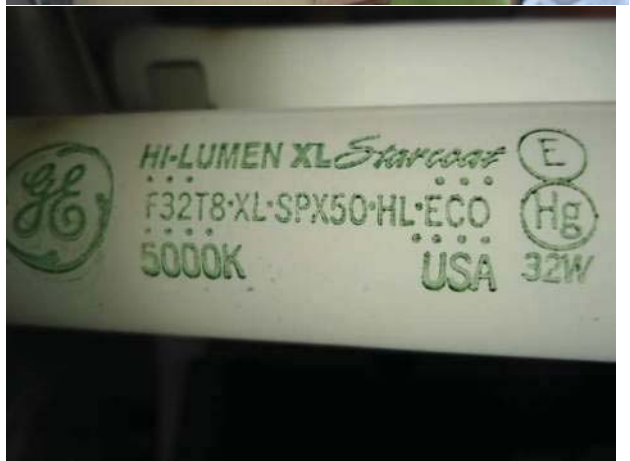
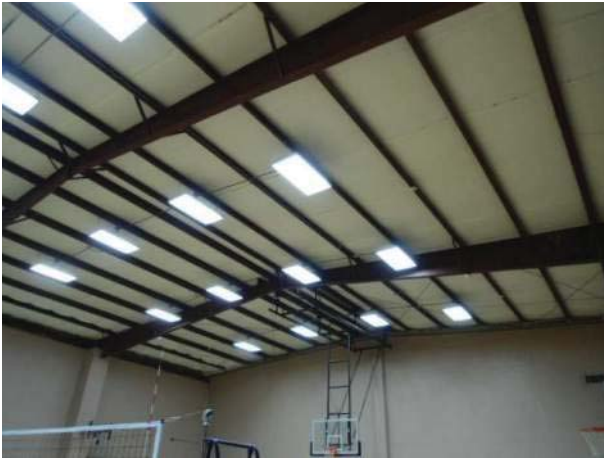
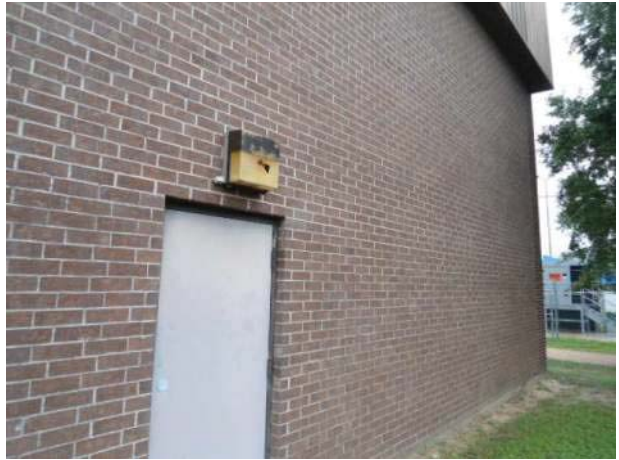
2. Several safety switch enclosures serving exterior HVAC equipment (i.e. chillers serving Community Center, DX condensers and package units serving Gymnasium) appear to be substantially weathered and in poor condition due to being constantly subjected to environmental elements. Switches were not cycled to confirm operation.

4. General lighting fixtures inside appeared to be newly retrofitted with T8 lamps and reflectors for improved efficiency.
5. Exterior light fixtures were not operating due to the time of day but many fixtures appeared to be in poor or inoperable condition.

6. Several exit lights were tested in the original Community Center and Gymnasium facility and were inoperable. Exit lights were tested in the Community Center addition and were found to operate correctly with internal back-up batteries. A complex wide, after-hours test should be conducted to determine the extent of emergency lighting and deficiencies.

1. The system appears to be in good condition except for a number outdoor disconnect switches.
2. Outdoor security lighting should be upgraded with LED type light fixtures.
3. Since there is no dedicated computer power system, consideration should be giving to installing an isolated ground and surge protected system should computer failures or glitches be experienced.

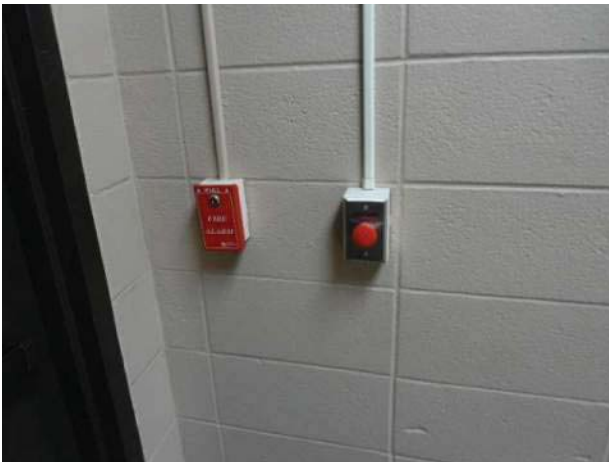
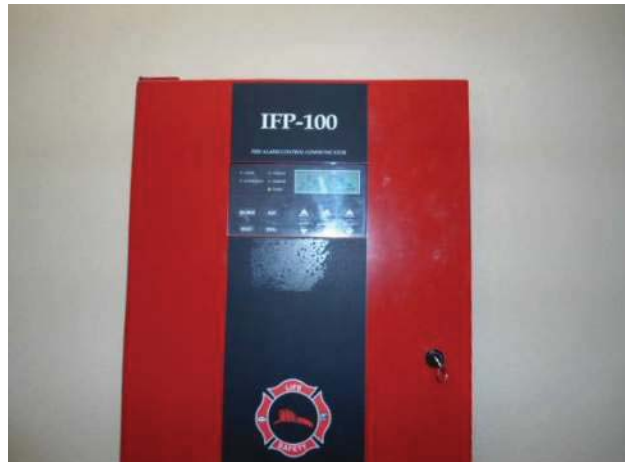
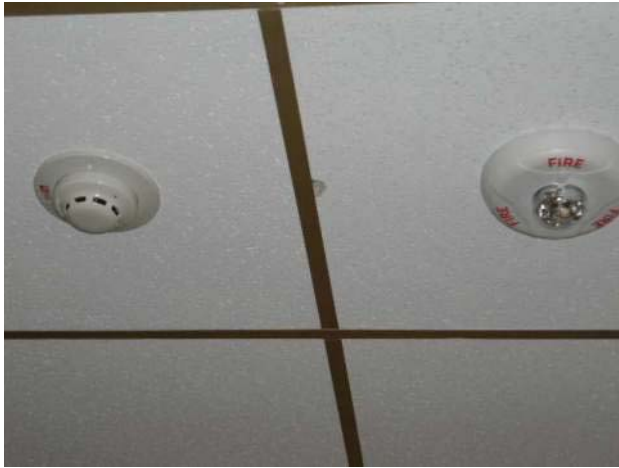
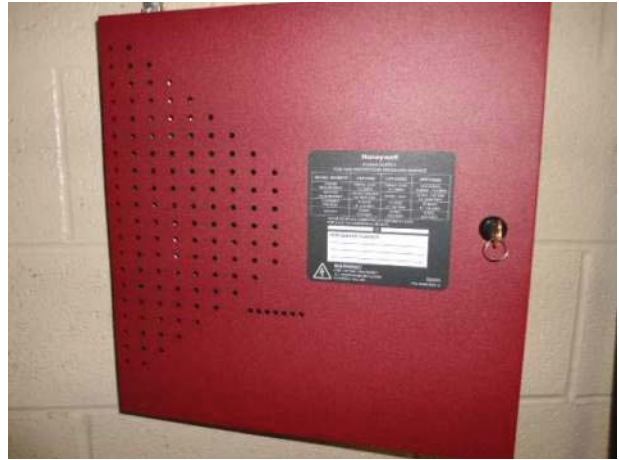
1. The system in the Community Center had no troubles or alarms on the panel display and appears to be serviceable. An extensive review of the system was not conducted but appears to be installed in compliance with the "Addition to Deer Park Community Center" design requirements. The system has current maintenance and inspection tags.
2. A Honeywell power supply was noted in the Gymnasium facility. Devices appear to have been upgraded, consistent with the Community Center.

1. The fire alarm system appears to be operable and well maintained. Although not required, consideration should be given to upgrading the system to the latest codes.

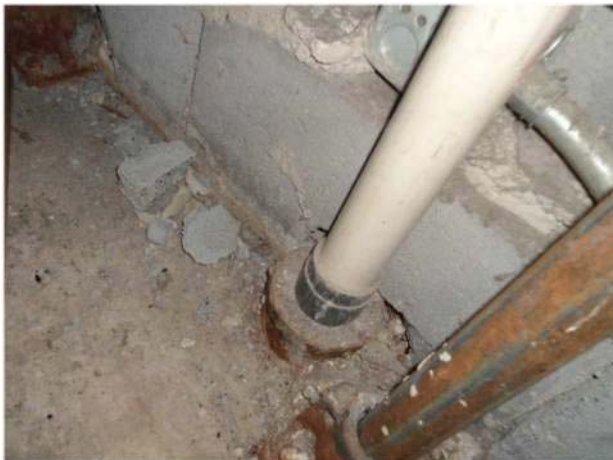
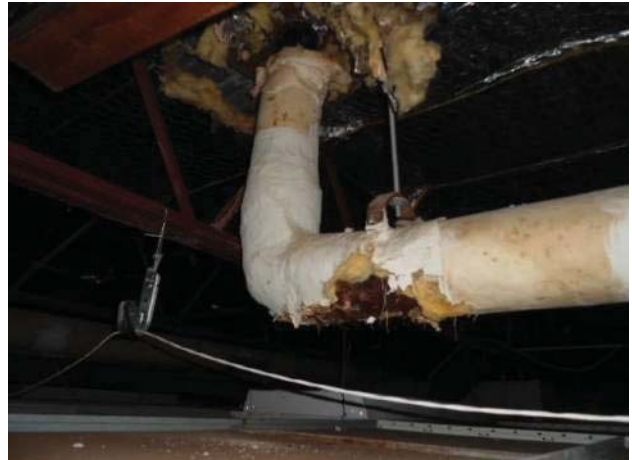
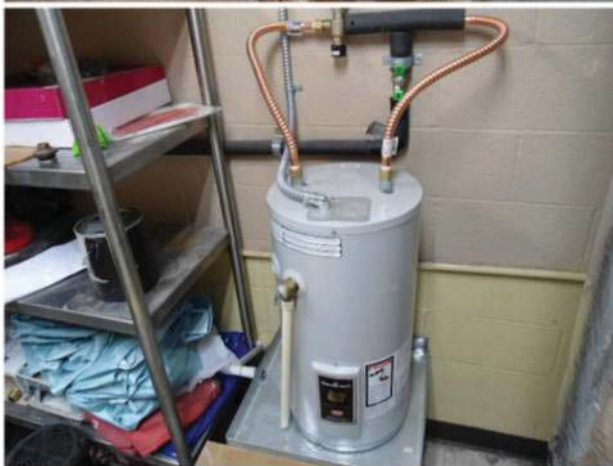
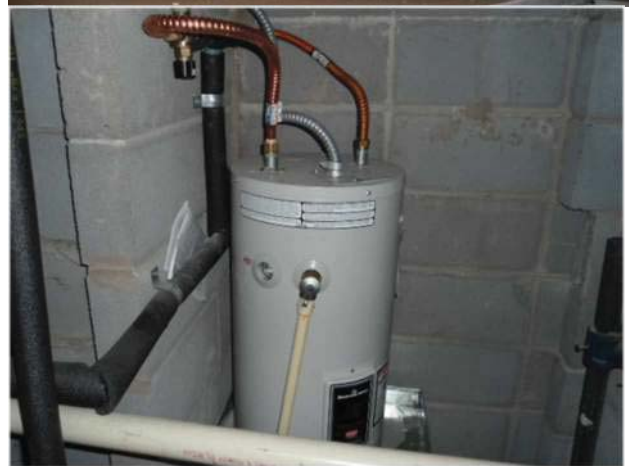
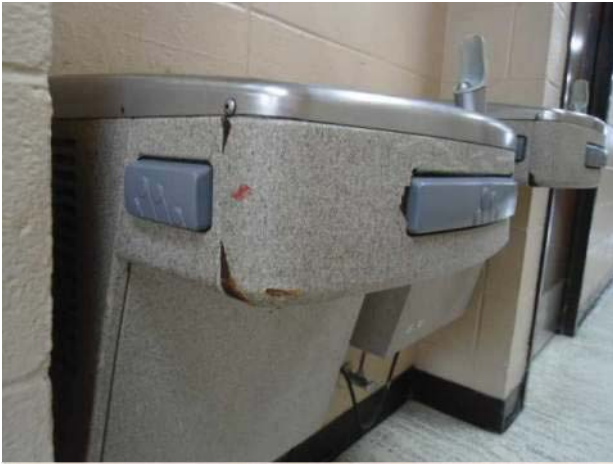
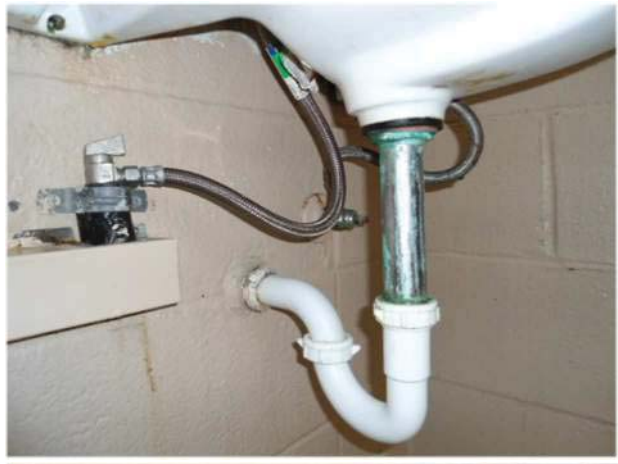
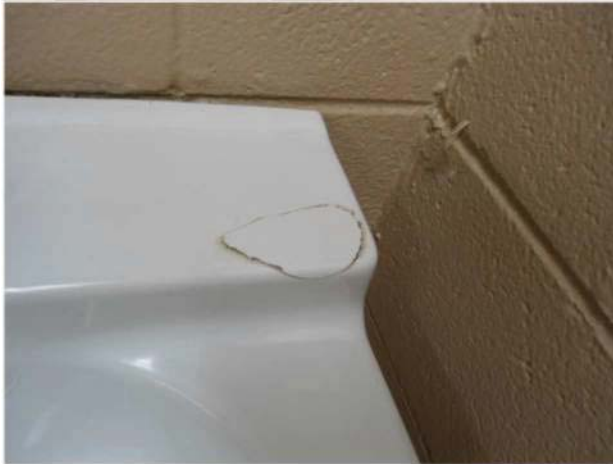
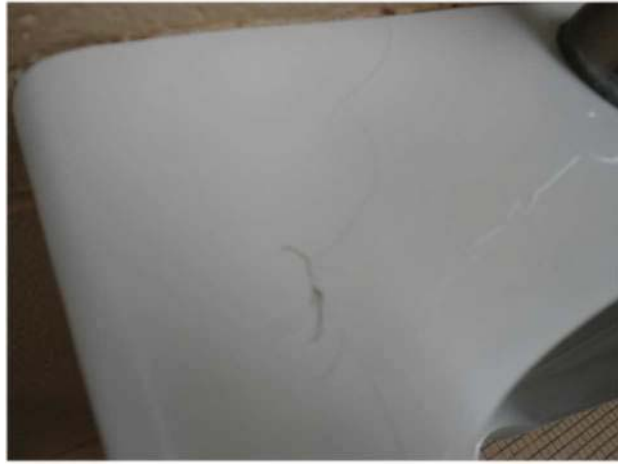
1. Lavatories appeared to be in serviceable condition; however, a few surface imperfections/damages were noted along with several service connection leaks. Most lavatories did not have ADA insulation kits on the water and waste piping.
2. Sinks appeared to be in serviceable condition.
3. Several faucets have superficial corrosion.
4. Urinals and water closets appeared to be in serviceable condition. Several associated flush valves have superficial corrosion.
5. Drinking fountains appear to be in serviceable condition; however, several have cosmetic damage and show signs of extensive wear.
6. It appeared that most, if not all, of the electric water heaters have been recently replaced and are in serviceable condition.
7. Above ceiling horizontal cast iron storm sewer piping, shows severe corrosion in existing Community Center.

1. Galvanized water pipes tend to rust on the inside and develop pin-hole leaks with age. The severity of these problems depends on the quality of the original piping and the quality of the water. I did not see indication of rust in the water and the visible piping did not show signs of leakage or repair. The piping system should be monitored and may require future replacement with other materials.

2. Underground cast iron pipe corrodes over time. If sewer stoppages occur fairly often, this may be a sign the pipes are cracked or collapsing. The condition of the piping was previously assessed by video camera and should be periodically monitored as necessary

3. Plumbing fixtures and valves are serviceable but replacement should be considered for appearance. Handicap protective wrap should be installed on sinks and lavatories. Note that contemporary codes limit the flow rates of flush valves so new valves will probably be incompatible with the existing water closets and urinals.

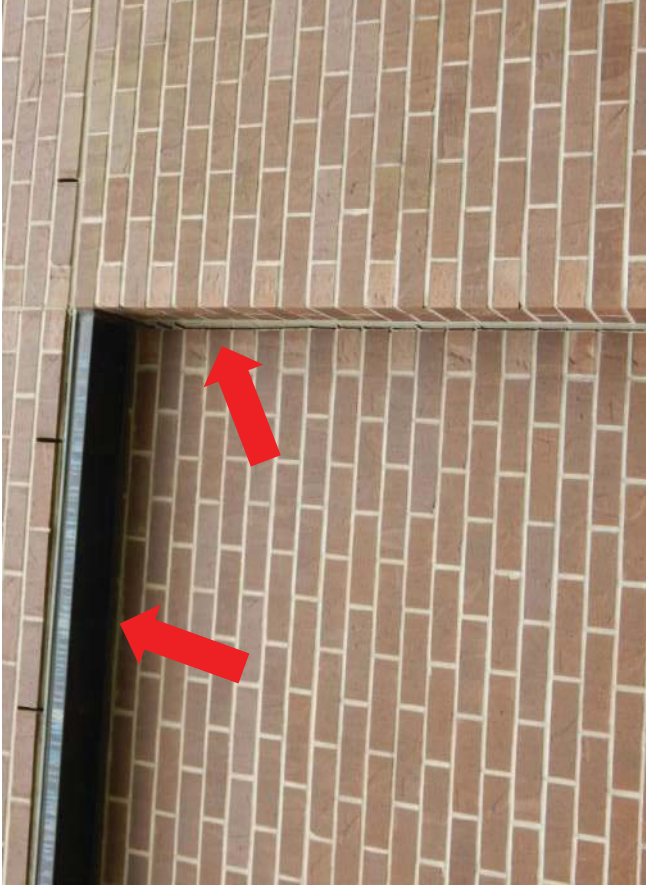
#2 Minor separation in caulk joint at end of inset brick panel.  
No brick header per architects detail.

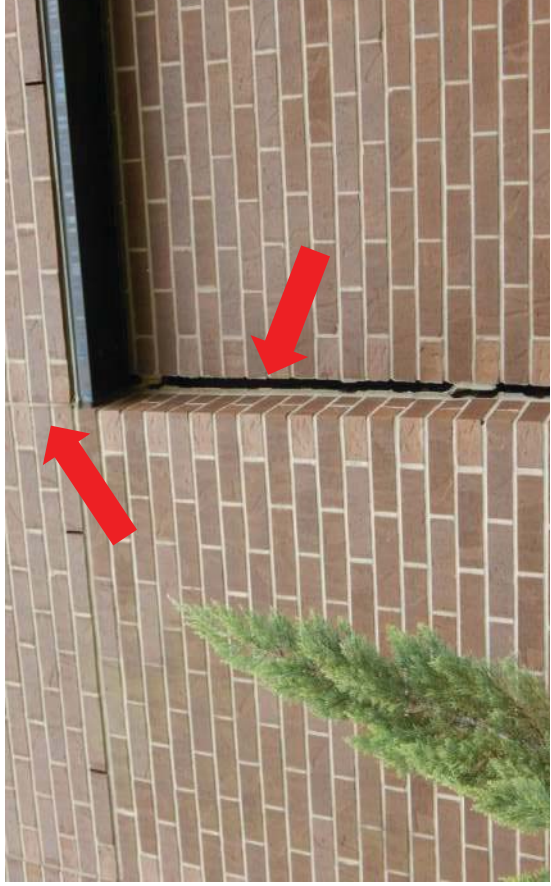
#3 Separation in caulk joint at end of inset brick panel of  
approximately 1". No separation in brick control joint above.

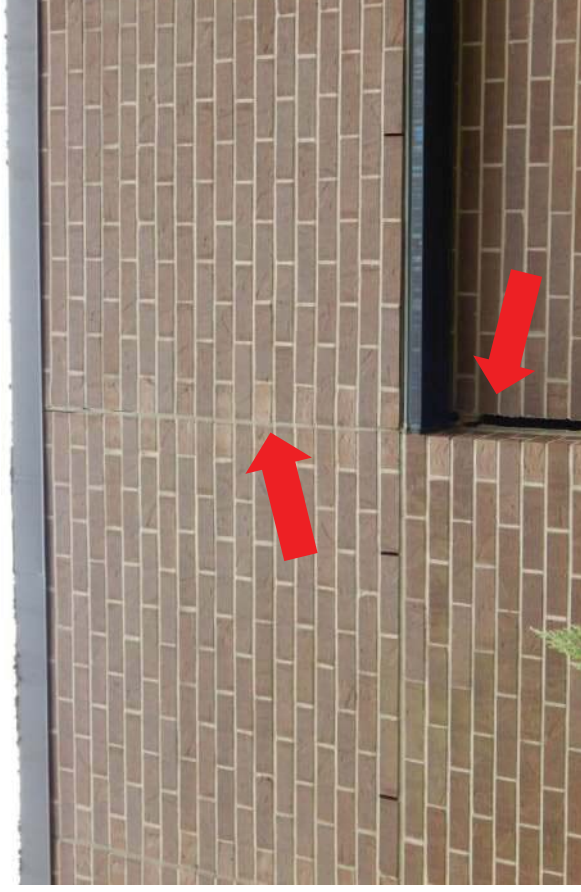
#4 Separation in caulk joint at end of inset brick panel of  
approximately 1". No separation in brick control joint above.

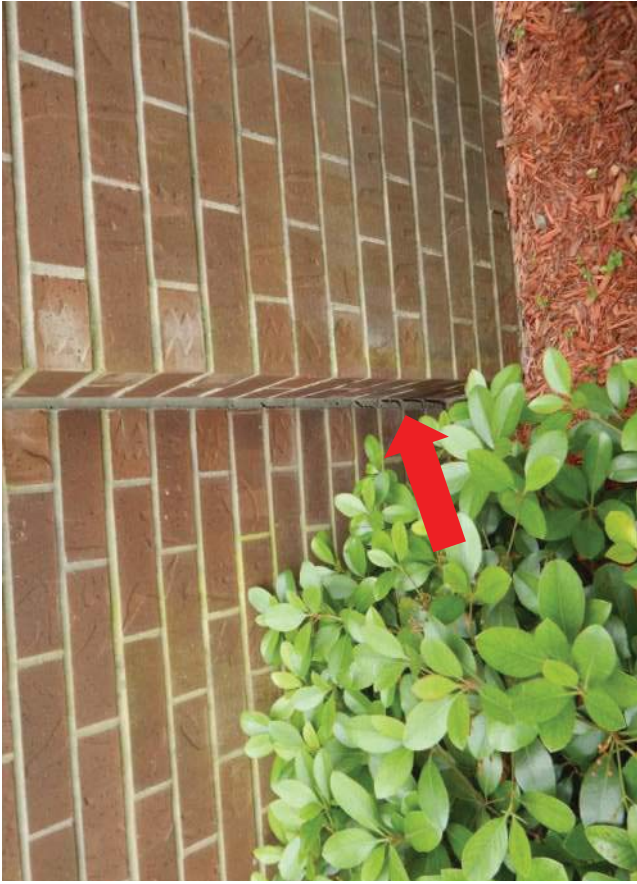
- 4) Photograph 5 is showing minor separation of the caulk joint at the bottom. Photograph 6 is at the same location at the top and is showing no separation in the control joint.

#5 Minor separation in caulk joint at end of inset panel.

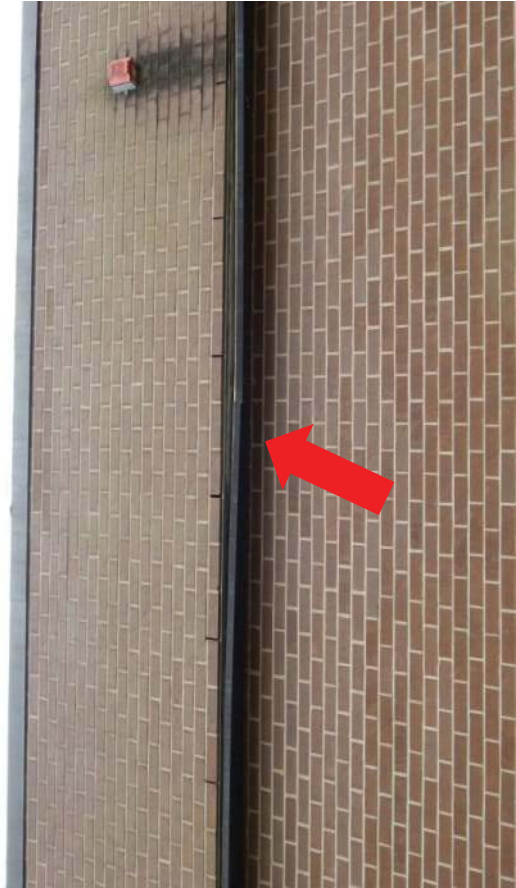
#7 Sheet metal soffit is sagging down. This is where the brick header was omitted and sheet metal added (typical).

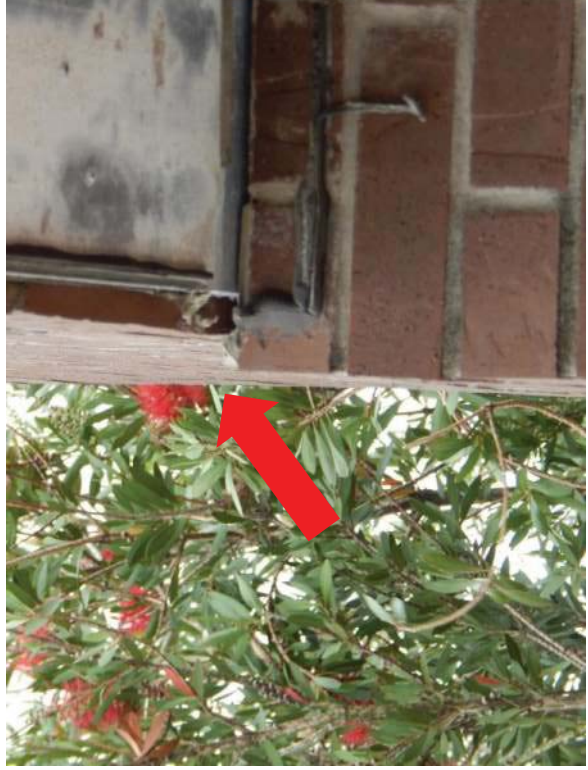
**#20** Showing brick column has moved outward to south approximately 1"

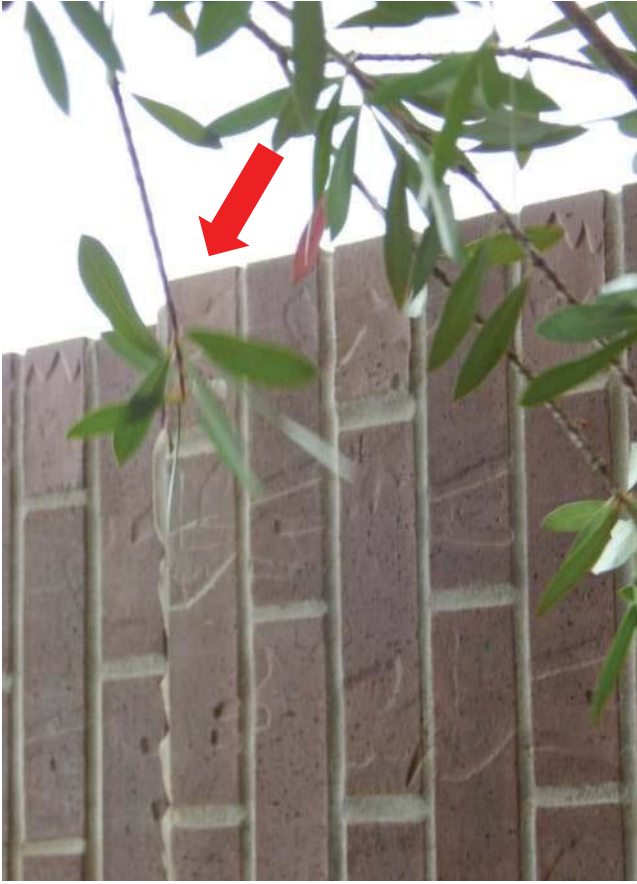
#21 Showing brick column has moved outward to the East approximately 1"
