# Building Observations Survey ©2016

## Deer Park Community Center Deer Park, Texas

**Building Survey for Deer Park Community Center,  
610 East San Augustine Street, Deer Park, Texas**

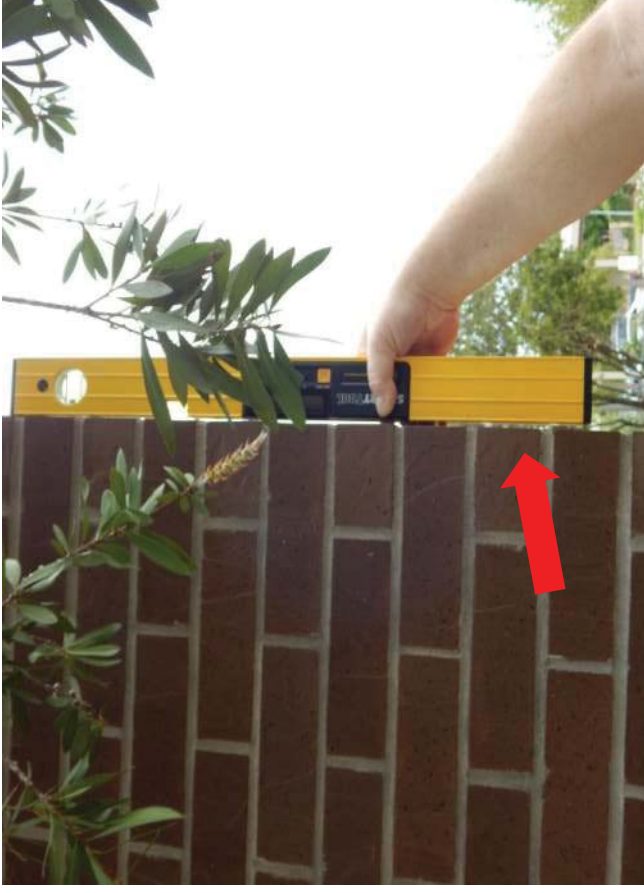
#22 Showing how brick column is leaning outward at the top of the East

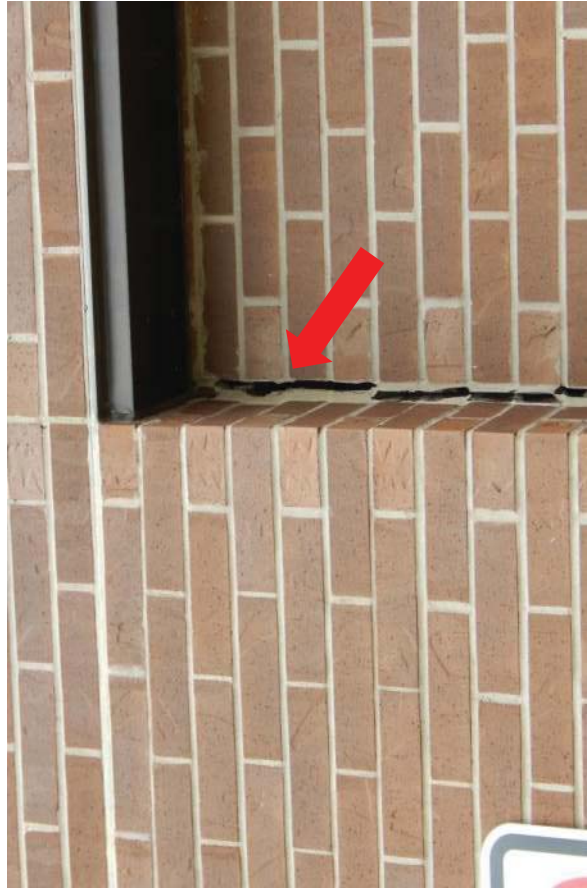
#23 Separation in caulk joint at end of inset brick panel of approximately 1/2".  
No separation in control joint above.

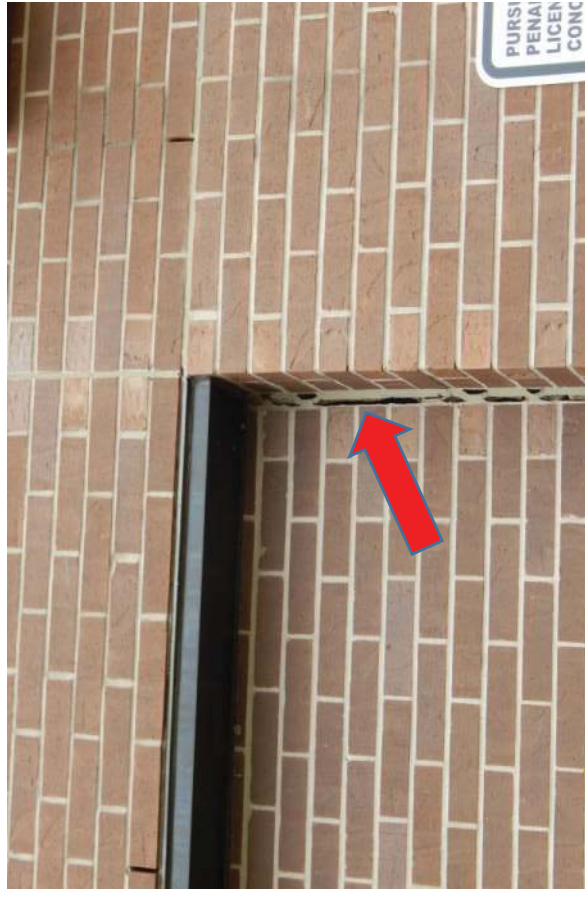
#24 Separation in caulk joint at end of inset brick panel of approximately 1/2".  
No separation in control joint above.

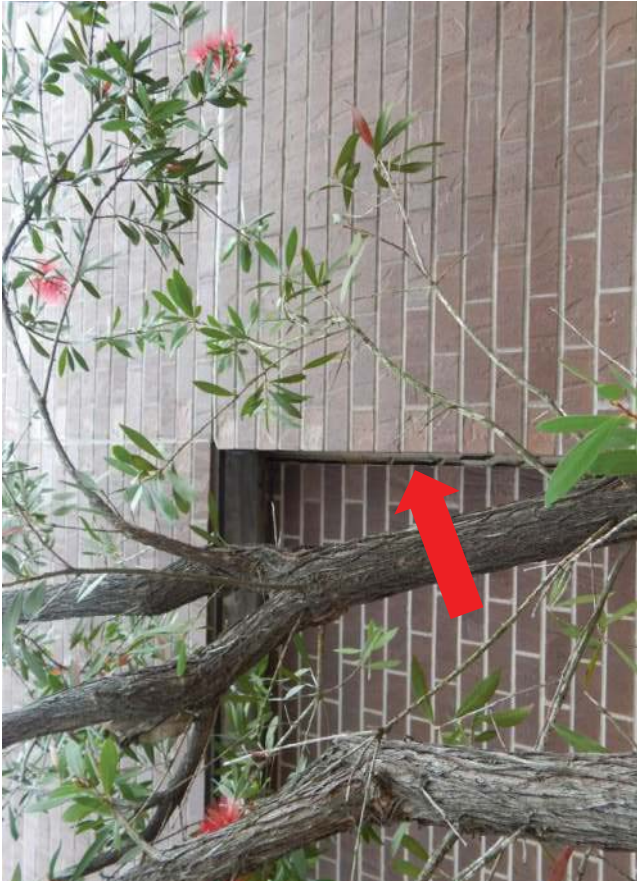
**#25** Separation in caulk joint at end of inset brick panel of approximately 1/2".

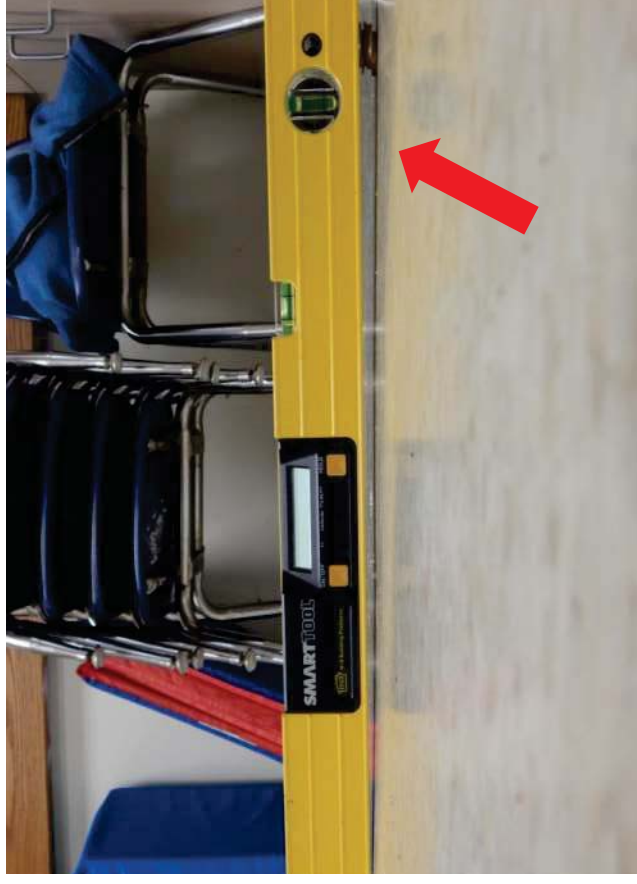
#39 Level on floor showing slope of approximately  $\frac{1}{4}$ " per foot

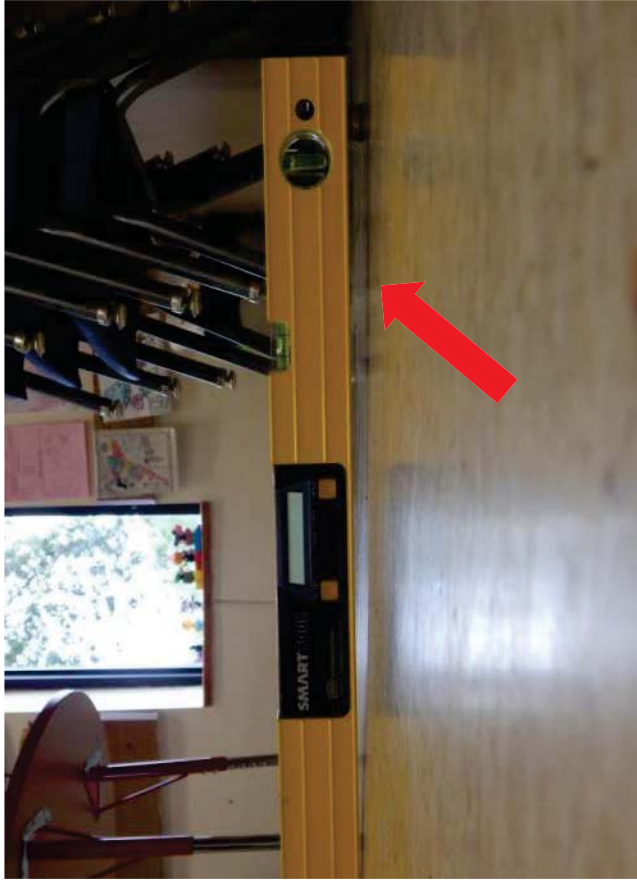
#40 Level on floor showing a slope of approximately 5/16" per foot

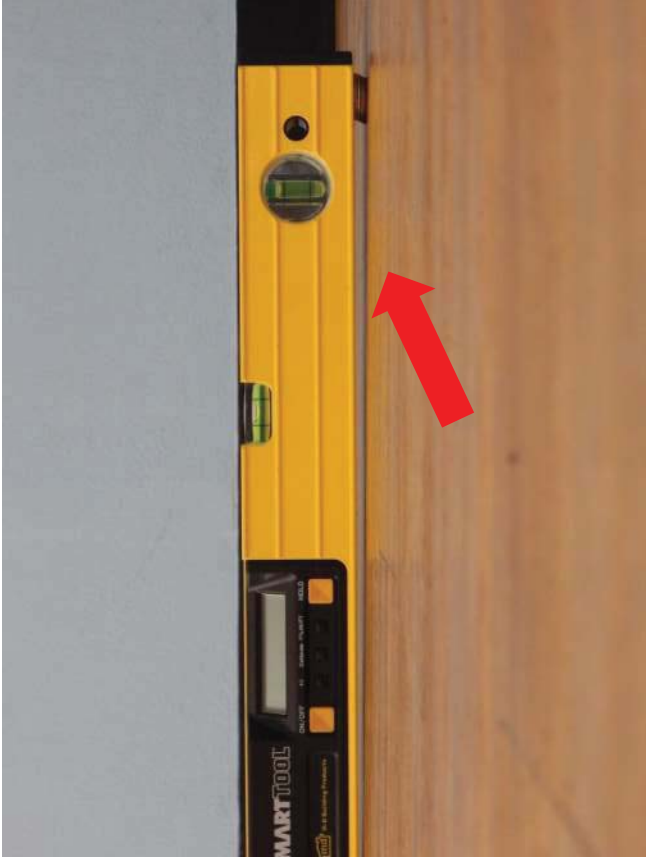
#43 Level on floor showing sloping down toward the North East corner at approximately 1/8" per foot

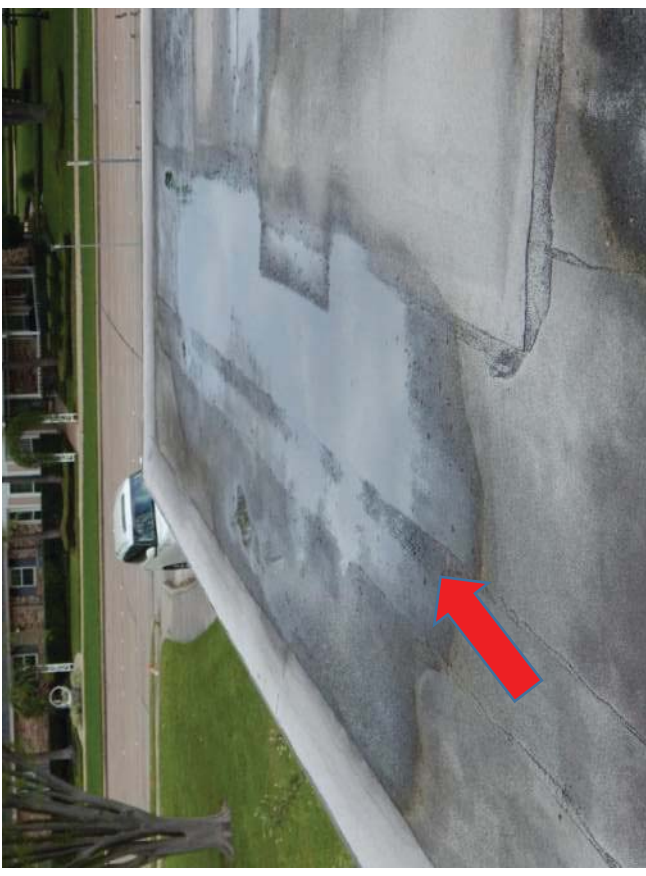
#51 Roof over phase one of community center showing standing water

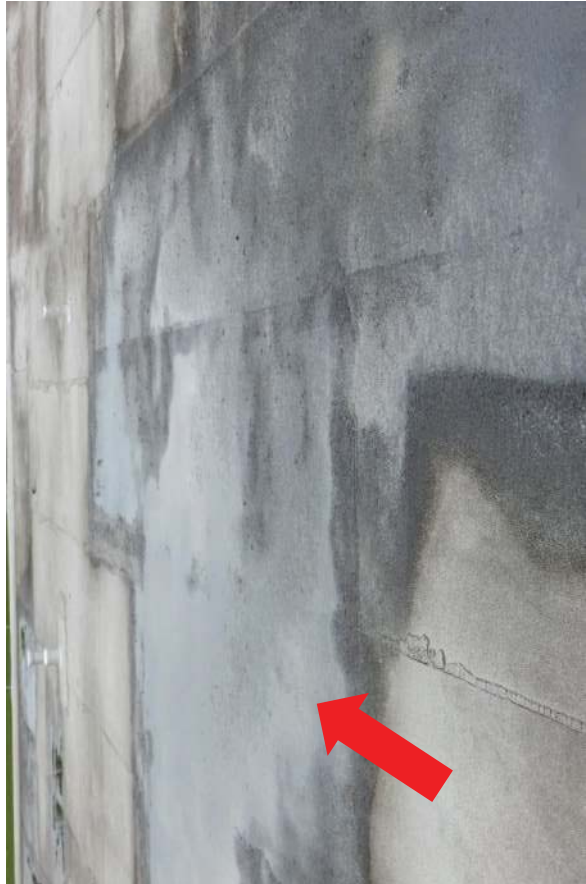
#52 Roof over phase one of community center showing standing water

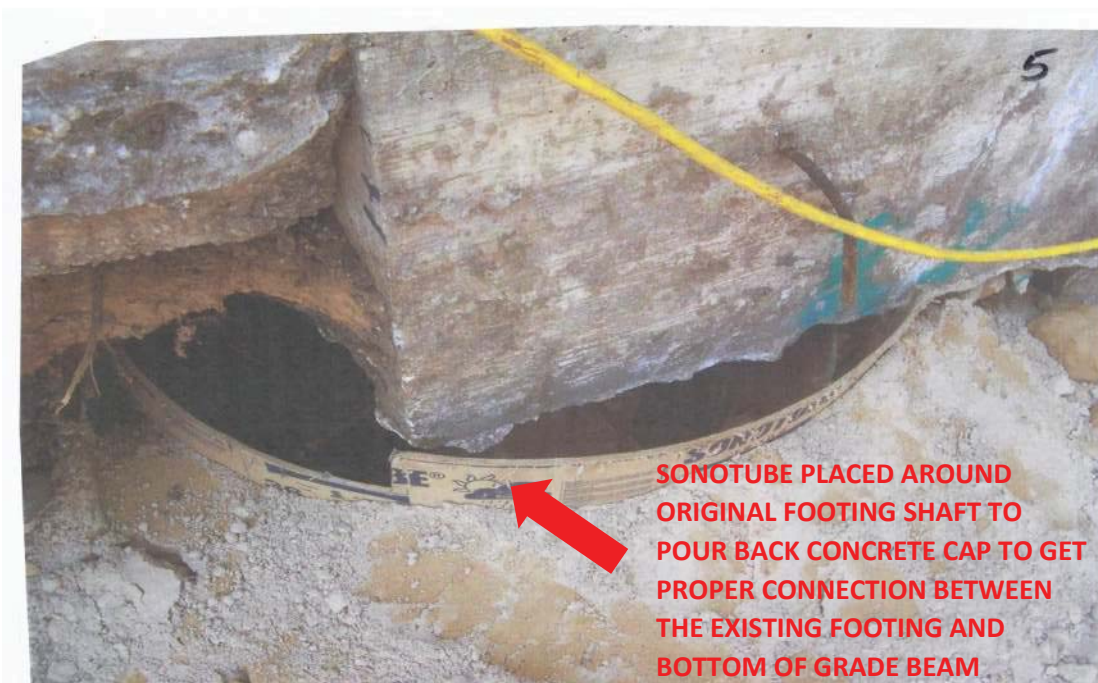
#4 Photo taken by contractor of Phase Two showing how concrete cap was being poured between existing footing and grade beam

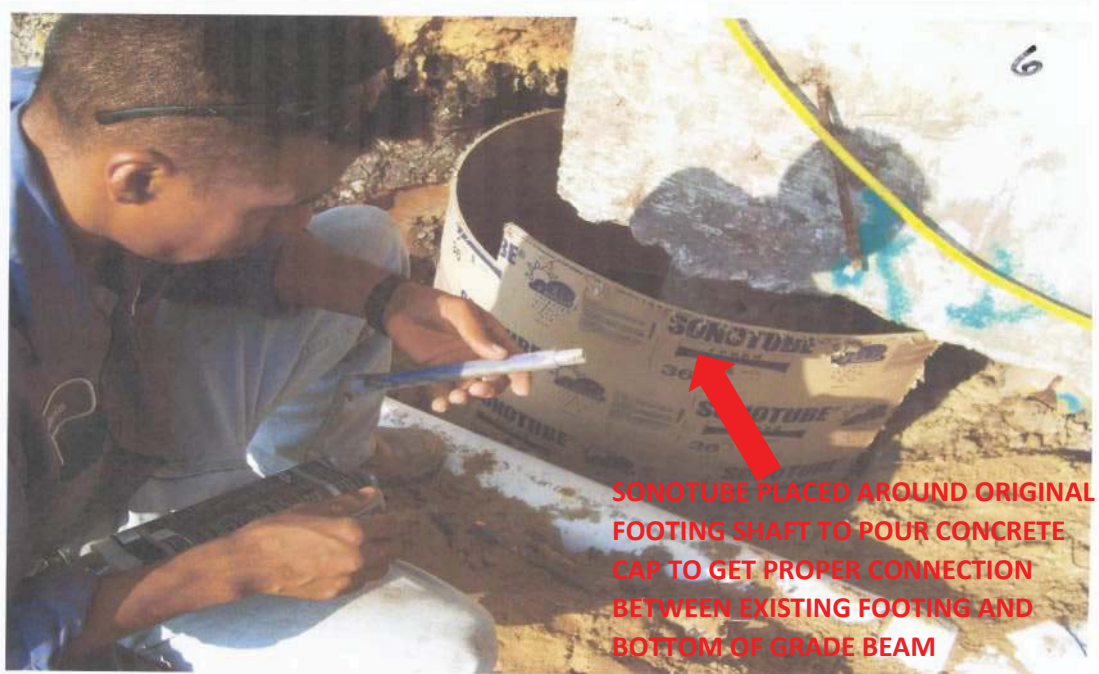
#5 Photo taken by contractor of Phase Two showing how concrete cap was being poured between existing footing and grade beam

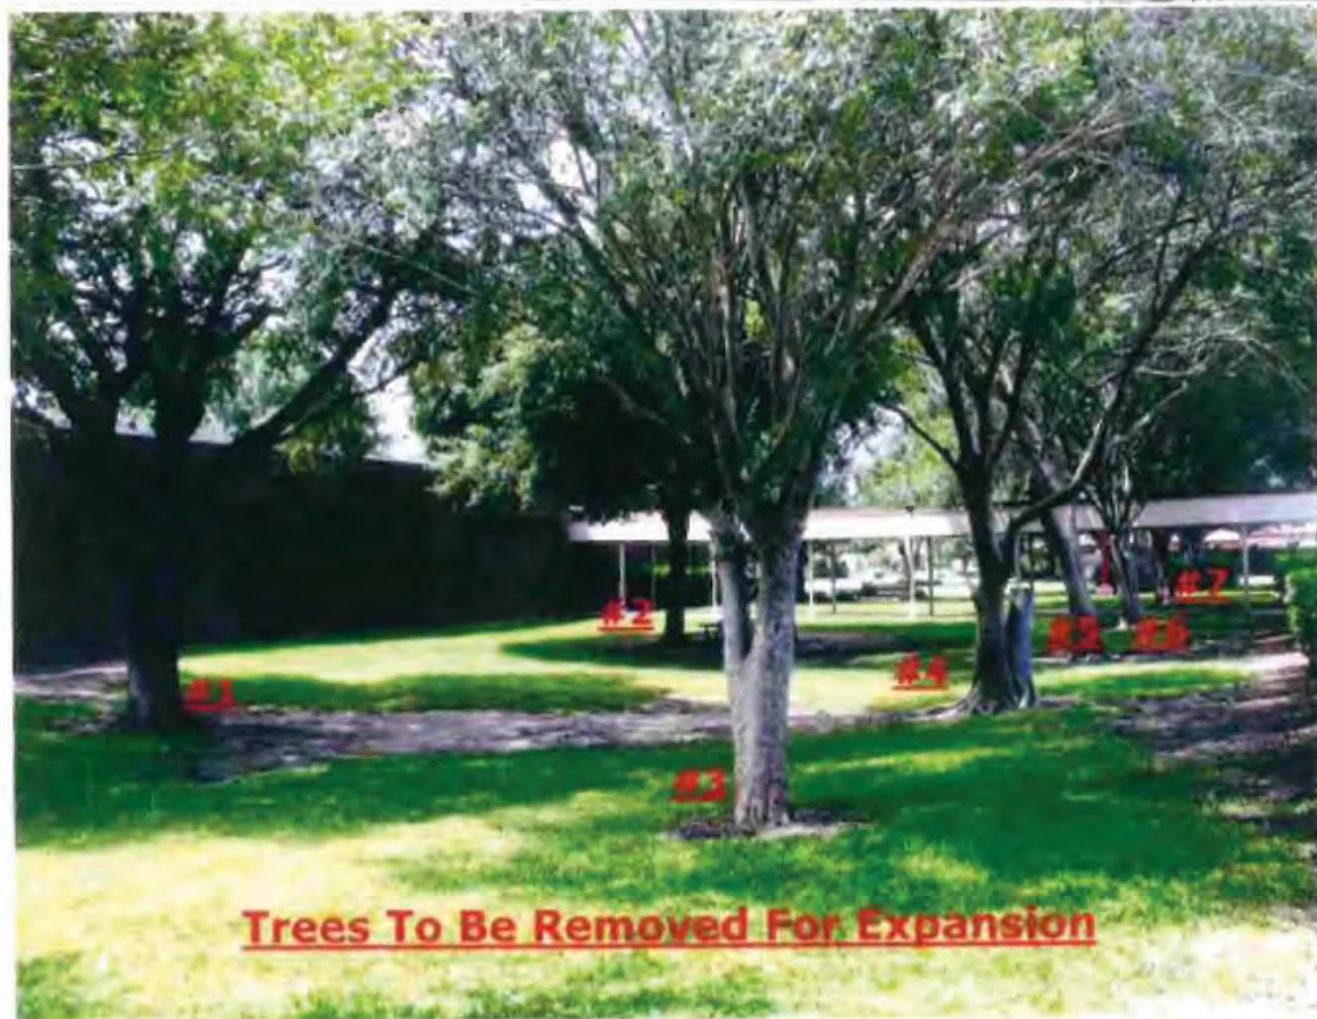
A file containing previous engineering reports, plumbing tests, addition construction inspection records and photos, e-mails, letters, foundation repair contracts for the original building and geotechnical reports was provided by The City of Deer Park to Terracon. Two photos were provided to Terracon labeled "Trees to Be Removed for Expansion". The photos number from 1 through 7, the mature deciduous trees which were removed prior to the addition construction. See Figures 5 and 6 in Appendix B.

The removal of water from the foundation supporting soils by certain species of trees can lead to a desiccated or drier soil zone in the range of three to six feet below the surface. This zone is, in effect, pre-consolidated by the removal of moisture by the tree. If the tree is removed, rebound of the desiccated zone slowly occurs as water re-hydrates the soils and the soil volume expands. Terracon was provided with two photos by The City of Deer Park labeled "Trees to Be Removed for Expansion" The photos number from 1 through 7, the mature deciduous trees which were removed prior to the addition construction. See Figures 5 and 6 in Appendix B. Further, aerial photography of the site from July 2005 to March 2011 indicates that mature trees were removed from the site prior to construction. See Figures 7 through 10 in Appendix B. Whenever mature trees are removed from a site prior to construction, special procedures should be employed to allow rehydration and volume change of the soil to occur prior to the actual commencement of building. It is likely that the removal of these trees prior to construction of the building have contributed to differential movement of the building slab-on-grade foundation.

**Figure 5 – Trees to Be Removed For Expansion: Sheet 1**  
Deer Park Community Center  
Deer Park, Texas  
Source: The City of Deer Park  
Terracon Project No. F3128529  
September 30, 2013

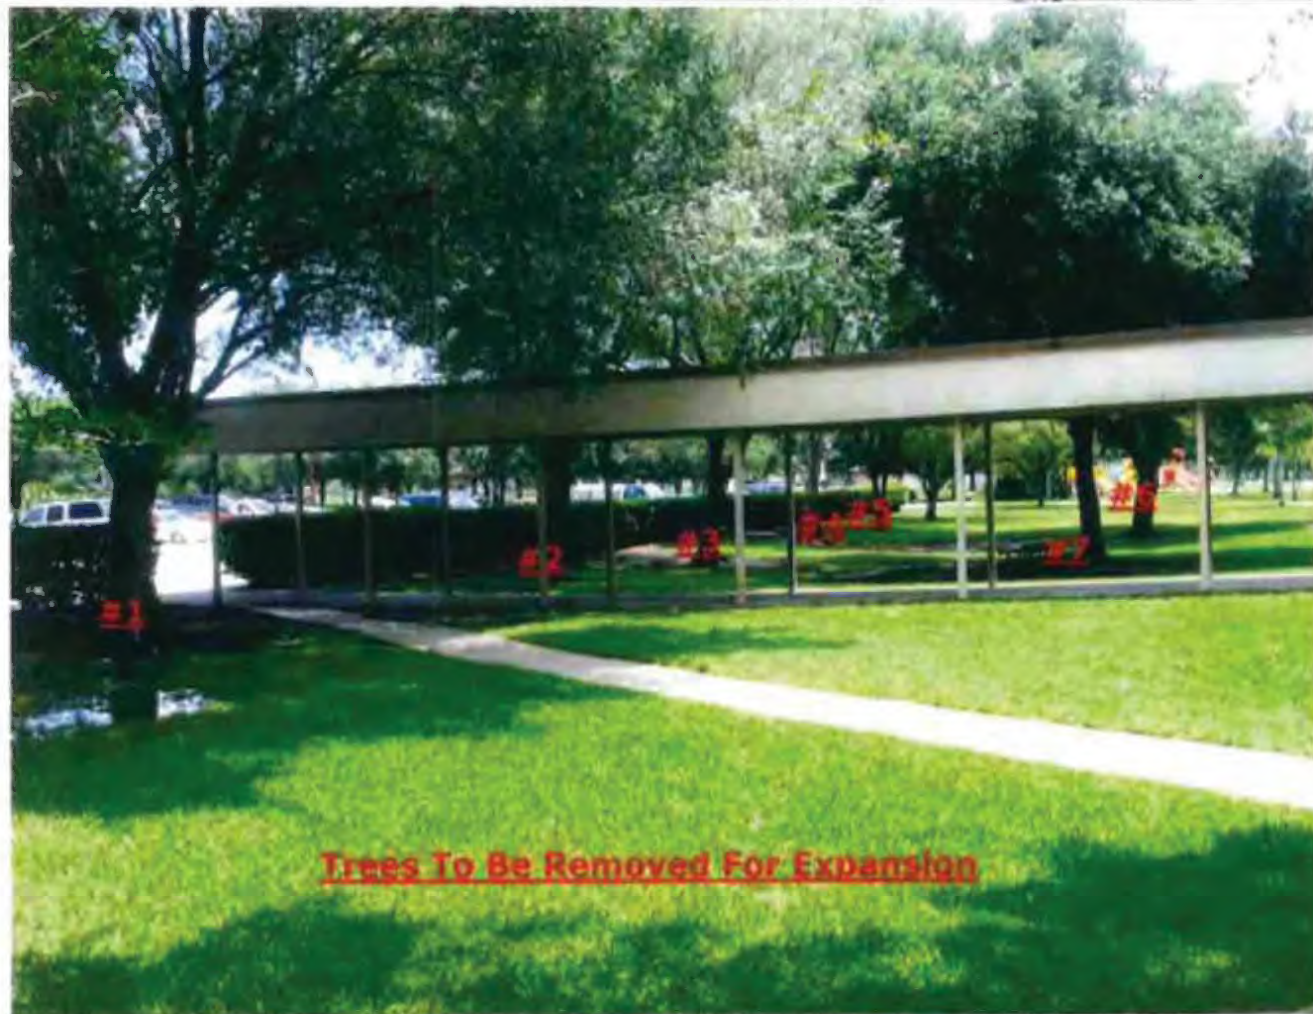
**Figure 6 – Trees to Be Removed For Expansion: Sheet 1**  
Deer Park Community Center  
Deer Park, Texas  
Source: The City of Deer Park  
Terracon Project No. F3128529  
September 30, 2013

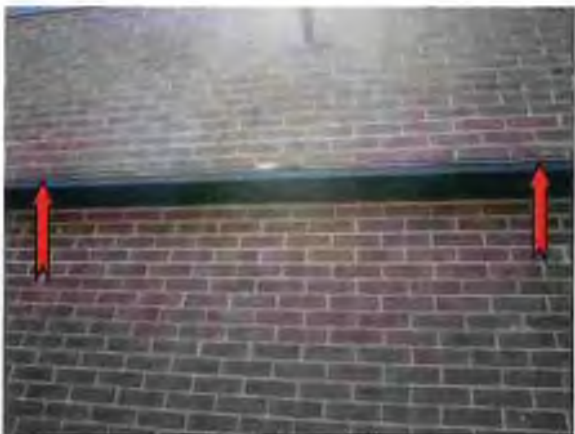
**Photo #5** Separation between the brick veneer and the metal flashing

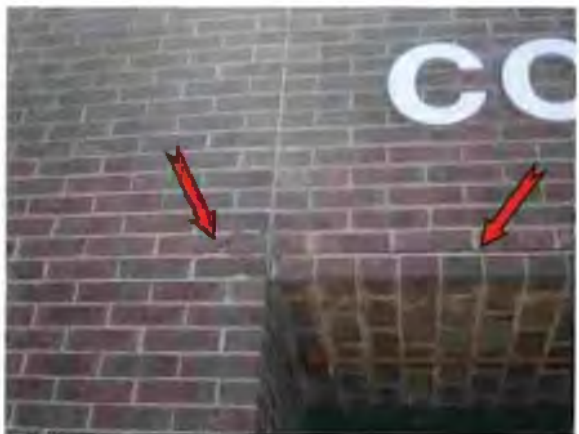
**Photo #6** Masonry-mortar-joint crack

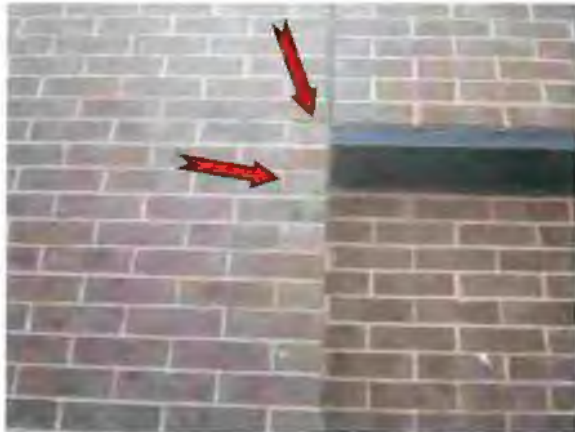
**Photo #7** Masonry-mortar-joint crack

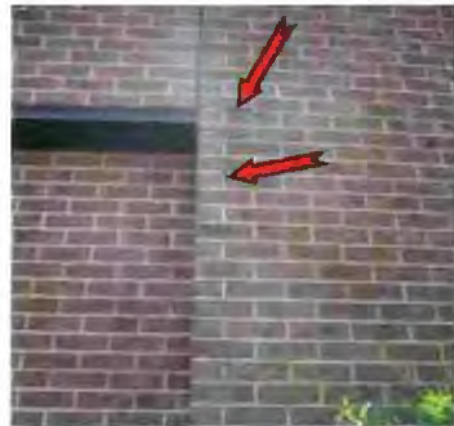
**Photo #8** Masonry-mortar-joint crack

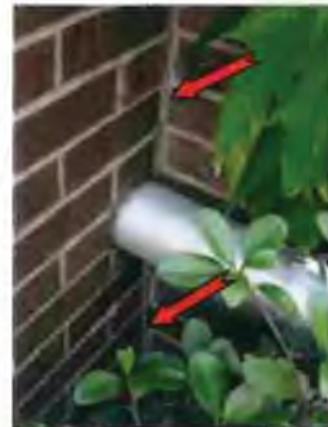
**Photo #10** Separation at expansion joint

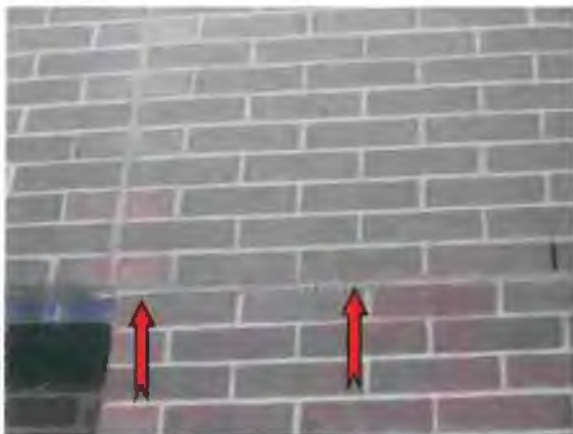
**Photo #11** Separation at expansion joint

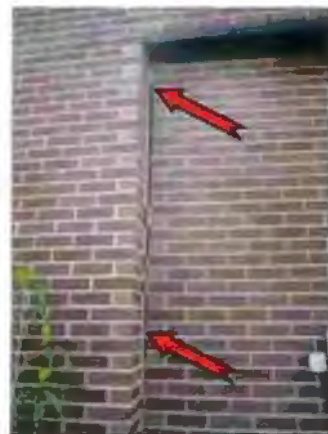
**Photo #12** Separation at expansion joint

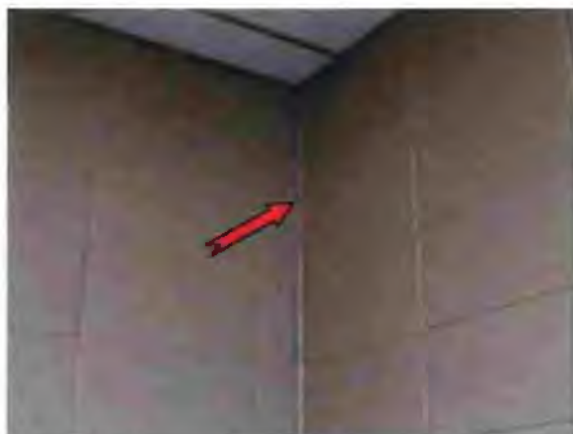
**Photo #24** Crack at corner of concrete masonry unit walls

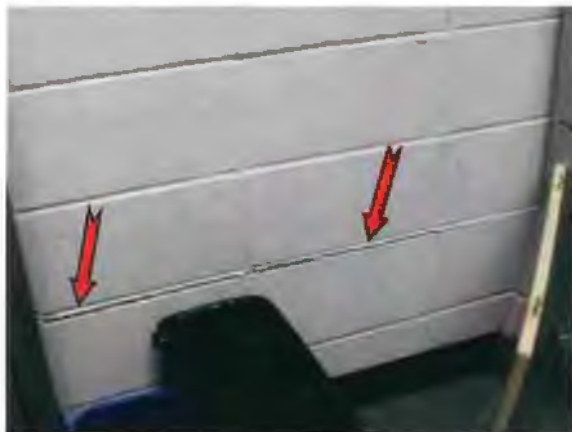
**Photo #27** Joint crack in concrete masonry unit wall

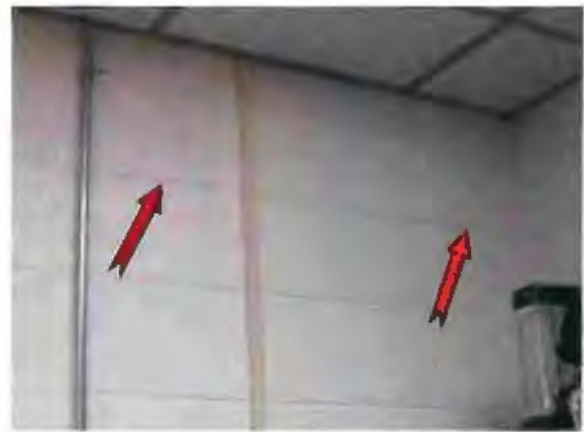
**Photo #28** Joint crack in concrete masonry unit wall

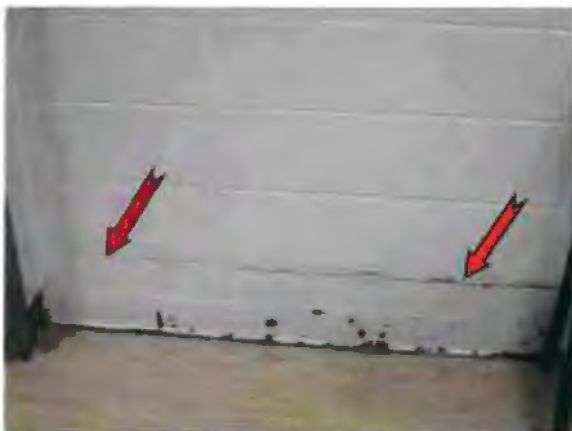
**Photo #29** Joint crack in concrete masonry unit wall

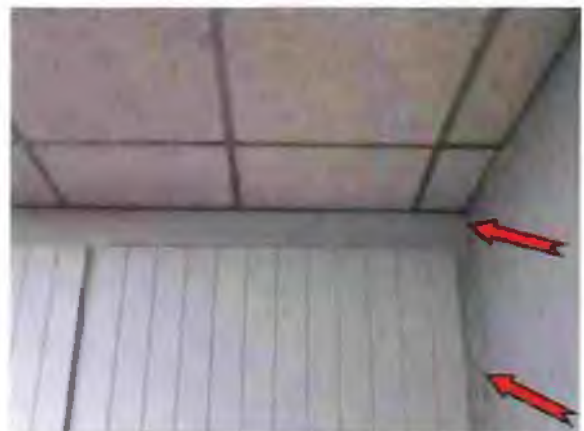
**Photo #30** Crack at corner of concrete masonry unit walls

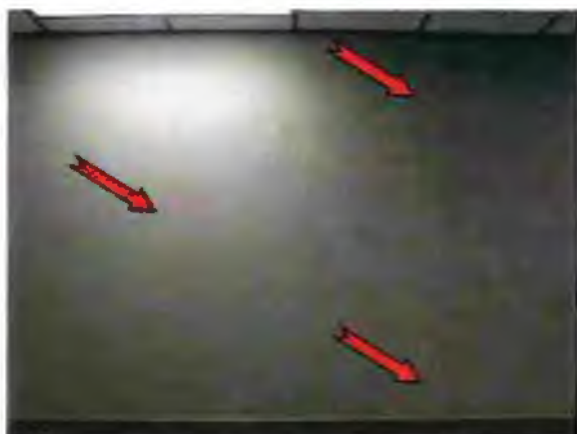
**Photo #31** Cracks in gypsum wallboard wall

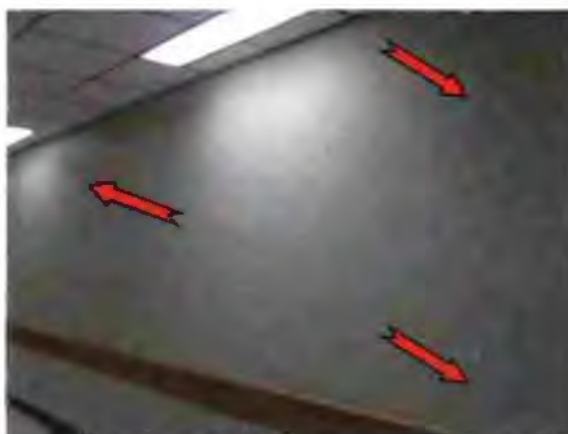
**Photo #32** Cracks in gypsum wallboard wall

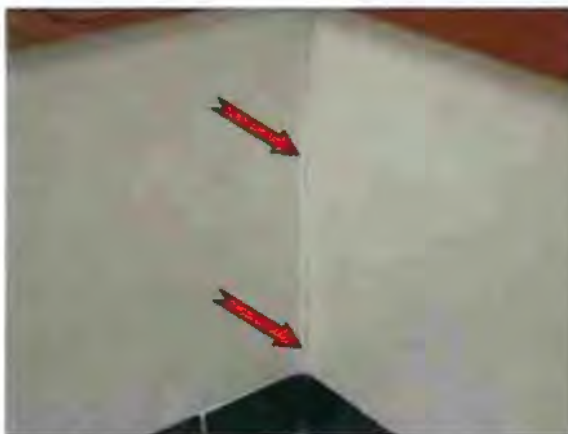
**Photo #34** Crack in gypsum wallboard walls

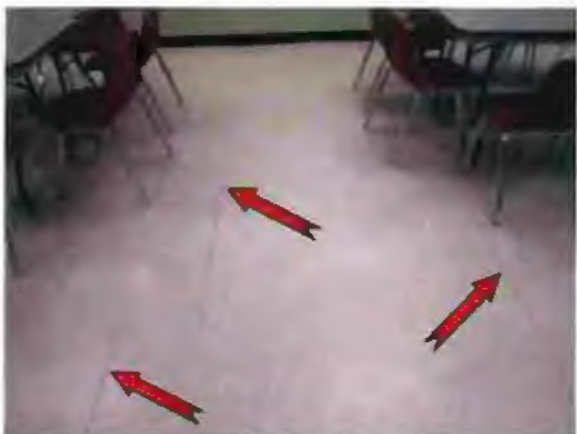
**Photo #35** Separations in vinyl tile floor

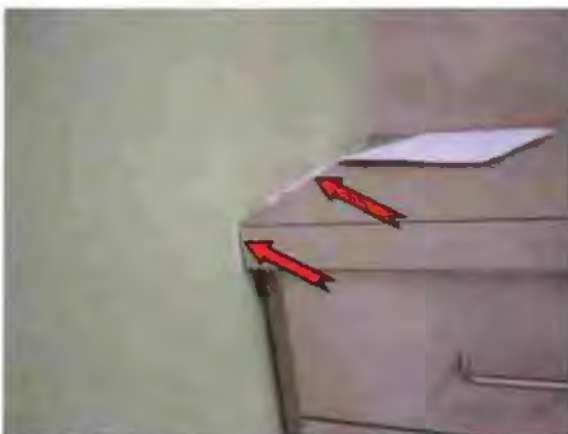
**Photo #36** Separation between counter top and wall

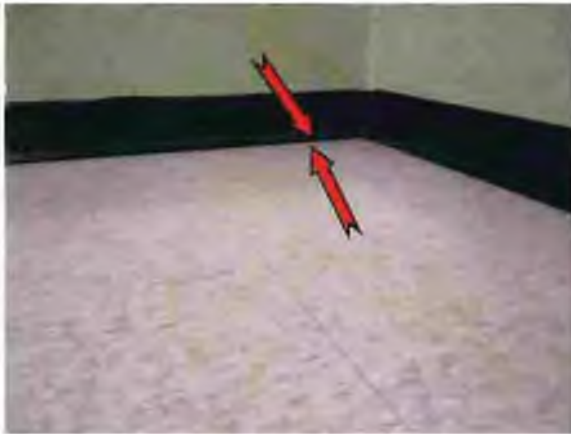
**Photo #37** Separation between the baseboard and the floor

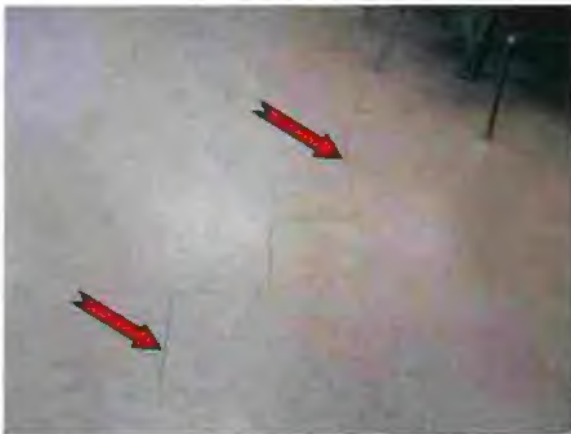
**Photo #39** Separations in vinyl tile floor

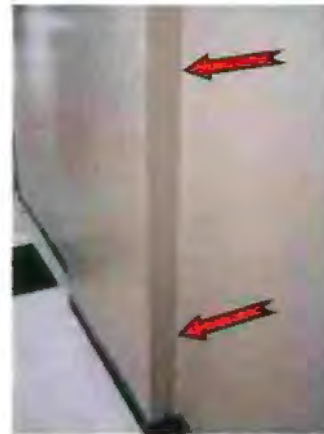
**Photo #40** Crack in gypsum wallboard wall

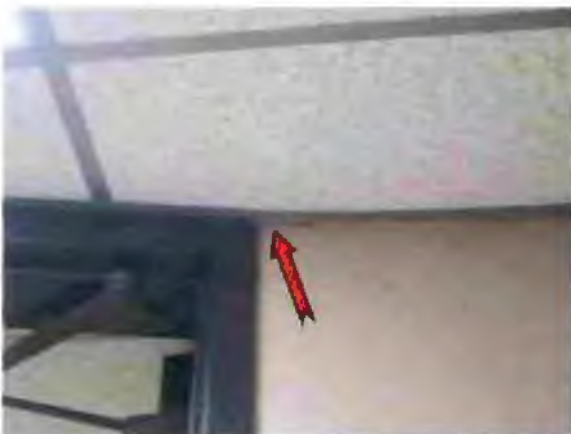
**Photo #41** Separation between the gypsum wallboard and the suspended acoustical ceiling

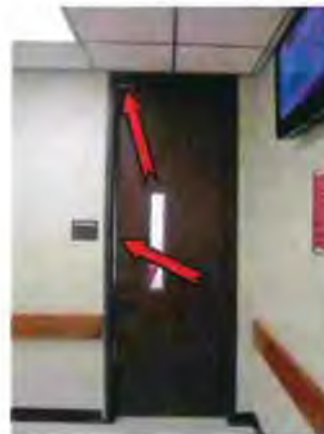
**Photo #42** Door out-of-square with respect to its frame and binding in its frame

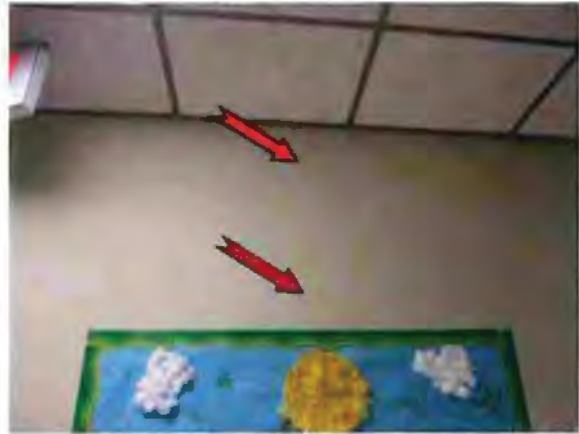
**Photo #44** Crack in gypsum wallboard wall

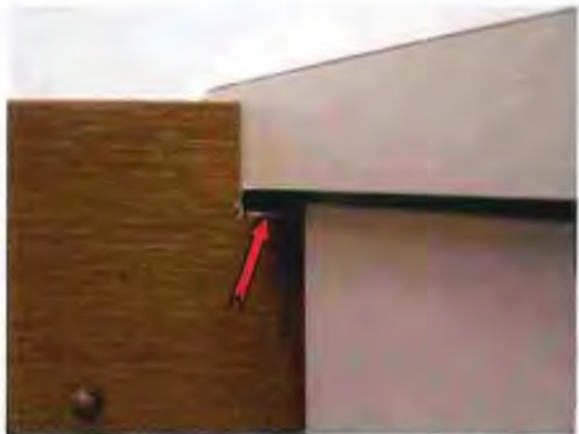
**Photo #48** Separation between wood trim and counter top

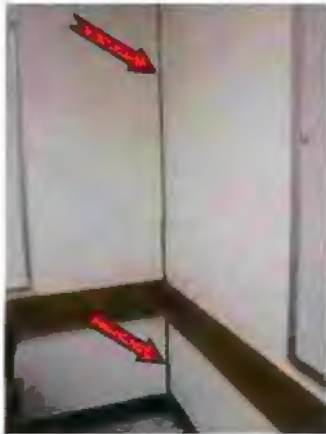
**Photo #49** Separation in gypsum wallboard wall

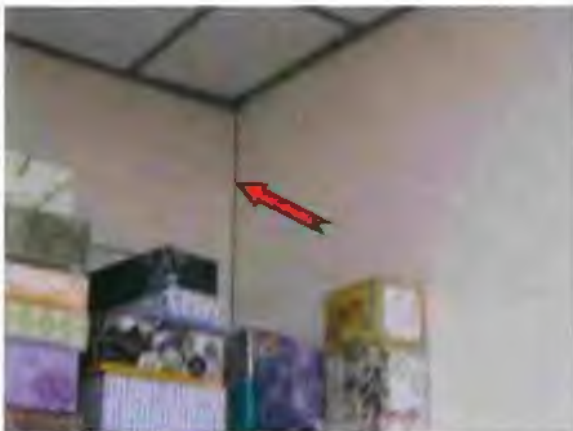
**Photo #53** Separation in gypsum wallboard wall

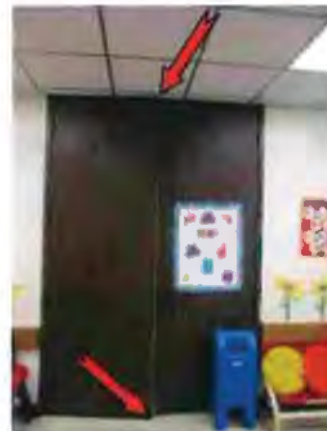
**Photo #54** Door out-of-square with respect to its frame and binding in its frame

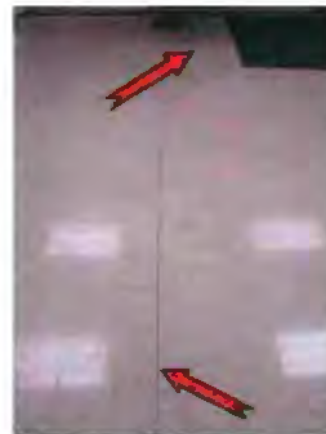
**Photo #60** Separations in vinyl tile floor

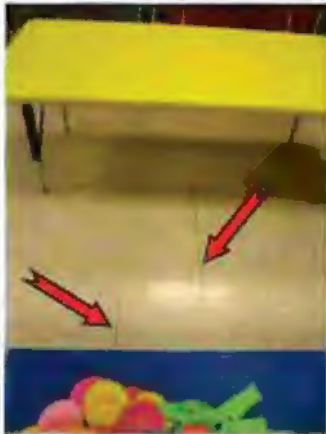
**Photo #61** Separations in vinyl tile floor

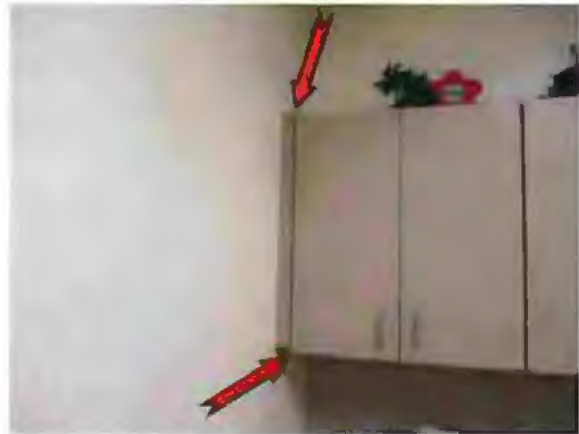
**Photo #62** Cabinet doors out-of-square with respect to their frame

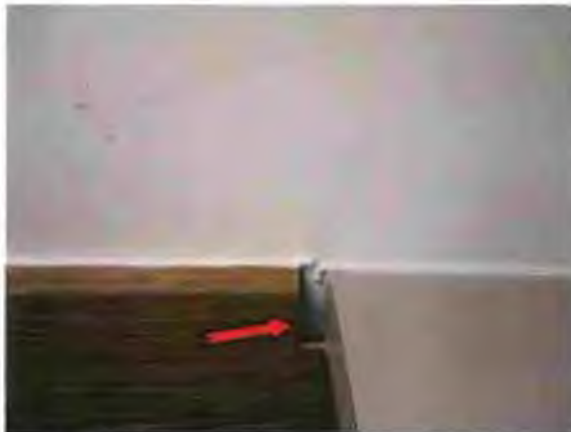
**Photo #63** Separation between wood trim and counter top

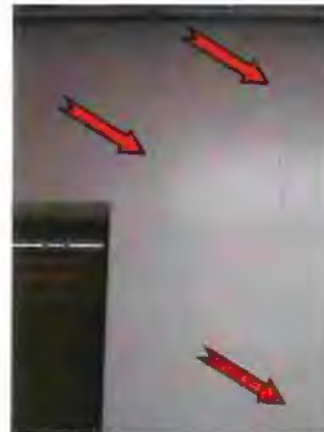
**Photo #64** Cracks in gypsum wallboard wall

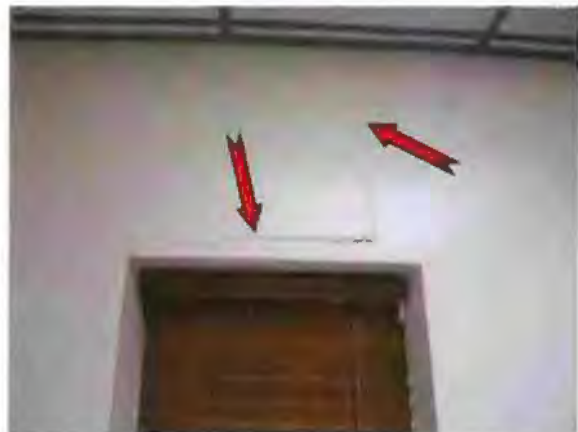
**Photo #66** Crack in gypsum wallboard wall

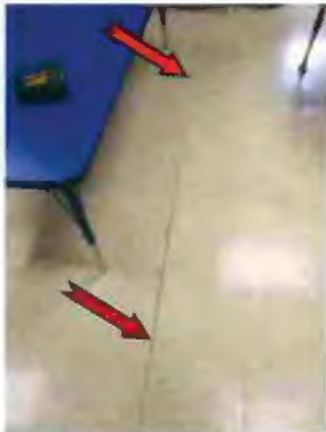
**Photo #69** Separations in vinyl tile floor

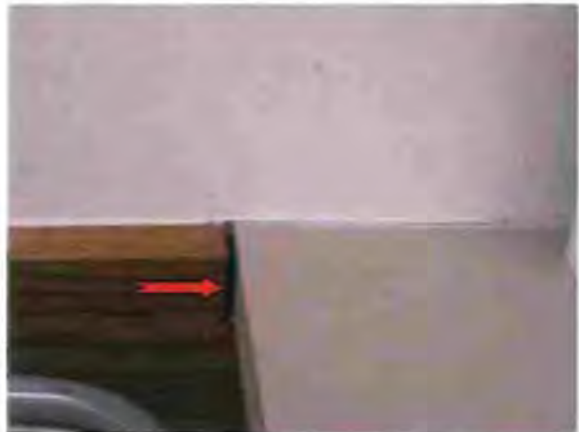
**Photo #70** Separation between wood trim and counter top

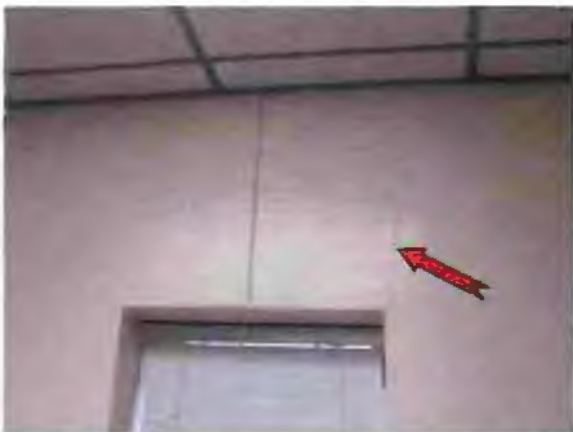
**Photo #71** Crack in gypsum wallboard wall

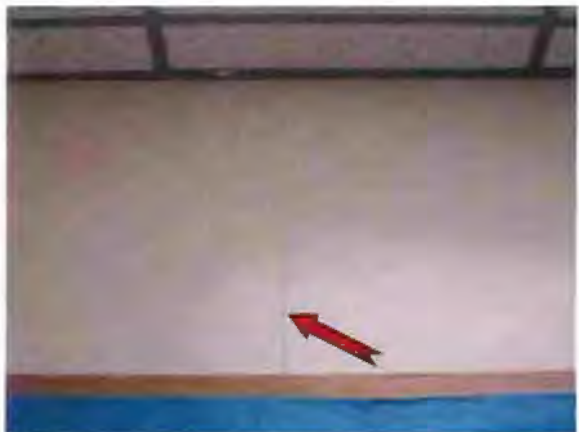
**Photo #72** Crack in gypsum wallboard wall

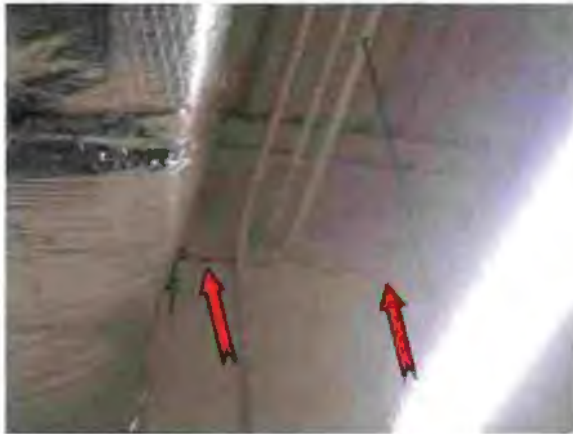
**Photo #73** Crack in gypsum wallboard wall

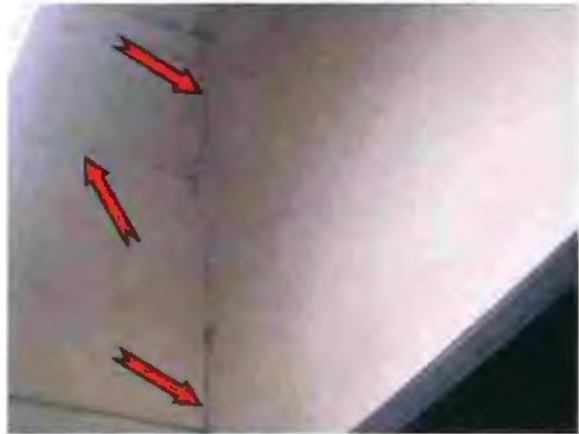
**Photo #74** Crack in gypsum wallboard wall

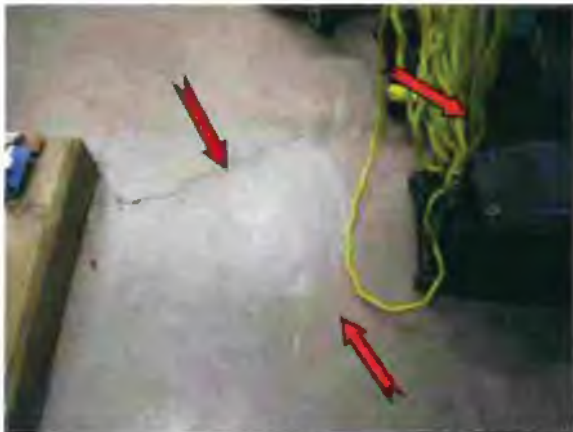
**Photo #75** Cracks in exposed concrete floor

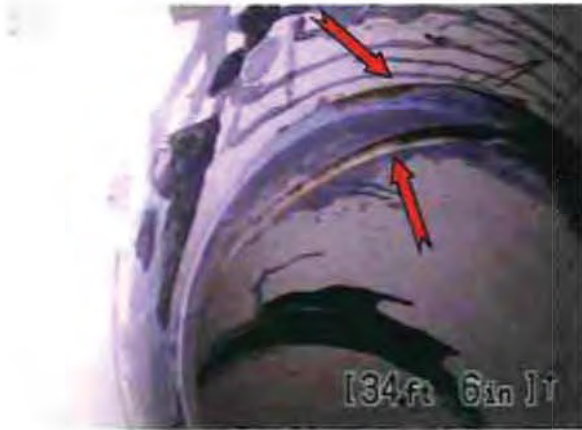
**Photo #79** Broken pipe a in the 12-inch PVC storm line for the original building

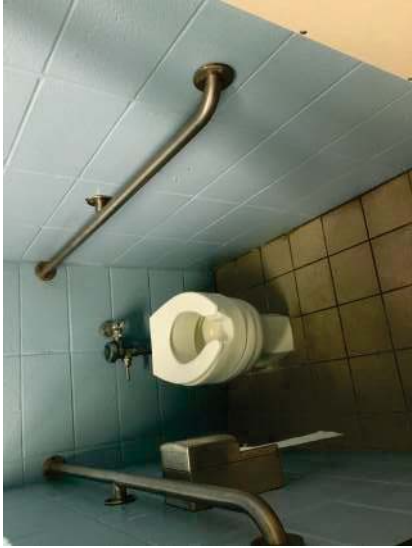
**Subject:** Men & Women's Locker Rooms  
**Page:** Birds Eye View  
**Status:** Not Acceptable  
**Note:** One water closet in each locker room must be accessible and comply with all codes in 604.  
**Element:** Water Closets  
**Barrier:** Location, Clear Space, Grab Bars, Etc.  
**TAS Codes:** 604  
**Web Links:** <http://www.tdlr.texas.gov/ab/2012abtas6.htm#604>

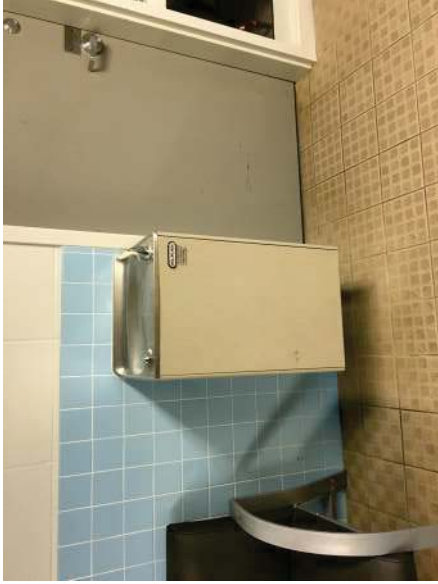
**Subject:** Shower House  
**Page:** Birds Eye View  
**Status:** Not Acceptable  
**Note:** Where drinking fountains are provided, two must be provided. One far walking persons, and one that is accessible to non ambulatory people. They fountains must comply with the applicable code in 602.  
**Element:** Drinking Fountains  
**Barrier:** Minimum Number, Mounting Height  
**TAS Codes:** 211, 602  
**Web Links:** <http://www.tdlr.texas.gov/ab/2012abtas6.htm#602>
